Ovingham Bridge Blog – January-March 2015

Truss repairs part 2 of ?

Truss repairs – part 1 of ?

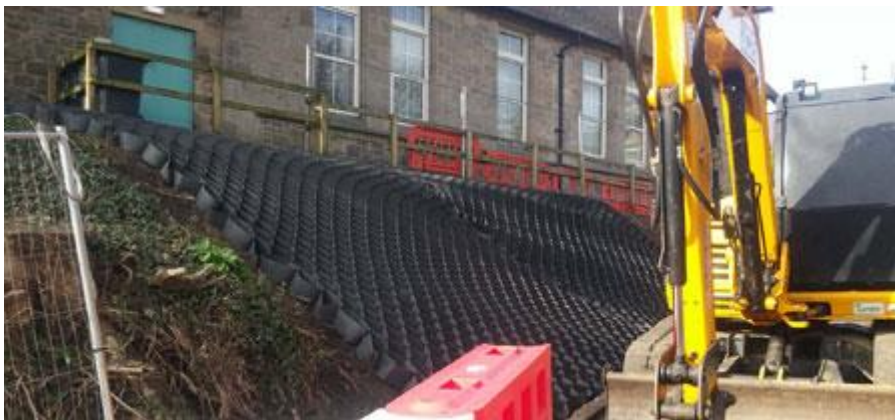
Photo taken 20 February, showing the honeycomb installed on slope. The next stage is to fill the honeycomb cells with topsoil.

The honeycomb structure is normally used on river banks to prevent higher river levels eroding newly installed slopes. It is being used here to retain the topsoil, in broadly the same manner as it would on a river bank.

The honeycomb is anchored in a trench at the top and is pinned to the slope.

Because the slope is steep, it will not be replanted with grass seed. The plan is to replant it with ground cover plants which will only need minimal maintenance.

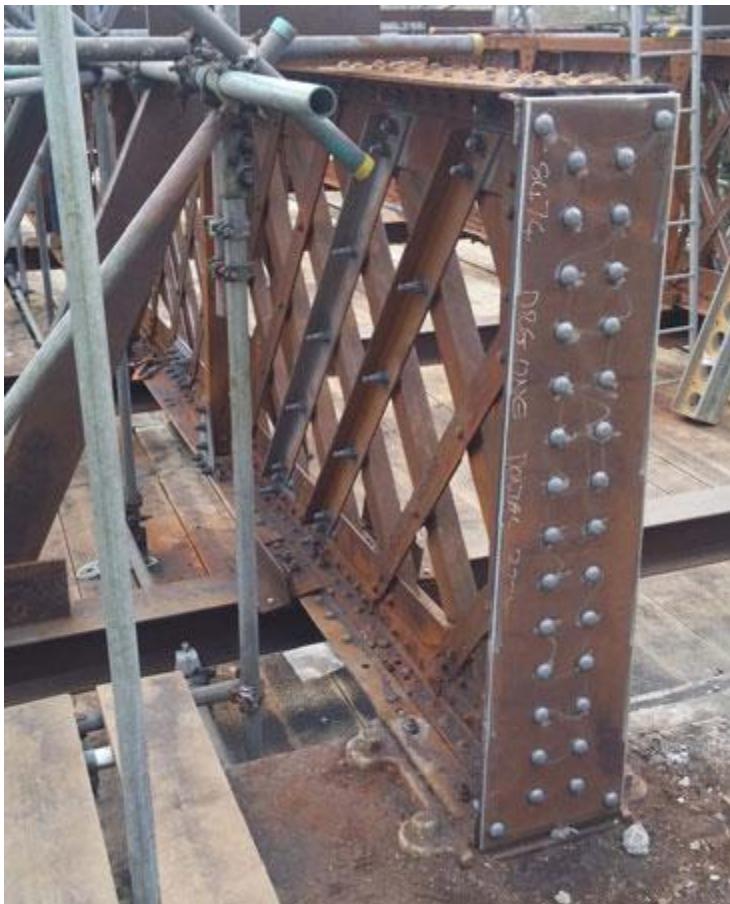
Downstream Truss, Bay one, End Stiffner

Photo taken 19 February, refer to blog 17 which shows the stages prior to this. The end stiffeners were badly corroded and have been replaced. In order to prevent water ingress into the plies of metal beneath the stiffener plate, a capping plate will be added to the top of the stiffener.

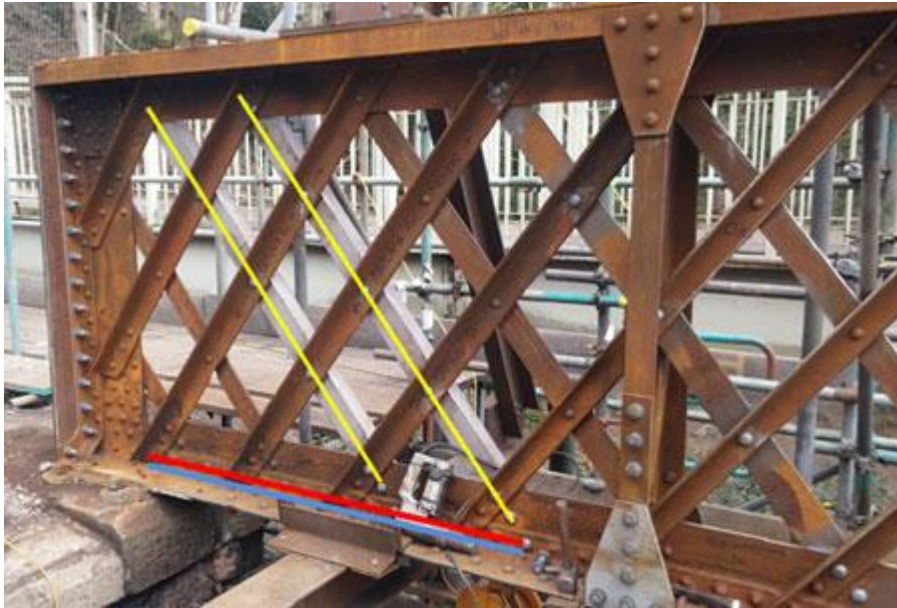
Downstream Truss, Bay one. Ovingham abutment

Photo taken 20 February, showing the first bay behind the end stiffener shown above. This bay which is 2.286m (7' 6") long, is in a poor condition. The contractor has replaced some of the lattice web members. However further progress cannot be made until the repair to the bottom chord of the truss is finalised. The angle which connects the web plate (red line) to the bottom chord (horizontal plate and blue line) is badly corroded. Repairing this is complex because to repair the angle requires removing both lines of rivets. Removing the fixings changes the truss into a T section and their removal will weaken the structure.

The repair has to be done in short lengths, to maintain the truss' strength. Once installed the repair has to be spliced together to ensure it is effective. The yellow lines show replacement angles to the lattice web.

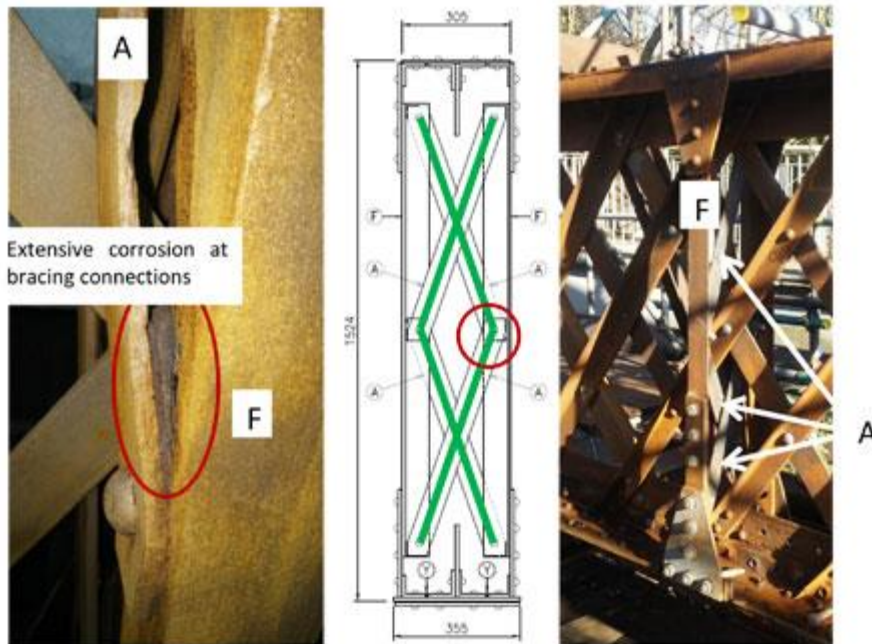
Typical U-Frame Stiffener Bracing Member

Photograph on the left shows the U frame bracing (labelled A) connection with the vertical angle (labelled F). Member F is a 3" x 3" angle, while member A is a 2.5" wide x 3/8" thick flat.

The connection details (circled) are a water trap and this has led to significant corrosion of both the bracing element and the vertical angle. Approx 40% of the bracing members will be replaced in span 1, nearest Ovingham. By contrast only 20% of these members will be replaced in span 2.

Where corrosion of the angle is extensive, the angle will also be replaced. The photograph on the right shows a U-frame stiffener with three bracing members repaired. New members appear silver in contrast to the original brown members of the truss.

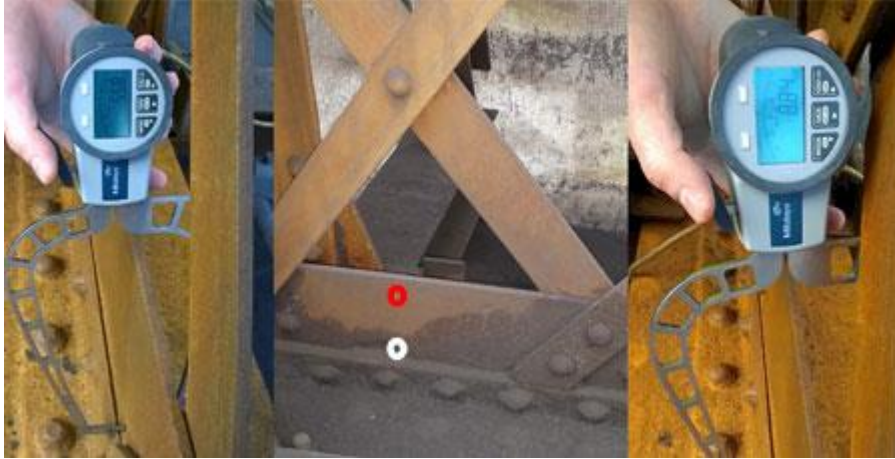
This measurement was taken in span 1 (Ovingham), away from the worst corrosion. Refer to the central photograph for position. The plate is supposed to be 3/8" thick (10mm). At the top (red dot on central picture) where water has not sat it measures 9mm thick. It has lost 0.5mm per face in 130 years.

At the base of the plate (white dot on central picture) where the angles forms a water trap the measurement is 5.5mm. It has lost 2mm per face in 130 years. This will have to be repaired.

The black staining in the central photograph, is salt impregnation of the wrought iron. This has to be reduced to acceptable levels, in order to receive the paint system.

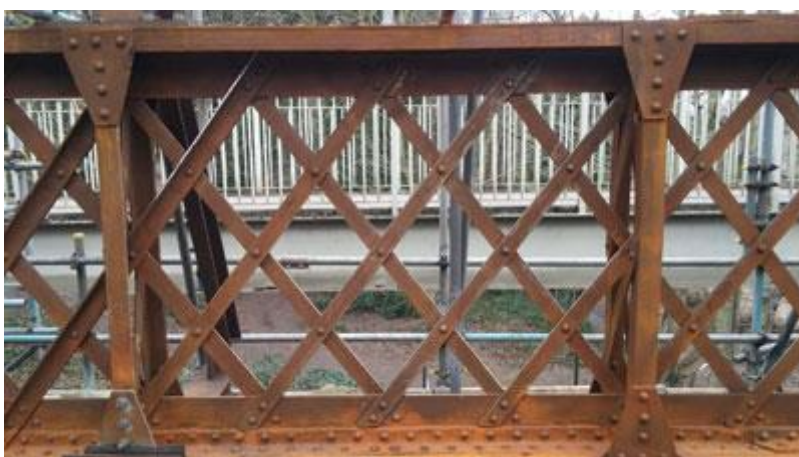
This photograph was taken 13 February 2015.

Firstly the extent of the web plate corrosion, as noted above.

Secondly, the edges of the lattice work have been ground off to a pencil edge radius, showing clean and shiny metal beneath. This is because the paint system can be damaged by sharp edges on the metal. Something the Victorians were not aware of at the time they built the bridge. Every edge on the bridge has to be ground down in this manner.

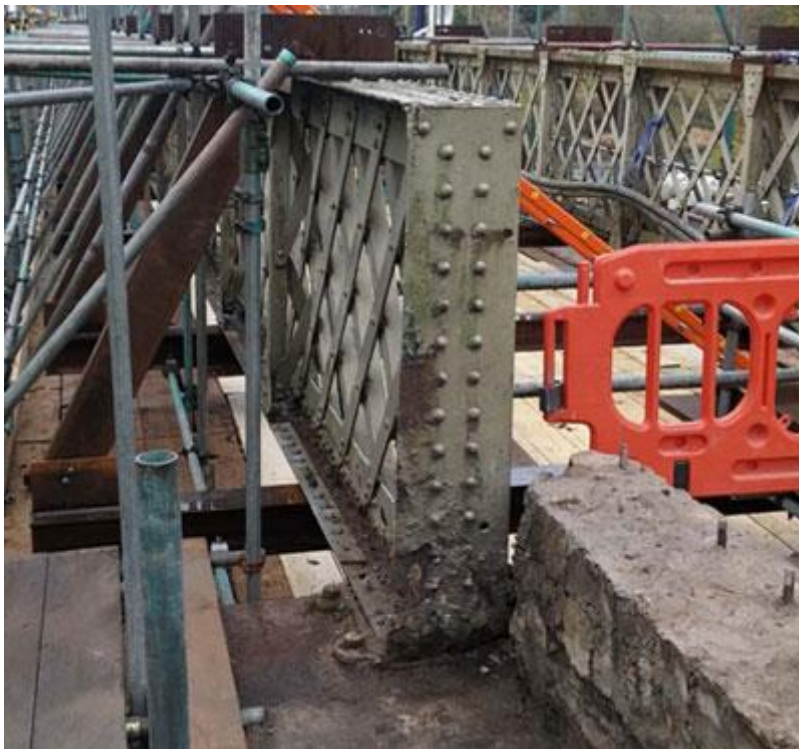
Photograph taken 12 November 2014, Showing corroded end stiffener in place

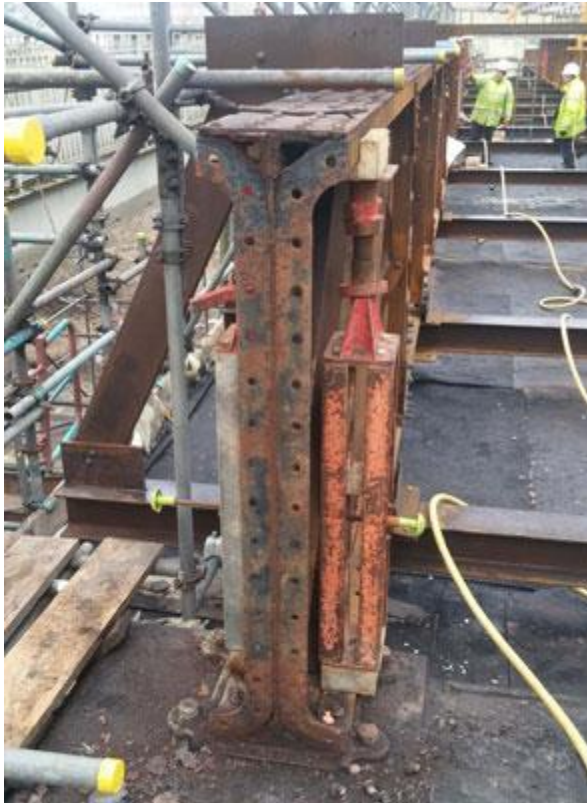
Photograph taken 13 February, with end stiffener plate removed. Note the props are installed to ensure the truss is adequate to carry its own weight and the temporary bracing.

These repairs are carried out at the abutments (where the bridge meets the land). Similar repairs are required at every pier leg, as well as additional repairs. Hence the reason for all of the enclosure coming down.

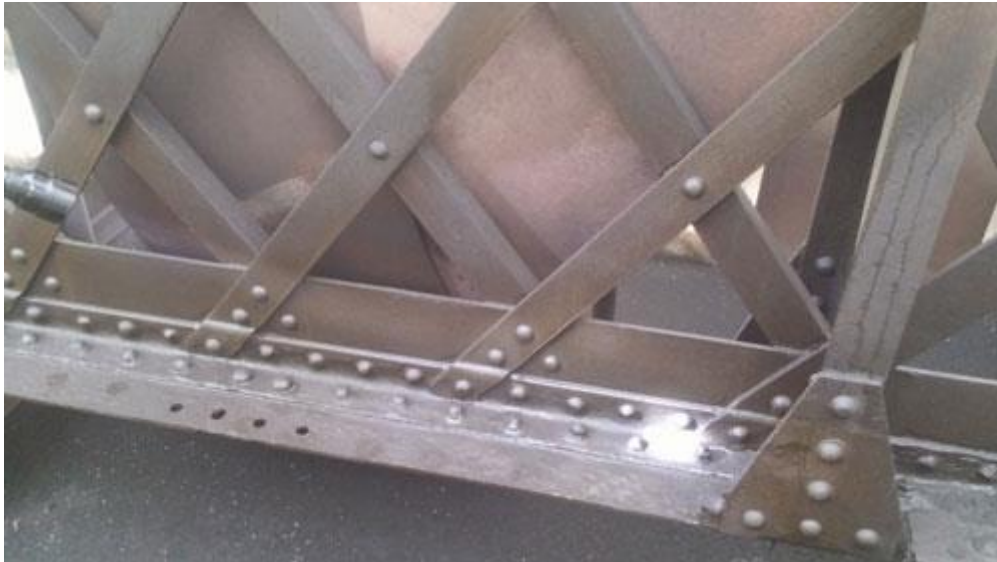
Photograph taken 18 December 2014, after test blast

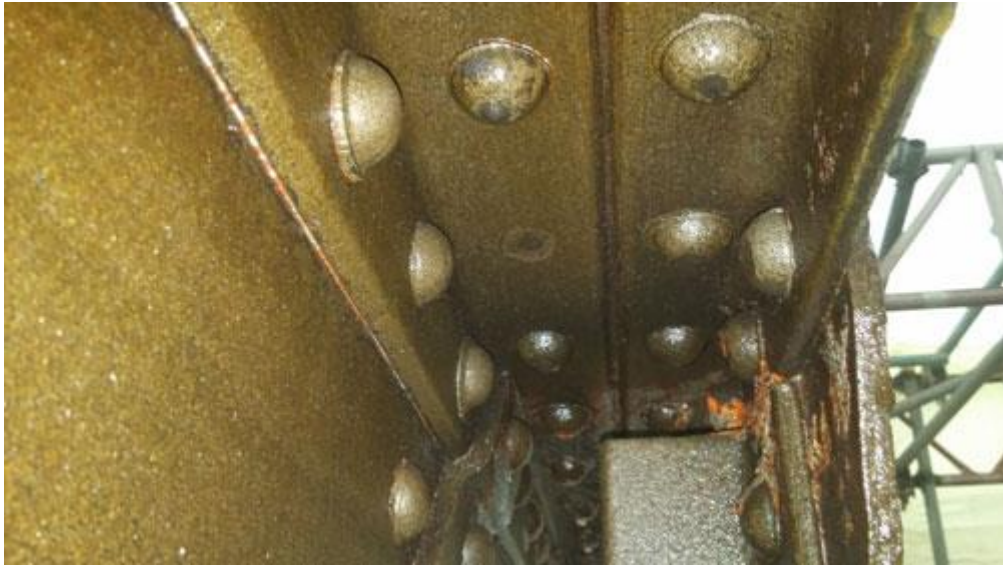
Photograph taken 18 December 2014.

This was taken underneath the top chord, the blasters have found it difficult to remove the paint from the inside back face of the top part of the truss. Note the orange colour on the right of the photo.

This is the reason for doing a trial blast, it resolves any issues with blasting access to all parts of the bridge.
