# Ovingham Bridge Blog – June-August 2014

27 August 2014

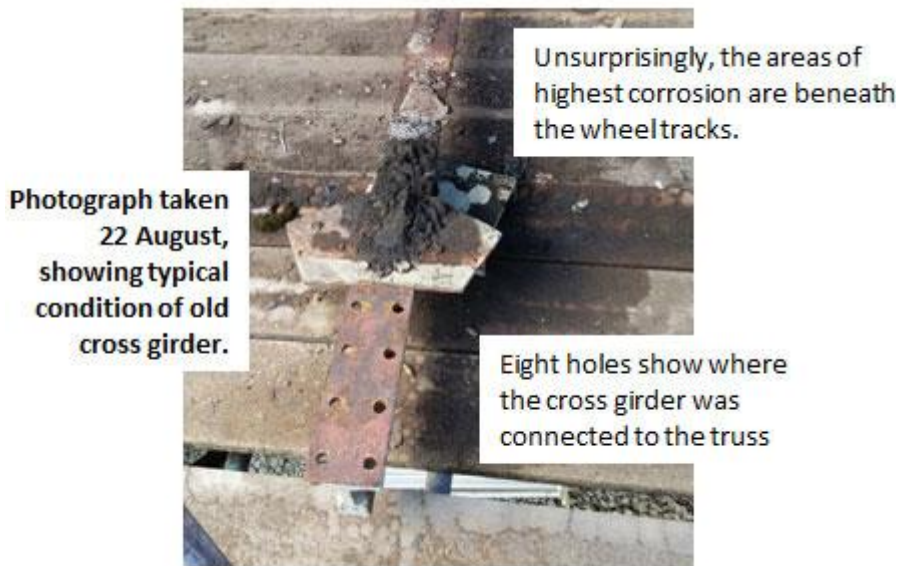
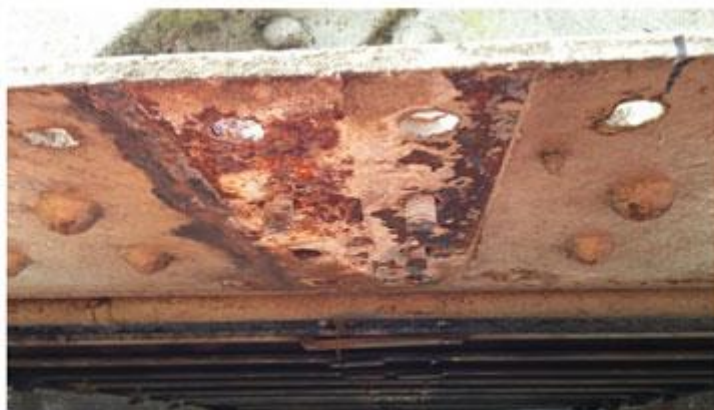
Photograph taken 22 August showing typical condition of bottom chord soffit, where cross girder was fixed to truss

Although the photographs were taken in span 2, it demonstrates the typical condition of the trusses at cross girder positions.

Before this can receive the temporary bracing arrangement, refer to Blog 02 (8 July 2014) for the layout. It has to be prepared to remove the old lead based paint and any corrosion. The prepared plate has to be measured, compared to its original thickness and repaired as required.

Once the repair has cured the section is re-measured to ensure the minimum plate thickness has been achieved. Once the desired minimum thickness has been achieved, the section is painted. Once the paint has cured the truss is ready to receive the temporary bracing.

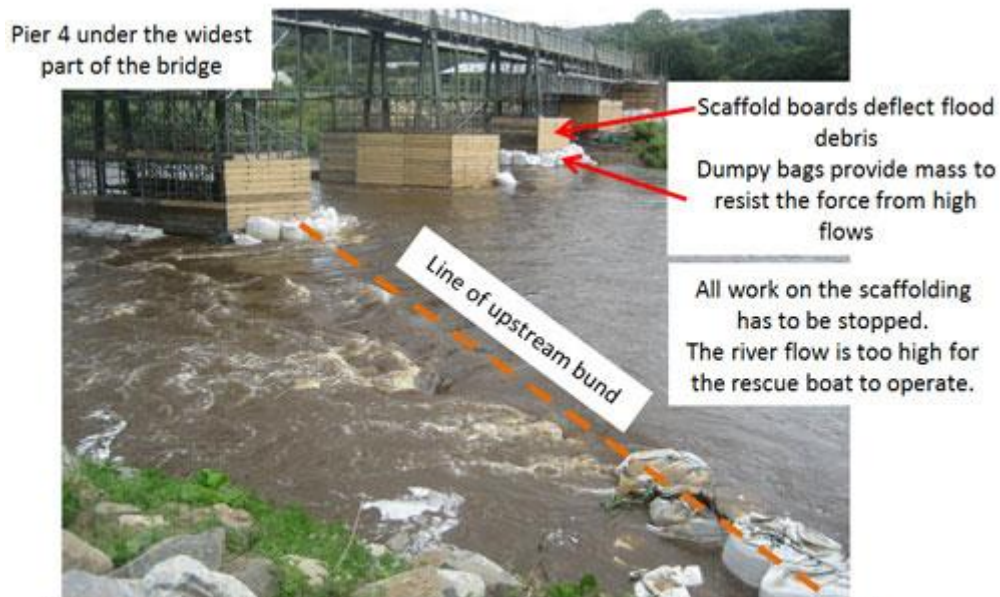
Photograph taken 11 August showing the river level covering the upstream bund

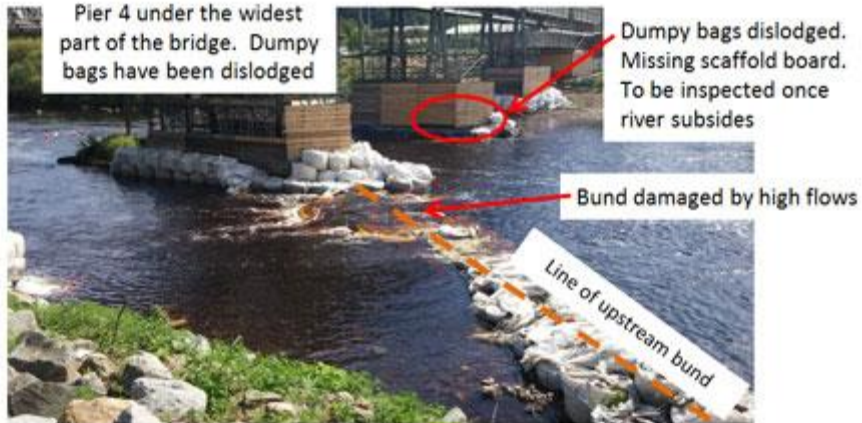
Photograph taken 18 August the river level has dropped, but not enough to assess the damage from heavy rainfall over the weekend 9/10 August

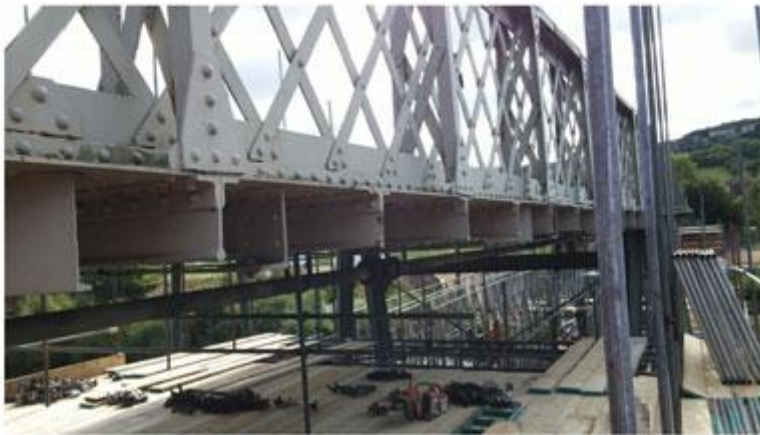
Photograph taken 22 August, inspection of the scaffold foundations demonstrated they were undamaged.

The photograph is taken on span 4 (Ovingham side of the passing place) looking towards Prudhoe showing construction of span 5 scaffolding.

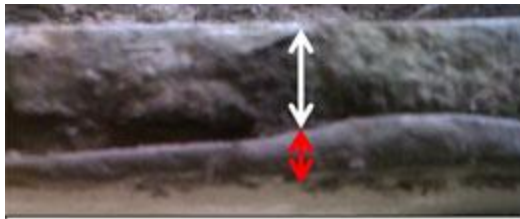
Corrosion is typically caused when unpainted metal is exposed to water and deicing salts. Whilst the bridge cannot be gritted due to the weight restriction. De-icing salts are carried onto the bridge by vehicles taking it from gritted sections of road.

Plate (red arrow) was originally 9.5mm (3/8") thick. It now measures approximately 5mm (1/5") thick. Extra metal will have to be added to the affected area before demolition can commence.

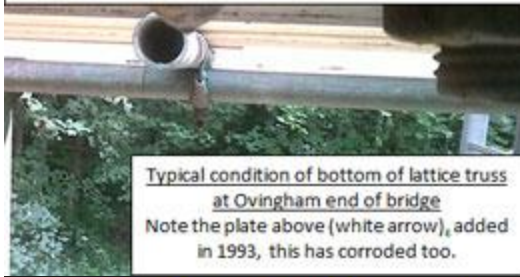
Typical condition of bottom of lattice truss at Ovingham end of bridge  
Note the plate above (white arrow), added in 1993, this has corroded too.

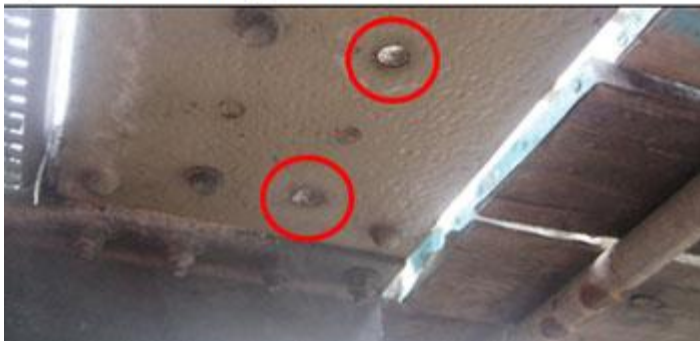
Typical condition of bottom of lattice truss showing missing rivets.

Besides the obvious loss of connection between structural elements, missing rivets allows salt laden water to penetrate the wrought iron. Corrosion then commences

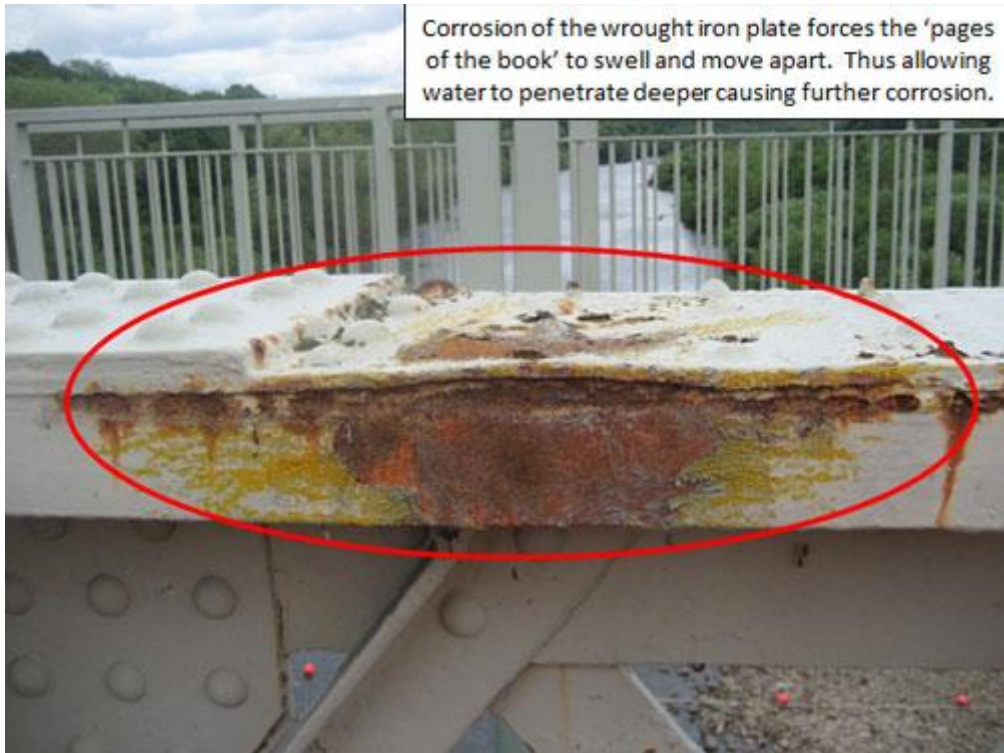
Typical corrosion of the lattice truss – see photograph below

Wrought iron is a laminar material, which means it is like the pages of a book. This is because it was folded in on itself and then rolled during manufacture. This process is repeated dozens of times until the desired plate width and thickness is achieved.

Once water enters the pages, the iron starts to corrode and expand. The photograph below is a typical example.

This will have to be grit blasted, to remove the lead based paint. Once blasted, the damage will be inspected and repaired prior to painting.
