Ovingham Bridge Blog – September-December 2014

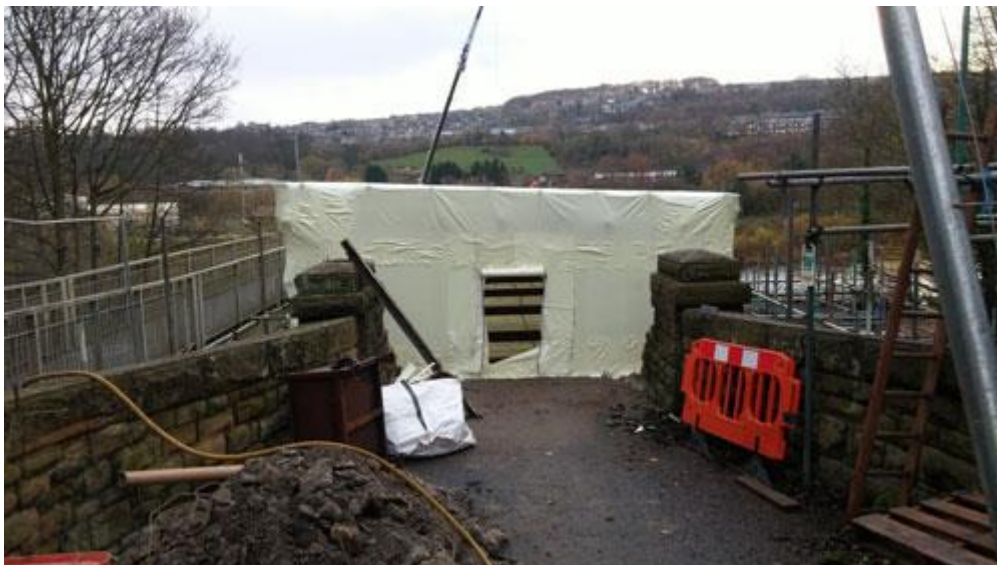
Photograph taken 24 November 2014

This is not an enclosure to keep the work men warm and dry! The enclosure is to contain lead based paint, once grit blasting of the truss starts. The truss has had approximately twenty coats of paint applied to it over its life. This is the first time all of those coats will be removed.

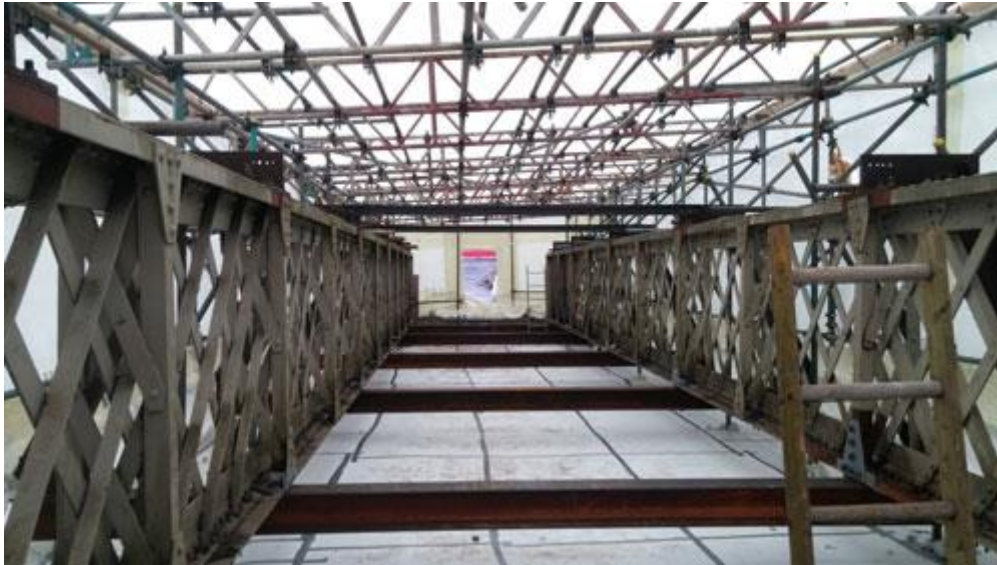
Photograph taken 24 November 2014

Taken inside the enclosure.

Note the scaffolding structure inside to provide a frame for the sheeting. The white floor is a corrugated plastic with taped joints. This provides a watertight enclosure for wet grit blasting. The water helps to suppress the lead in the atmosphere once it's released from the bridge. Lead is a highly toxic substance both to humans and wildlife. All work to enclose the bridge has to be done with permission from the Environment Agency.

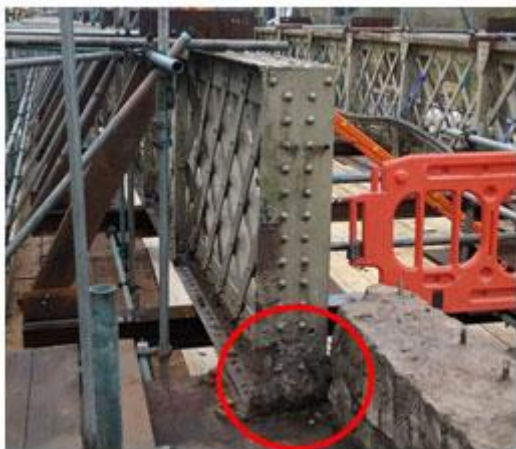
Photograph taken 12 November 2014

Wall and width restriction partially removed behind the truss nearest the footbridge.
See photograph below for detail of corrosion at base.

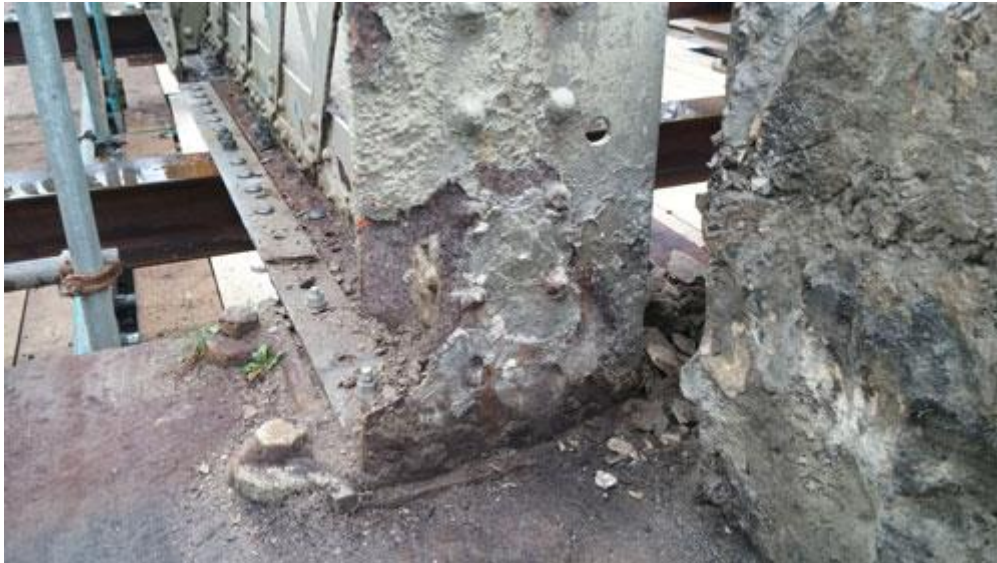
Photograph taken 12 November 2014

End stiffener badly corroded at its base. There are four of these in total, each will be replaced. The truss has to be grit blasted to remove the lead based paint, prior to carrying out any repairs.

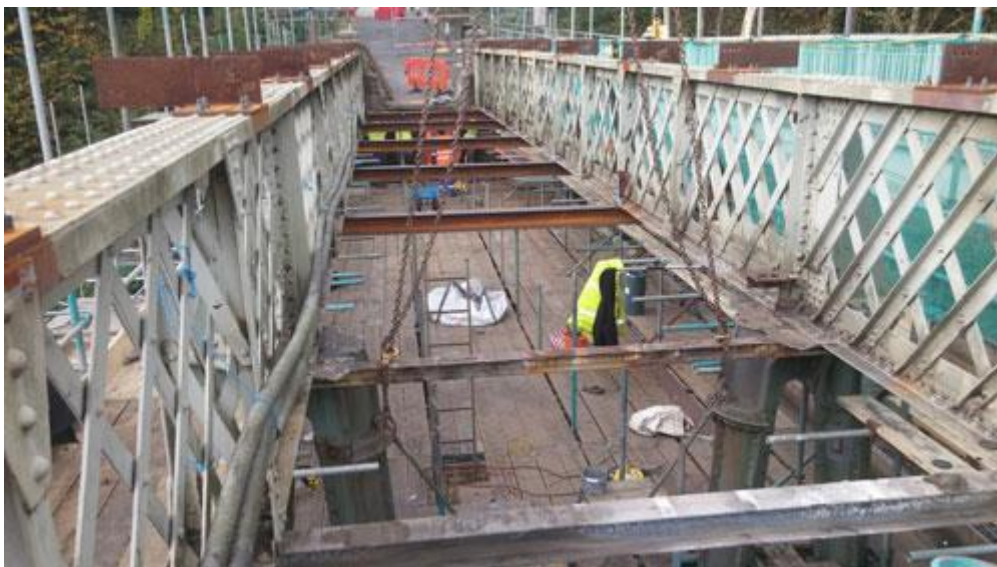
Photograph taken 27 October 2014. The roadway to span 1 (nearest Ovingham) has been removed showing temporary bracing (five furthest away) and existing cross girders (two nearest).

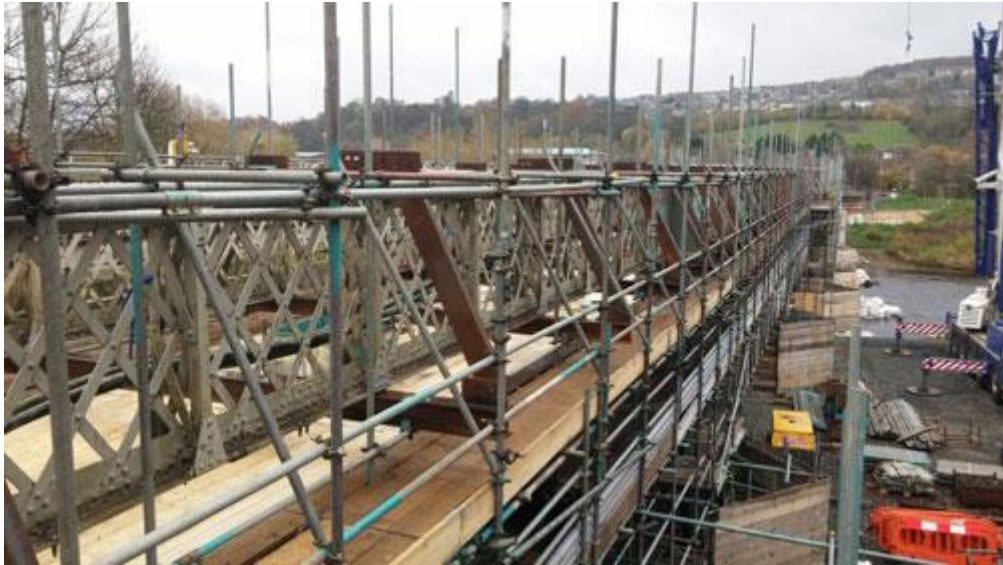
Photograph taken 12 November 2014 showing knee braces along upstream truss. Note scaffold level is now within 500mm (20") of the old road level.

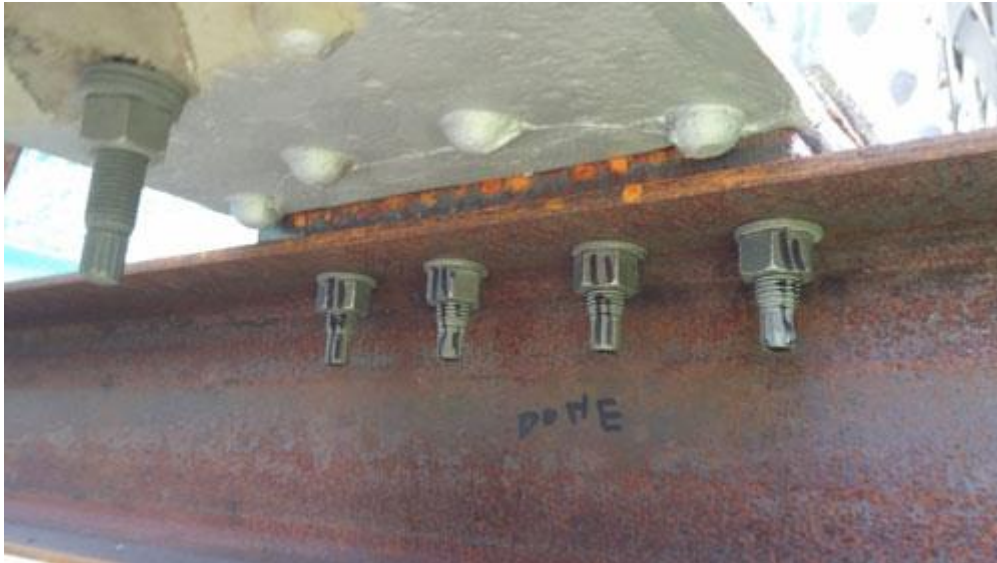
Photograph taken 27 October 2014 Connection detail between painted truss and temporary bracing.

Four Tension Control Bolts have been torqued and are marked to denote they have been installed correctly.

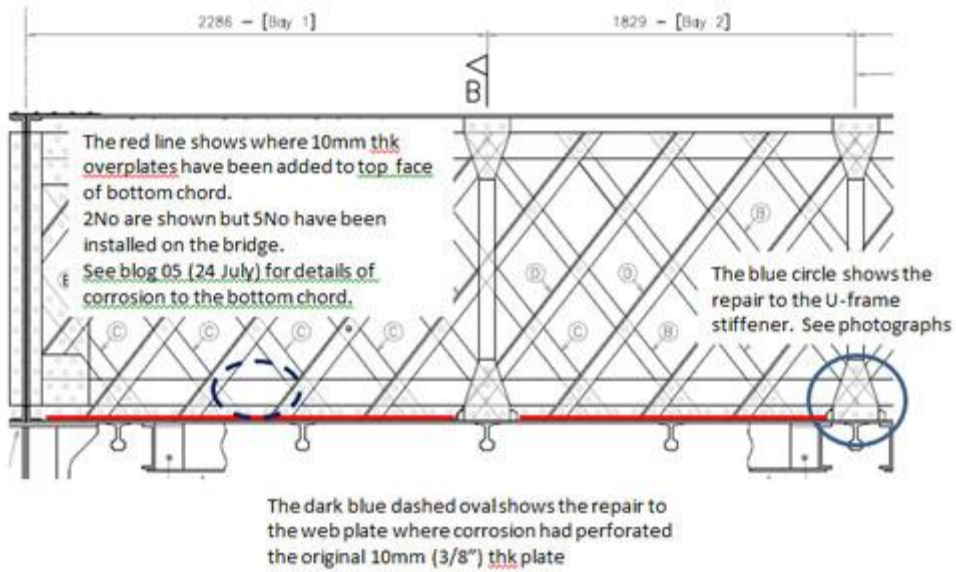
Detail to upstream elevation at Ovingham end of bridge showing extent of repairs
 Members called off as B and C are flats, members called off as D and E are angles
 10mm thk overplates (red lines) and web plate repair (dark blue oval)

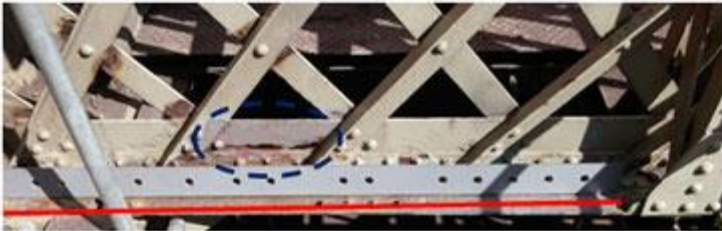
28 August – web plate after needle gunning to remove lead based paint and loose material. Over plate offered up to bottom chord to ensure holes match between existing and new elements. New holes cannot be drilled into the bridge as this weakens the original structure.

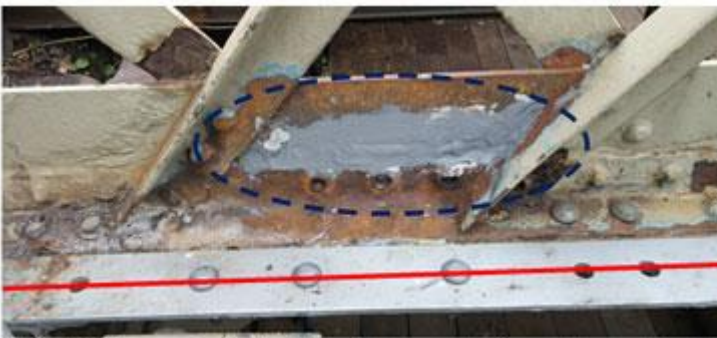
25 Sept 2014 – repair after installing Belzona, note 10mm thk overplate to bottom chord is now installed

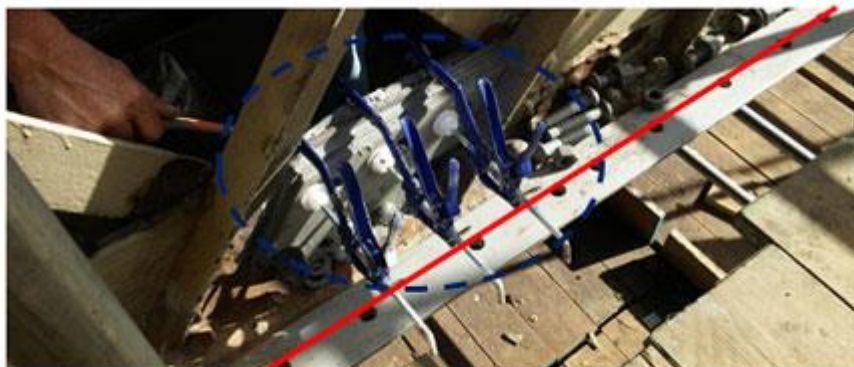
26 Sept – web plates installed (both faces), with 10mm thk overplate beneath

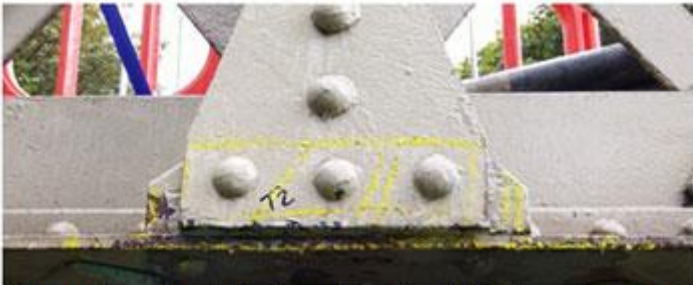
29 August - yellow chalk shows the extent of surface prep required at the U-frame stiffeners

This U-frame stiffener is at location T2, which is the second temporary bracing frame from the Ovingham end of the bridge. It has to be repaired before the temporary bracing goes in because it provides bracing to the trusses, so they remain stable when the deck (what was the road) is removed.

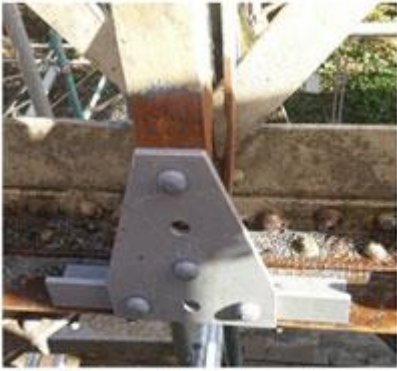
10 October – existing gusset plate and angle replaced with new elements. Note angle is not yet fixed to bottom chord.

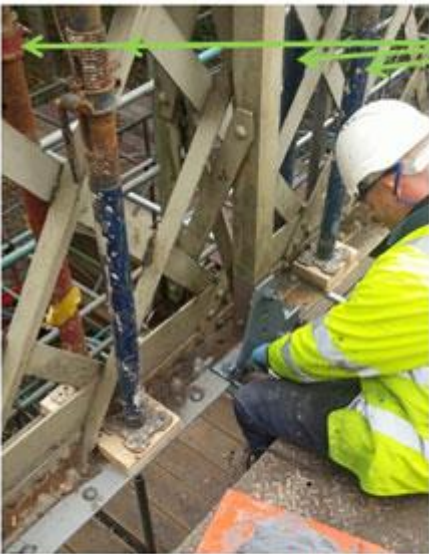
Note props to truss to allow U-frame stiffener to be repaired

14 October – Gusset plate and angle fixed to bridge. Belzona repair metal used to provide a good contact between all elements.

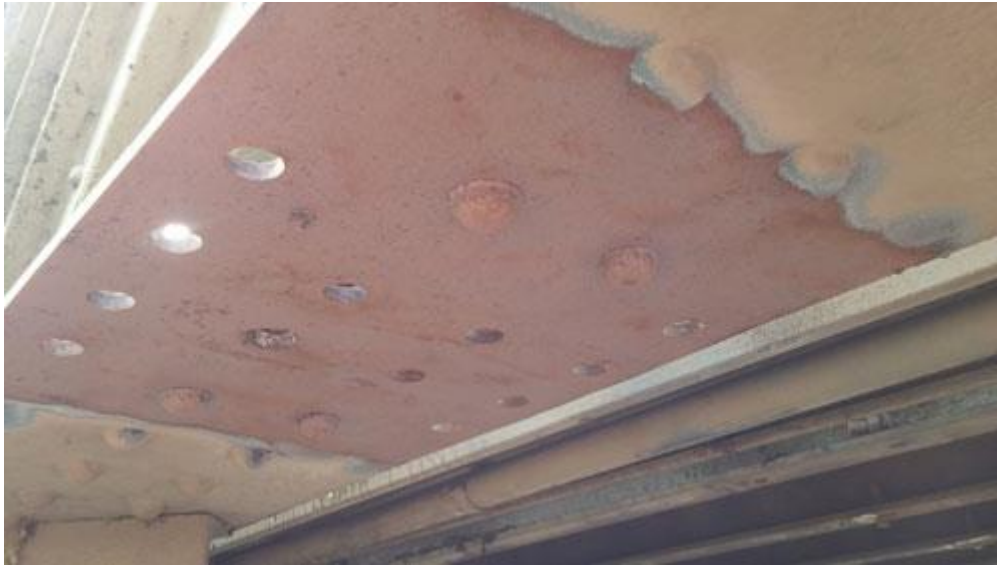
Photograph ref A above taken 11 September 2014 showing cross girder removed and finished surface preparation to underside of truss.

The 130 year old plate has survived well. The prepared plate shows no evidence of pitting or corrosion.

All the corrosion and pitting shown in photograph ref B will require repair, while photograph ref A will not.

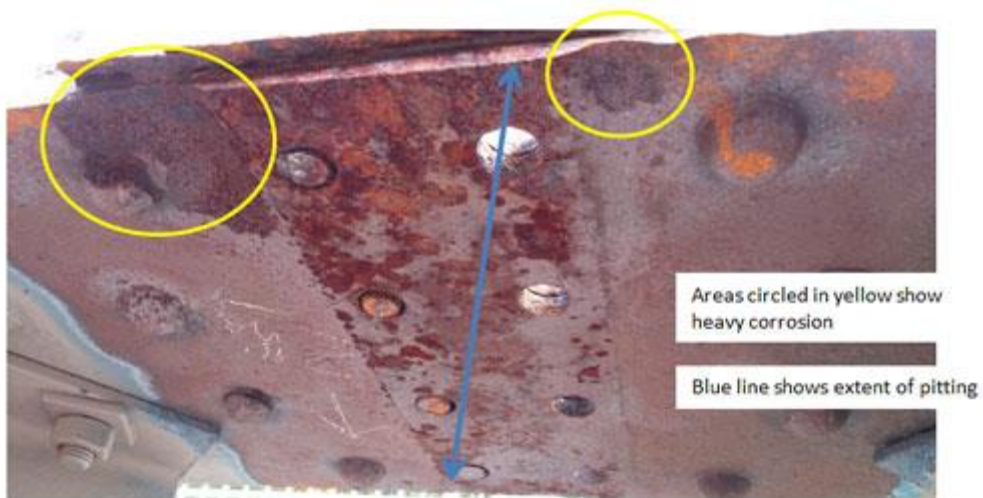
Photograph ref B taken 11 September 2014 showing cross girder removed and surface preparation to underside of truss, at a different position to photo ref A.

Note heavy pitting and extensive corrosion at the cross girder position.

This variation is typically due to inclusions within the wrought iron which were not removed during the manufacturing process.

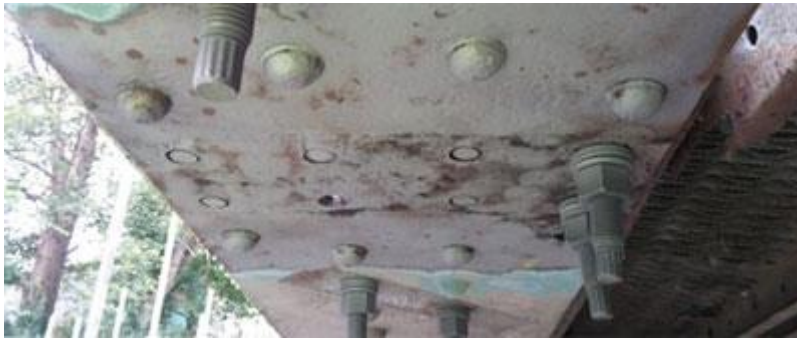
Photograph ref A taken 29 August 2014 showing cross girder removed and surface preparation to truss soffit

Photo ref A was taken following cross girder removal and surface preparation using a vacuum blast.

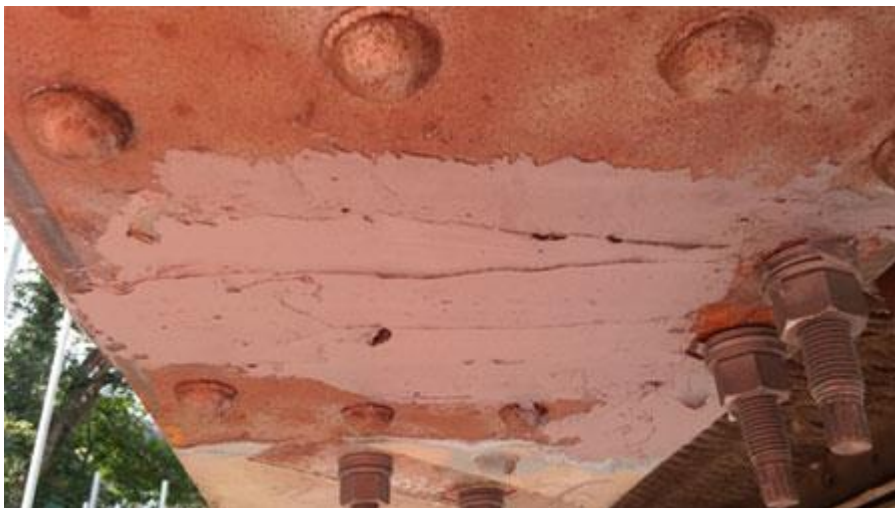
Photograph ref B taken 2 September 2014, showing repair to truss soffit

Photo ref B was taken after applying repair material to the prepared area.
