# Ovingham Bridge Blog

## Issue 28

### “Ovingham End - Repairs”

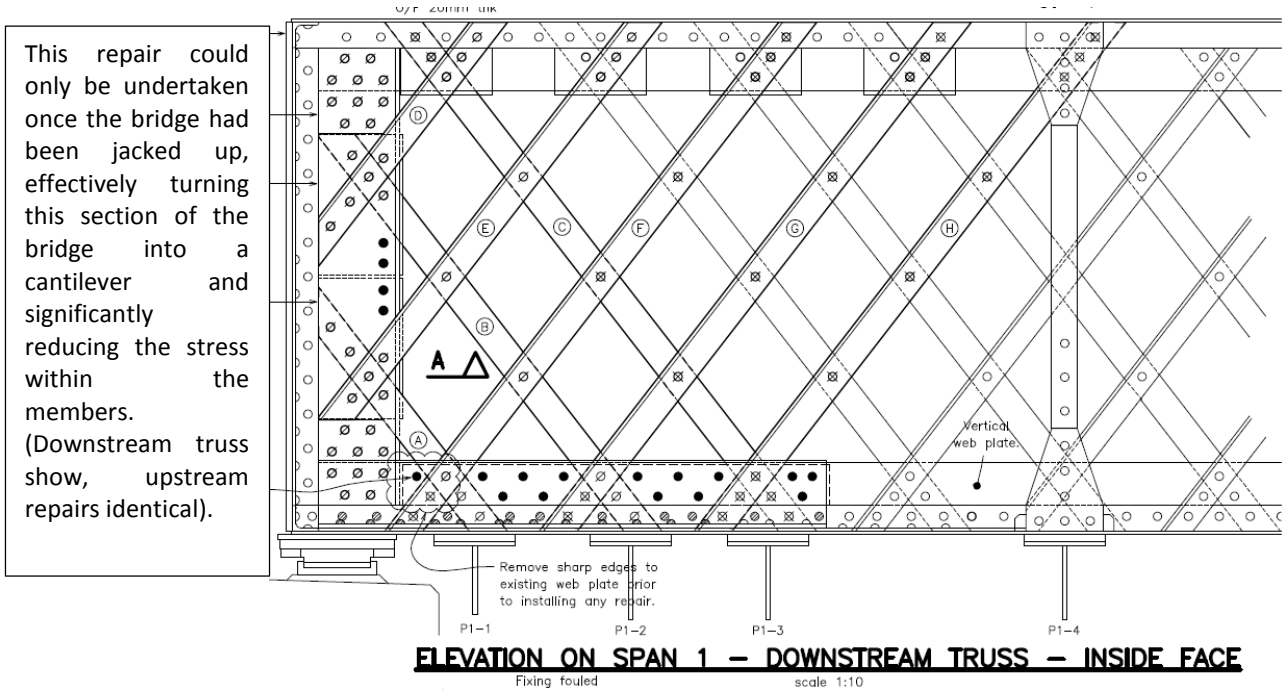
Significant corrosion in span 1 was discovered after the initial wet-blasting phase. This corrosion required a complete repair as sections of the wrought iron were less than 1mm (1/32”) (originally 10mm (3/8”). Due to the way the bridge was constructed, the method of repair had to maintain the existing members, while strengthening the section, (see blog 15/10/14 for further details on repairs to this span).

Typical condition of these plates

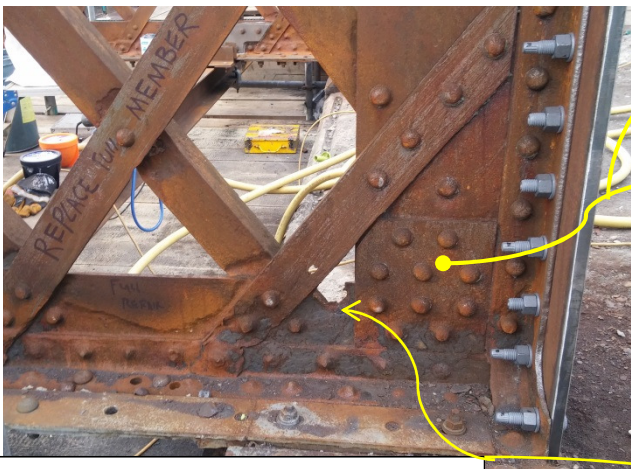
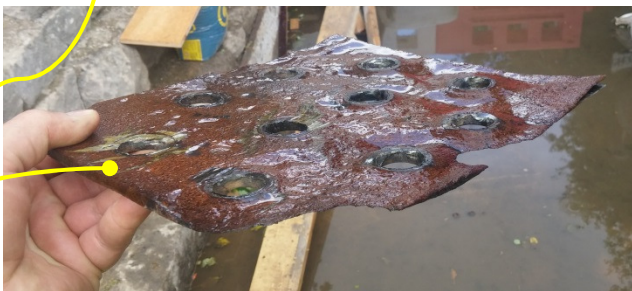
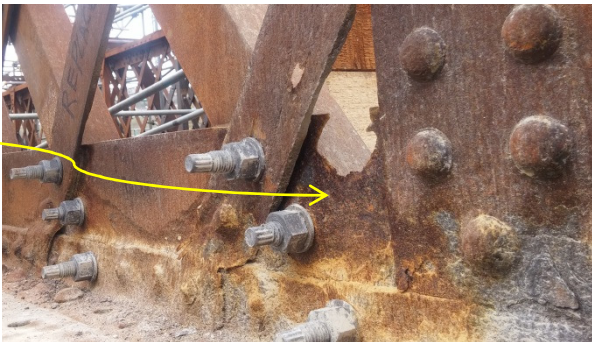
Web splice plate 1mm (1/32”) thick, originally was 10mm (3/8”) thick. In places there is total loss of section .

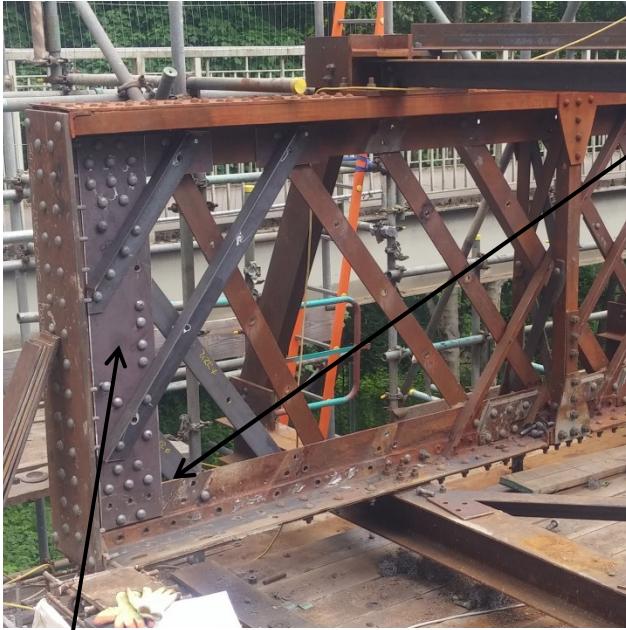
Vertical cover plate, as member had sustained significant corrosion, not the number of web members which have been removed.

From analysis of the bridge, high stresses were found in this location, requiring strengthening due to the significant loss of wrought iron.

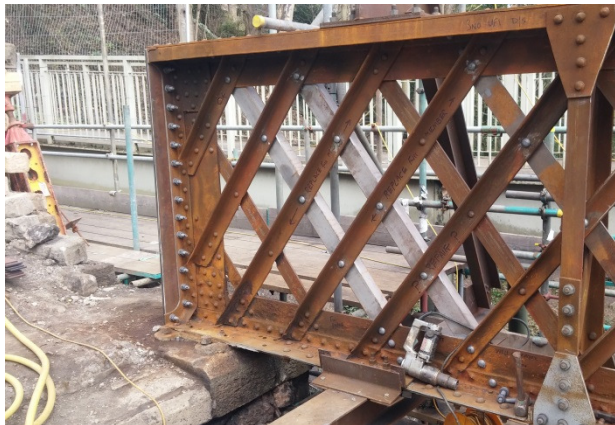
Condition of the bridge, before full repair
