Hexham Bus Station Road Safety Review

Northumberland County Council

October 2014

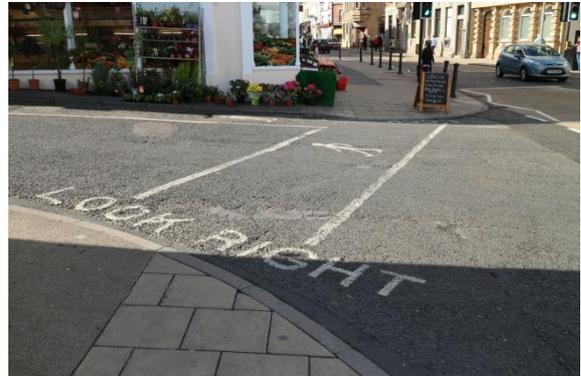
Crossings between Priestpople and bus station island

Description: Two informal crossings are in place between the southern footway of the B6305 Priestpople and the central island area of the bus station. These crossings are formed using a non prescribed continuous road marking, with a pedestrian symbol and text each end indicating which way pedestrians should look for oncoming traffic.

- The non prescribed marking introduces ambiguity into who has priority at the crossing. From discussions with staff on site at the bus station, it was inferred that bus drivers had been instructed to give way to pedestrians on the crossing, however the markings on site infer no particular priority and could easily be misunderstood by drivers unfamiliar with the site and in particular drivers of other vehicles (non buses) that have not been fully briefed on the operational nature of the pedestrian crossings.

- Provide a clear indication of priority that is recognisable to all road users, this may be achieved by either removing the current informal crossings to make it clear that priority is to vehicles or by introducing formal zebra crossings between the footways on Priestpople and the central bus station island to make it clear that priority is to pedestrians.

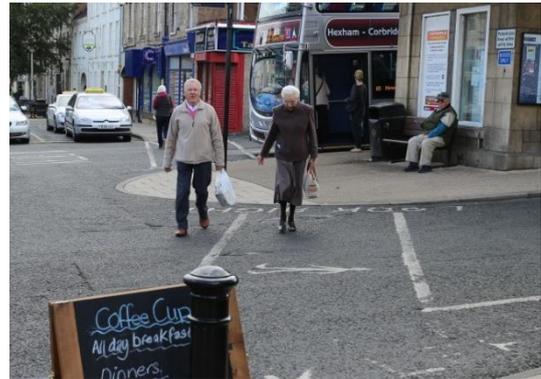
Low kerbs and tactile paving

Description: A large area of footway to the northern end of the bus station had no kerb check. In addition, tactile paving was not evident at on the central pedestrian crossings or bus boarding points.

- Without a kerb check, visually impaired pedestrians may have difficulty in determining the interface between the footway areas and the highway, increasing the risk to visually impaired pedestrians of walking into the highway areas and coming into collision with moving vehicles.

- Tactile paving for pedestrian crossings and bus boarding points improve the conspicuity and provide a guide for visually impaired pedestrians at crossings across the highway and to orientate themselves to the boarding points. The absence of tactile paving increases the risk of visually impaired pedestrians stepping into the highway and coming into collision with moving vehicles.

- The existing tactile paving on the western side of the western crossing is configured to direct pedestrians into the carriageway and has the potential to place a visually impaired pedestrian at risk of coming into collision with moving vehicles.

- Ensure that interfaces between the footway and highway can be determined by visually impaired pedestrians, this may be achieved by introducing a full height kerb check between the footway and highway.
- Improve the conspicuity of the crossing points for visually impaired pedestrians, this may be achieved by providing tactile paving to crossing points that are in frequent use by pedestrians in and adjacent to the bus station site to reduce the risk of collision between pedestrians and moving vehicles.
- Revise the incorrectly aligned tactile paving on the western side of the western crossing.
- Improve the conspicuity of the boarding points in the bus station, this may be achieved with the use of tactile paving to indicate the interface between bus boarding points and docked buses.

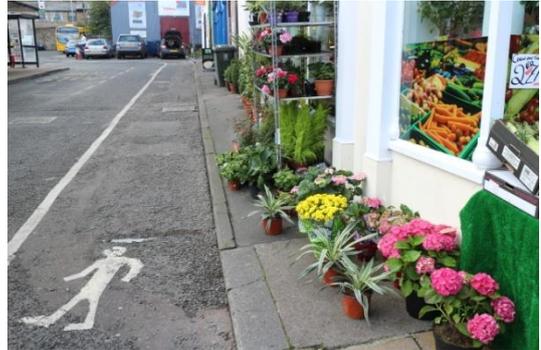
Western footway

Description: A pedestrian route is located to the western edge of the bus station, this is formed from a narrow kerbed footway and an area segregated from the carriageway by road markings. Over running of the segregated area by vehicles entering the site was observed on the day of the review and obstructions to the kerbed footway prevented use by pedestrians.

- The kerbed footway is narrow and without obstruction would be of limited use for pedestrians, the obstructions effectively make the footpath unusable. As a result, pedestrians accessing the businesses on the western side of the bus station have to make use of the carriageway increasing the risk of collision, especially when walking south, away from Priestpopple.

- An alternative on carriageway segregated route has been provided, however vehicles were observed on the day of the review over running this area both to ease the swept path into the bus station loop and also to pass a stationary bus at the passenger drop off. This segregated area currently forms a primary means of access to businesses on the western side of the bus station, in particular a bicycle repair shop and a former print works, requiring pedestrians and cyclists to walk/cycle in an area that is over run, introducing a risk to these non-motorised users, of coming into collision with moving vehicles, especially when walking south, away from Priestpopple.

- Reduce the risk to pedestrians and cyclists of collision with vehicles. This may be achieved by the introduction of a kerbed footway along the western edge of the bus station. It is acknowledged that this may have impact on the operation of the bus station and is likely to require the relocation of the drop off stop to elsewhere on Priestpopple or to inside the existing bus station site, which is likely to create additional operational implications.

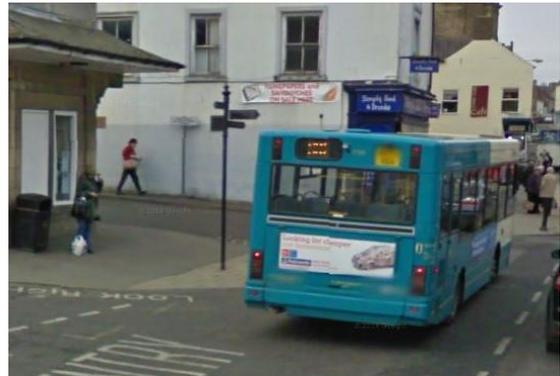
Priestpople facing bus stop

Description: Buses and community transport minibuses were observed picking up and dropping off passengers at the curved area of footway between the bus station and Priestpople. On enquiring with staff/drivers at the bus station, it was confirmed that buses drop off here due to delays caused by accessing and egressing this bus station site

- A number of scheduled and unscheduled services using a mix of bus and minibus vehicles use an area at the front of the bus station to drop off and pick up passengers. There is no kerb at this location and the highway geometry requires that alighting or boarding passengers step into the carriageway increasing the boarding height to the bus and risk of falls by passengers expecting to step from/to a raised footway.
- In addition, vehicles stationary at this location cause an obstruction to vehicles entering and leaving the main bus station loop, buses were observed taking a slow convoluted path around stationary vehicles, making visibility difficult for drivers exiting the bus station and also causing issues for pedestrians who were observed crossing in front of the exiting buses.

- Reduce the risks created by the lack of kerb and stationary buses, this may be achieved by investigating options to relocate the area currently used for buses and minibuses to stop to a new location either inside the bus station or adjacent to the bus station, this may include options to place bus stops/stands on the B6305 Priestpople or in the area currently used as a taxi rank.

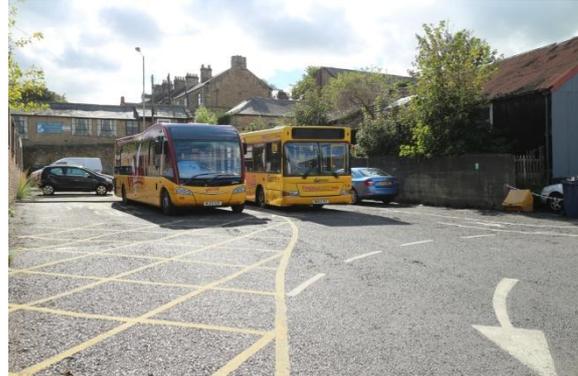
Reversing vehicles

Description: An area is available for buses and other vehicles at the southern end of the bus station. This area at the time of the site visit was used in part for short term parking of buses, loading of goods into adjacent businesses and some informal unpaid parking. Access to the area cannot be achieved solely with the use of a forward gear and buses were observed during the site reversing into the short term parking area. In addition, buses were also observed reversing inside the bus station access loop to aid alignment with the boarding points on the central island.

- Reversing of large vehicles introduces a risk of collision with pedestrians that may be crossing behind a manoeuvring vehicle. Whilst it is acknowledged that buses will need to reverse into short term parking and that some mitigation has been provided in the current arrangement, a risk remains that a pedestrian could be crossing behind a reversing bus.

- Buses reversing inside the bus station loop to aid alignment to the boarding points create a significant risk in that there is an informal pedestrian route on the periphery of the bus station loop, which provides access to businesses on the western and south western sides of the bus station.

- Cars and small goods vehicles accessing the parking area adjacent to the bicycle repair shop currently have to reverse out into the path of vehicles entering the bus station and in particular turn in reverse gear such that they approach the area fronting the bicycle repair shop. This turning whilst reversing action reduces visibility for the driver which in turn increases the risk of collision with pedestrians using the segregated on carriageway, in particular pedestrians stood outside the shop who may be otherwise distracted in the act of dismounting/mounting cycles.

- Ensure that the risk to pedestrians coming into collision with reversing buses is reduced or removed. This may be achieved by stipulating the use of a banks man whilst reversing or by removing the requirement for buses to reverse by providing a parking facility that can be access solely with the use of a forward gear, which given the constraints of the existing site, we expect that this would be remote to the existing bus station site.

- Reduce the risk of collision with pedestrians created by buses reversing inside the bus station loop. Previous reports indicate that there has been investigations into vehicle swept paths in this area and that whilst a degree of driver miscalculation and other obstructions may increase the times that drivers have to reverse, it is recognised that that the current bus station site has limited scope for accommodating driver miscalculation and other obstructions, especially when other vehicles are loading/waiting in the bus station. As such, whilst it easy to suggest that the need for reversing is removed, it is acknowledged that the possibility of buses reversing cannot be completely prevented at this location and collisions involving reversing vehicles would still be possible.

- Reduce the risk to pedestrians stood outside or accessing the bicycle shop to injury by manoeuvring vehicles, this may be achieved by reorganising the parking arrangements to remove the necessity to reverse near the shop entrance.

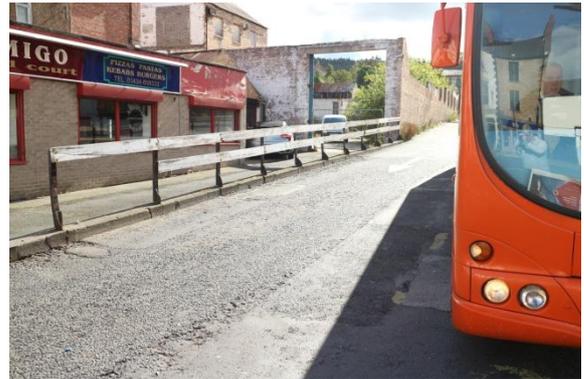
Visibility past stationary buses

Description: When crossing from the central island toward the east, visibility into the bus station is restricted by stationary buses.

- Reduced visibility when crossing in front of stationary buses increases the risk of collision between pedestrians and moving vehicles. During the site visit, a significant number of non-public service vehicles were observed using the bus station as a u-turn facility increasing the risk to pedestrians crossing at this location who may not expect a non-public service vehicle to be using the bus station and passing a stationary bus whilst they are crossing.

- Reduce the risk of collision by removing as many unnecessary vehicles as possible. This may require the introduction of access restrictions to the bus station that accommodates the needs of businesses for loading. It is acknowledged that access rights for the loading or unloading of vehicle at any time cannot be completely removed without a public enquiry and that the outcome of any public enquiry is beyond the control of the council so may not deliver the required restriction. Notwithstanding that, access could be restricted using a “motor vehicles prohibited with an exception for buses and loading by goods vehicles” restriction, placed such that the sign is within the adopted highway frontage to ensure enforcement of the moving traffic offence by the police is possible. The supplementary plate for this restriction is not prescribed in the Traffic Signs Regulations and General Directions and will require approval for use on the highway by the Department for Transport. This sign solution has been granted approval previously in other districts but that does not guarantee approval here.

- Reduce the risk of collision by improving visibility around stationary buses. The introduction of pedestrian build-outs from the central island to provide a safe place for pedestrians to observe if it is safe to cross and for drivers using the bus station to observe pedestrians crossing in front of stationary buses. A full depth build-out may not be necessary with careful consideration of vehicle speeds and visibility using Table 7.1 in Manual for Streets which provides a useful indication of stopping sight distances for low speed traffic. This could be used to establish a workable inter-visibility distance between drivers and pedestrians waiting to cross at this location.

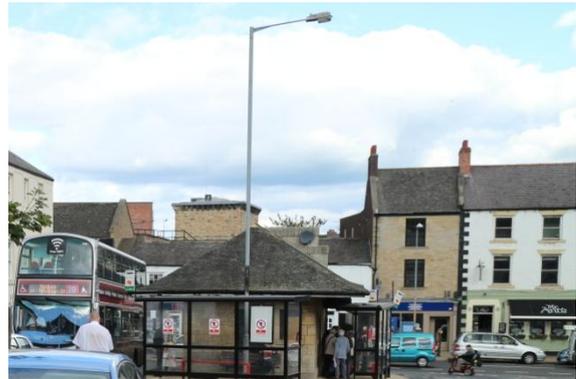
Illumination and CCTV

Description: Provision of illumination and CCTV in the bus station site.

- Although not observed in the dark, the positioning, age and mix of street lighting in the bus station, luminaires under the bus station canopy and illumination in the immediate vicinity from businesses has the potential to affect the conspicuity of pedestrians in the dark, increasing the risk of collision between pedestrians and moving vehicles.
- Whilst not specifically providing a road safety improvement, incidents that occur inside and adjacent to the bus station cannot currently be observed either during or after the event. These incidents may include collisions inside the bus station, behavioural issues of the public and drivers and any criminal activity. In addition, the use of CCTV could be used with the appropriate approvals from the DfT for enforcement.

- Investigate the illumination levels in and around the bus station and if appropriate, improve the level of illumination in the areas used by the public.
- Investigate the introduction of a comprehensive CCTV system

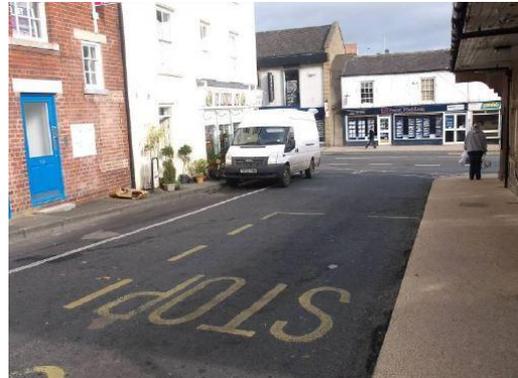
Delivery Vehicle Access

Description: The Technical Note prepared in May 2014 highlighted an issue with delivery vehicles servicing the businesses to the west of the bus station.

This was not directly observed during the site visit on the 24th September 2014 – Photograph from May 2014 Technical Note.

- Vehicles loading from inside the bus station block the segregated pedestrian route increasing the risk to pedestrians who will have to walk into the carriageway area and increasing the potential for collisions in the entry area of the bus station. The observation made in the May 2014 Technical Note regarding kerb over running is likely to be linked to this issue in that no kerb over running was observed in the site visit completed in September 2014

- Reduce the risk to pedestrians and for collisions in the entry area to the bus station by relocating where possible the loading of vehicles in the bus station and limited unnecessary access to loading only. This may require the introduction of access restrictions in the bus station (covered earlier in this report). In addition restrictions on loading in locations that have an influence on pedestrian routes and vehicle swept paths is recommended, however it is acknowledged that to do this, the highway areas in the bus station would need to become adopted highway to enable enforcement, however, it is understood that adoption may not be possible for a variety of legal complexities relating to ownership. It is acknowledged also, that it will be impractical to remove access for loading to businesses inside the bus station, limiting the potential road safety benefits of this mitigation over what could be achieved in a dedicated modern bus station facility.

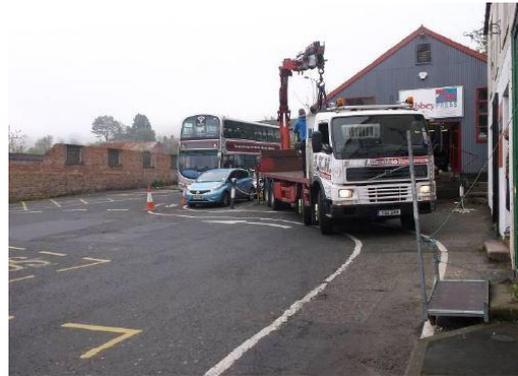
Loading to Print Works

Description: The Technical Note prepared in May 2014 highlighted an issue with a large vehicle servicing the businesses to the south west of the bus station.

This was not directly observed during the site visit on the 24th September 2014 – Photograph from May 2014 Technical Note.

- An issue relating to a large vehicle blocking the pedestrian route was highlighted in the May 2014 Technical Note. Although this was not observed in the September 2014 site visit, any future use of the former print works has the potential to create access requirements for loading by larger vehicles. This increases the risk that pedestrians are exposed to manoeuvring by vehicles of any size.

- Consideration is required on how these premises will be serviced in the future, this may include provision of a servicing lay-by that accommodates delivery vehicles, however it is acknowledged that the size and specific requirements are unknown at this stage. Any change of use would require consideration of servicing via the planning application process.
