Flood Investigation Report

Location: Hepscott	Incident Date: 6/9/2012 & 25/09/2012
---------------------------	---

Title: **Hepscott - areas affected by flooding 25/09/2012**

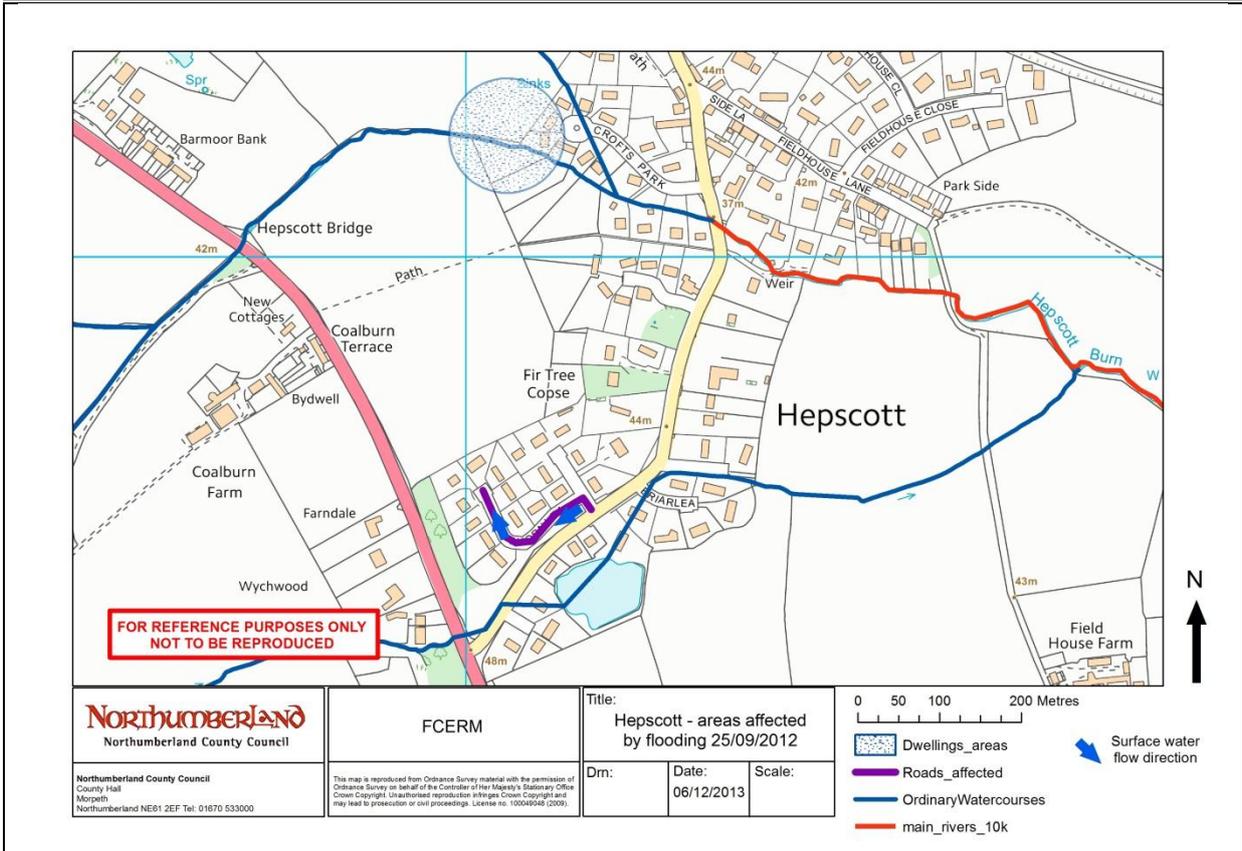
One property in Crofts Park (see map) was flooded on 06/09/12 and 25/09/12 following rainfall in an already saturated catchment, due to the unusually wet summer. Property level protection measures were installed in 2010 as part of a local flood alleviation scheme following the 2008 floods, during which Hepscott was badly affected. However, flooding to the property is reported to have entered the building through a basement that does not have waterproof protection. It is not known if the floodwater was conveyed from the nearby Coal Burn or whether it was the result of groundwater seepage from adjacent saturated land.

Flooding of a residential road (Thornlea) has been reported on several occasions during the summer of 2012, and in particular on 25/09/2012. Surface water from the nearby main road combines with overspill from a culvert entrance on the nearby burn, which runs adjacent to the main road through Hepscott. Flow then takes a path along Thornlea to a drain at the end of the cul-de-sac, which was unable to cope with the volume of surface water. Flooding to one property was narrowly avoided due to a combination of property level protection measures (as part of the above mentioned scheme), private modifications to the property and garden area, and a decrease in the rainfall intensity. Additional property level protection measures have since been installed on one property that is perceived to be at the highest risk of flooding following a similar rainfall event.
