Queen Elizabeth High School

Arboricultural Survey

December 2016

Client Name: Education Funding Agency
Document Reference: WIE10720-104-R-23-2-1-Arboricultural
Project Number: WIE10720

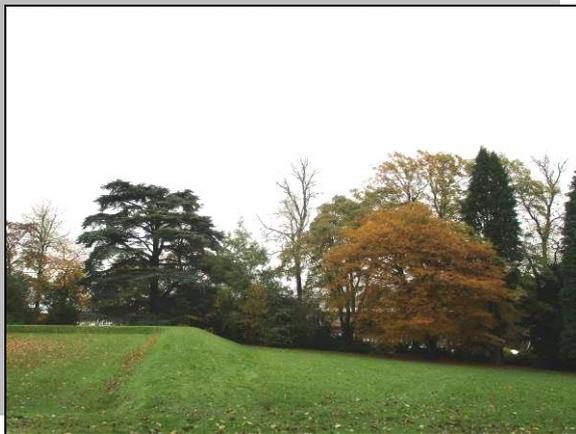
Photograph 1 (G33)

- 2.2. Trees within the survey area were mostly recorded within areas of mown grass and soft landscape, with a smaller number present within hard landscape (**Photographs 1, 2, 3 and 4**). The existing tree stock includes a mix of native and amenity deciduous and evergreen species, including Lime sp. (*Tilia* sp.), Silver Birch (*Betula pendula*), Cherry sp. (*Prunus* sp.), Plum sp. (*Prunus* sp.), Ash (*Fraxinus excelsior*), Goat Willow (*Salix caprea*), Norway Maple (*Acer platanoides*), Hawthorn (*Crataegus monogyna*), English Oak (*Quercus robur*), Sycamore (*Acer pseudoplatanus*), Sweet Chestnut (*Castanea sativa*), Beech (*Fagus sylvatica*), Horse Chestnut (*Aesculus hippocastanum*), Holly (*Ilex aquifolium*), Walnut (*Juglans regia*), English Elm (*Ulmus procera*), Elder (*Sambucus nigra*), Willow-leaved Pear (*Pyrus salicifolia* 'Pendula'), Red Oak (*Quercus rubra*), Laburnum (*Laburnum anagyroides*), Cherry Plum (*Prunus cerasifera* 'Nigra'), Apple (*Malus* sp.), Cherry Laurel (*Prunus laurocerasus*), Spruce (*Picea* sp.), Fern-leaved Beech (*Fagus sylvatica* 'Asplenifolia'), Yew (*Taxus baccata*), Blue Atlas Cedar (*Cedrus atlantica* var. *glauca*), Pine (*Pinus* sp.), Cypress (*Cupressus* sp.), Giant Sequoia (*Sequoiadendron gigantea*), Grey Poplar (*Populus x canescens*), Portuguese Laurel (*Prunus lusitanica*), Weeping Ash (*Fraxinus excelsior* 'Pendula') and Monkey Puzzle (*Araucaria araucana*). The trees surveyed vary from young to mature, with some of the larger specimens on Site considered likely to date from the construction of the buildings within the west of the Site in 1859.

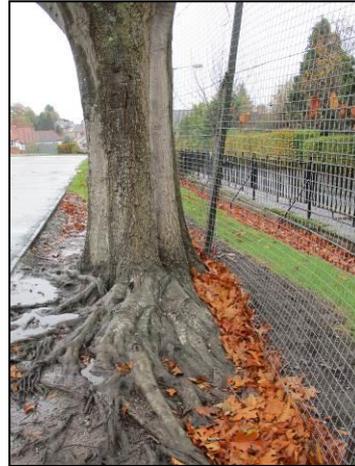
Photograph 4 (T20)

- 2.4. Several exposed shallow surface roots (**Photograph 4**), strangler roots (**Photograph 5**) and instances of deflection to macadam, concrete surfacing and walls were recorded across the Site. This suggests challenging below-ground rooting conditions, the exact cause of which has not been determined at this time. Several trees also displayed signs of historic strimmer/ mower damage to exposed roots and / or root flares (**Photograph 6**).

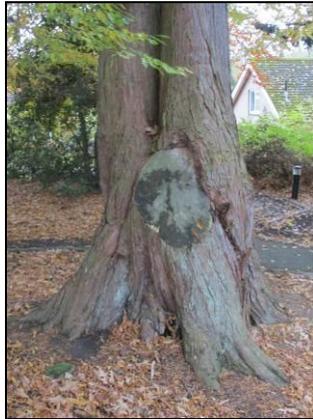
Photograph 7 (G33)

- 2.5. Variable degrees of wound wood development was noted in association with historic pruning wounds. This ranged from minimal (**Photograph 7**) to complete (**Photograph 8**) occlusion and infers a degree of variability in overall tree vigour within the existing tree stock. Several trees displayed large amounts of deadwood. This may be due, in part to challenging below-ground rooting conditions.
