# Health and Safety Inspection Report

Northumberland County Council

## Hexham Bus Station

#### Health and Safety Inspection

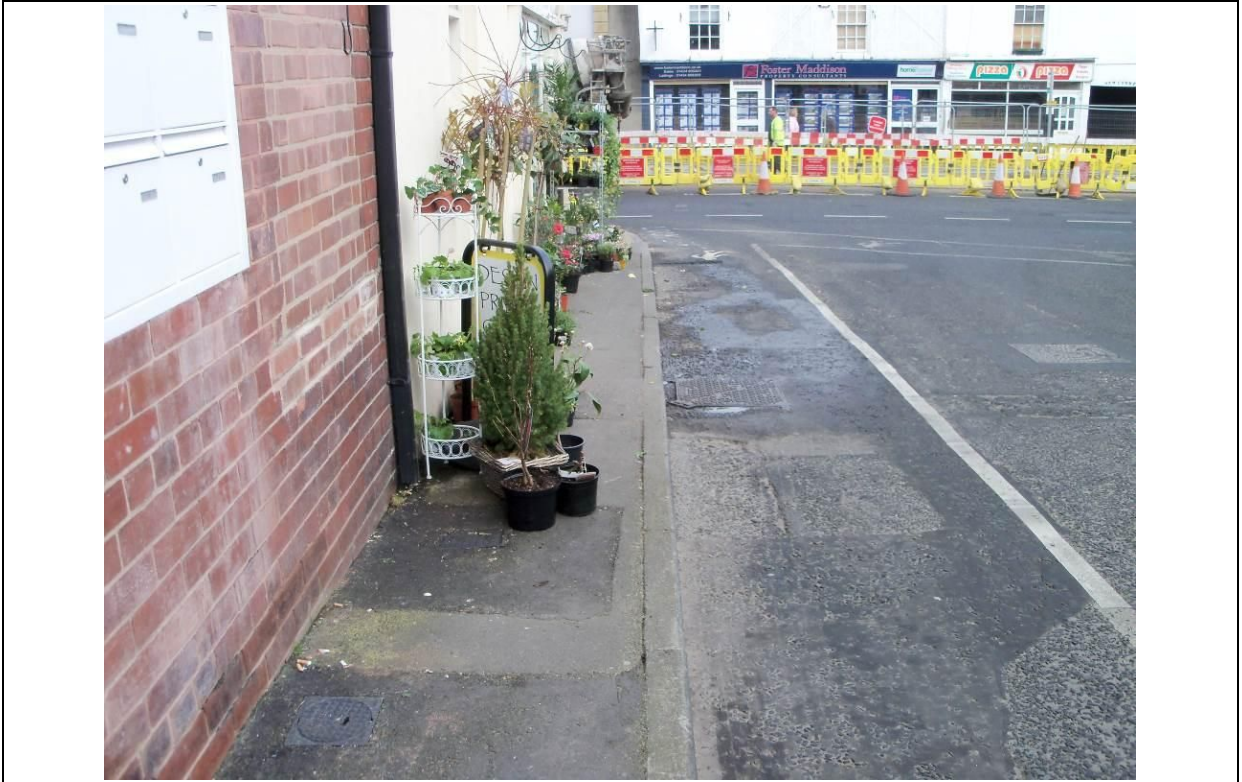
2.1 The means of separating vehicle and pedestrian routes within the station leaves much to be desired. The ownership of Commercial Place is not clear and many disputes have arisen in the past regarding access rights. The painted pathway on the road along Commercial Place is also often used as a delivery bay. This problem is exacerbated by the fact that the owners of the vegetable shop often display produce on sale along the existing path. Despite the lack of proper separation, drivers seem to take care when entering the station and no accidents or near misses have been reported. Ideally, this path should be widened and kept clear of goods, removing any need for pedestrians to walk on the road.

**Photograph 1** - This shows the dedicated pedestrian route blocked by displayed produce and a designated path within the Highway.

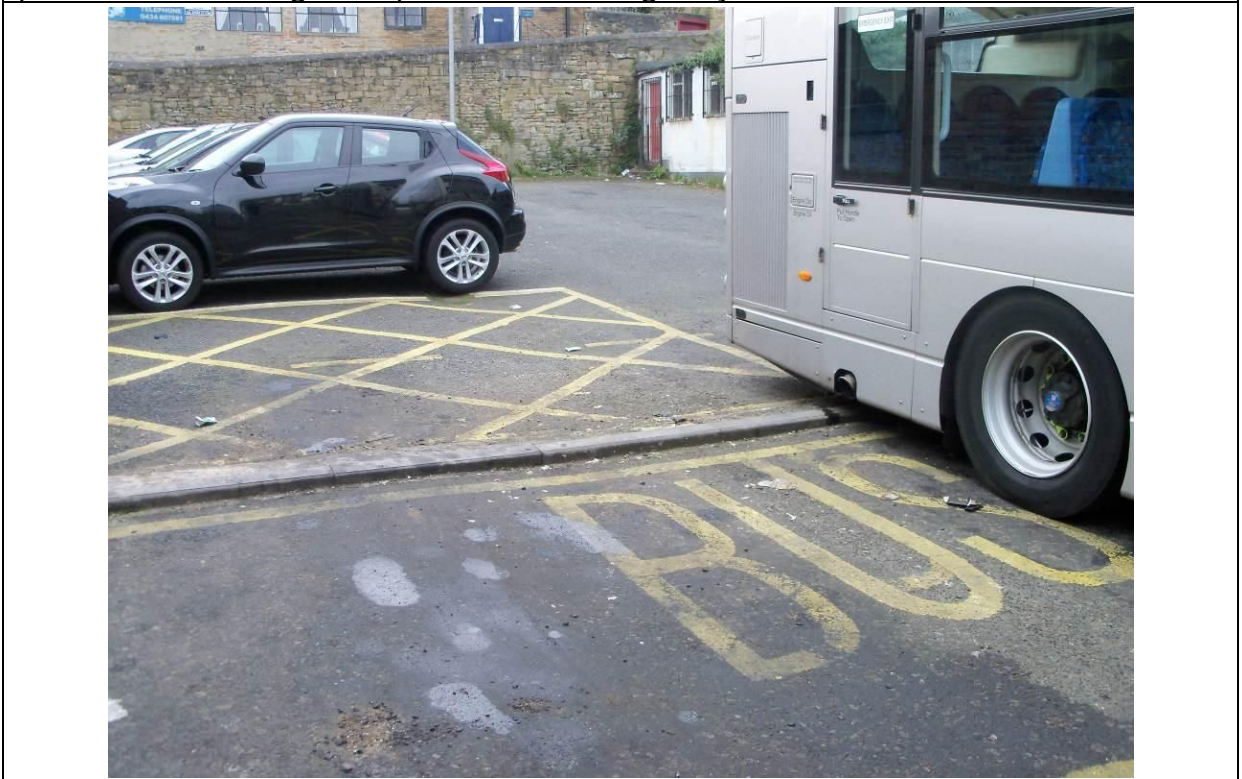
measures were seen as short term improvements due to plans at the time to create a bus station on an alternative site. These include bay markings; a keep clear hatched area and a raised kerb line. These measures appear to work well. Buses pull up straight in front of the bay and reverse slowly until the rear wheels hit the raised kerb line. The overhang at the back of the bus is then within the 'keep clear' hatched area. Whilst these arrangements fall well short of maintaining a totally pedestrian-free reversing area they seem to work without incident.

**Photograph 2** - The raised kerb line and keep clear area for bus layovers

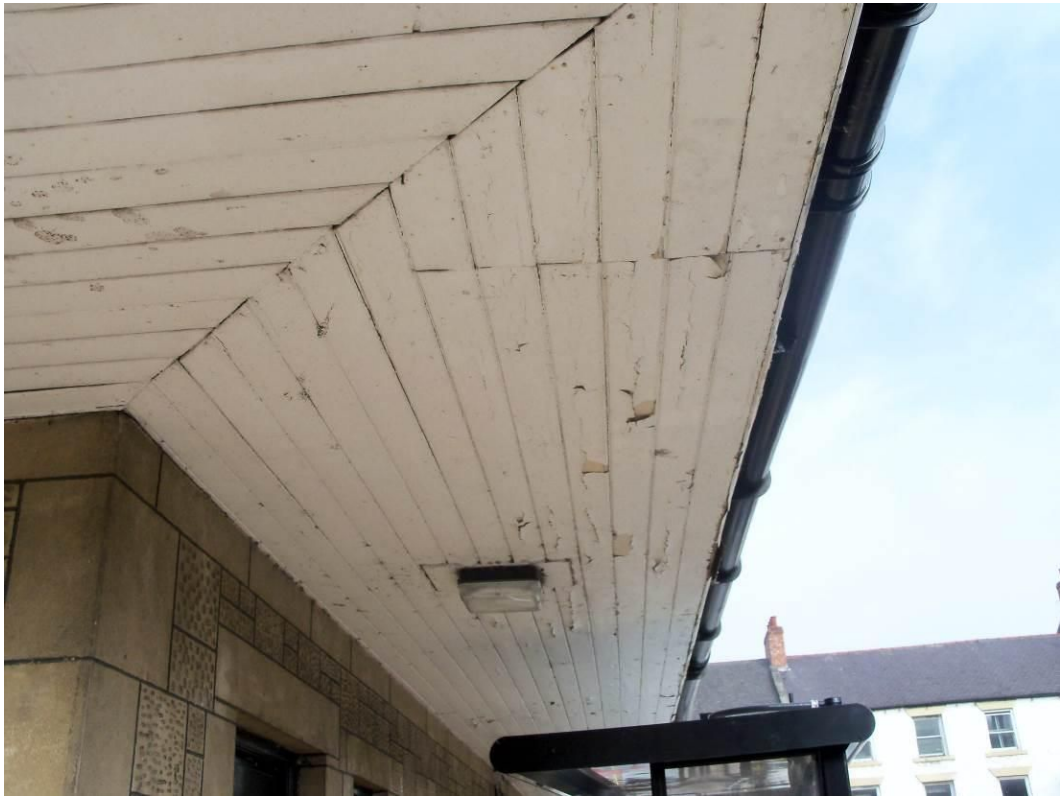
- 3.4 Whilst the external condition of the building is serviceable, there is much peeling of paintwork on the underside of the roof canopy which destroys its aesthetic appeal. I recommend that this is repainted. The standard of housekeeping at the rear of the bus station is poor; litter and weeds are evident around the site perimeter. We also noted that surface water drainage of the bus concourse is blocked by vegetation and other debris. It is not clear who is responsible for resolving these housekeeping and maintenance issues.

**Photograph 3** Peeling paint under the roof canopy

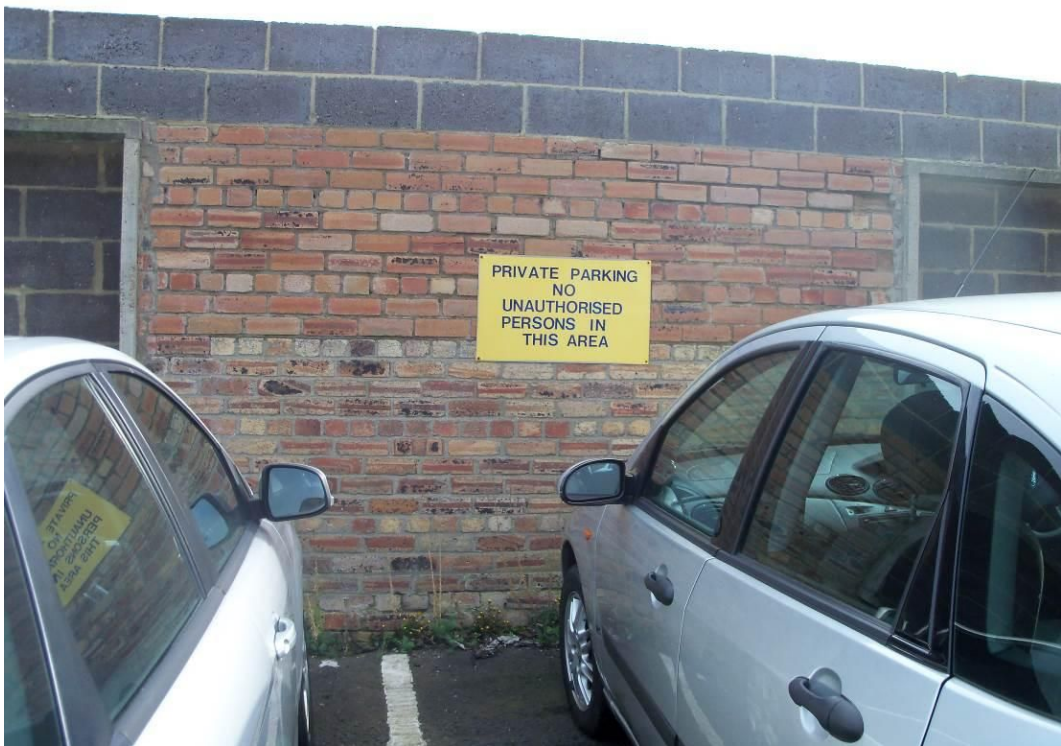
2.3 There is a defined area for staff parking at the bottom of the station which is used by Go North East staff. There is at least one of the business owners on Commercial Place who uses the car park. This individual claims to have permission to do this through a previous agreement with Tynedale District Council aimed at avoiding the need for parking on Commercial Place and blocking the access route. It is no longer used by any members of the public following the posting of signs prohibiting this in 2007.

**Photograph 4** Car Park Signage

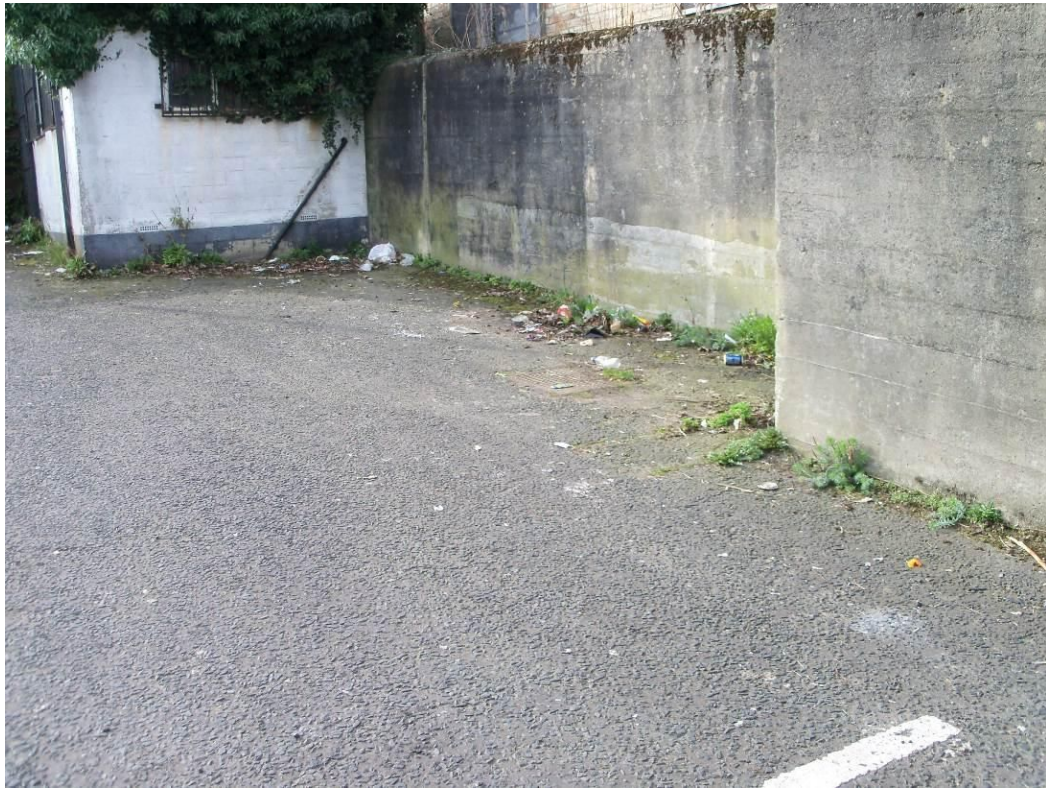
**Photograph 5** The standard of housekeeping in the bus stand is poor with litter and weeds evident around the site perimeter

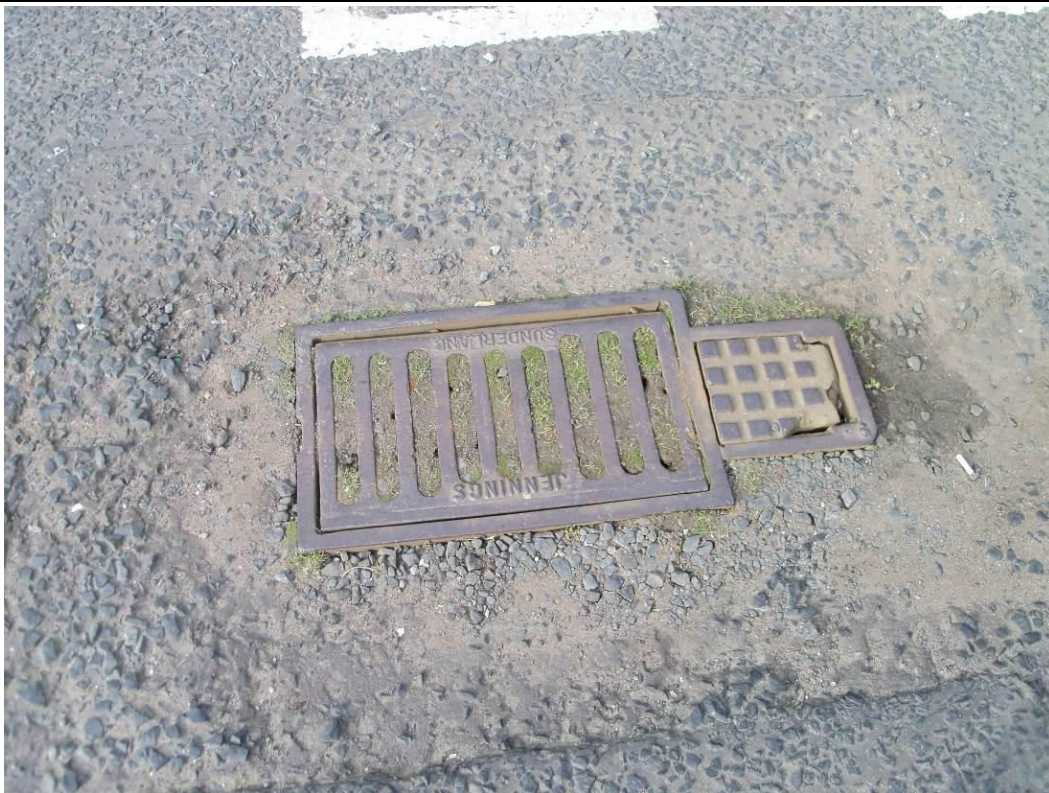
**Photograph 6** – blocked surface drains
