# Flood Investigation Report

## 4.2.4

Location: <b>Alnwick (west)</b>	Incident Date: <b>28/06/12</b>
---------------------------------	--------------------------------

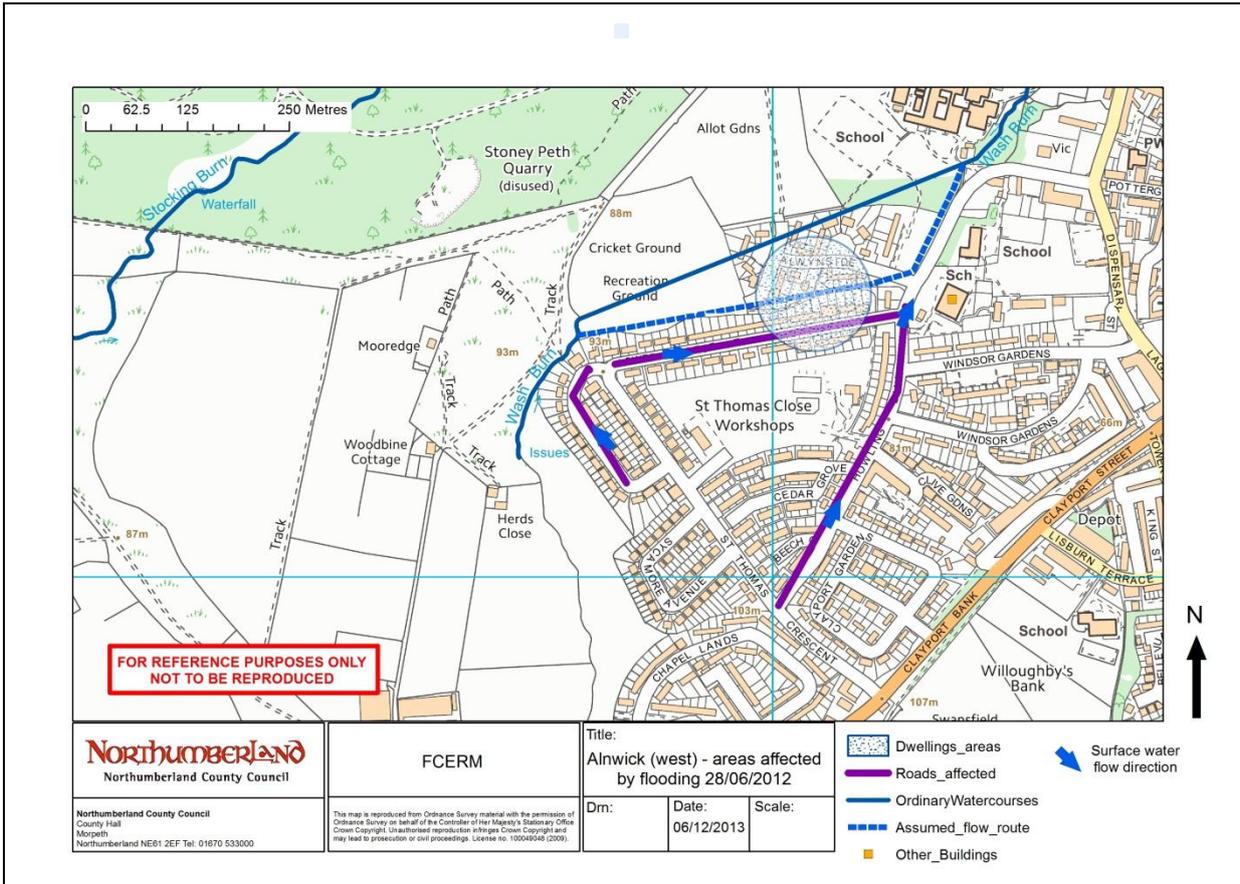
This rain caused residential properties to flood within Alwynside. Flooding occurred as a result of the Wash Burn, which is designated as an ordinary water course. The GIS data that we have available shows the Wash Burn as a straight line going directly under some properties in the northern side of Alwynside. This is an anomaly within the data. Often when a watercourse sinks and issues a straight line is drawn on the GIS data, as is the case here. After inspection we now know and can confirm that the Wash Burn runs in a culvert via the southern properties of Alwynside – shown by the cyan dashed line on the above map. Local residents were not aware of the presence of this watercourse.

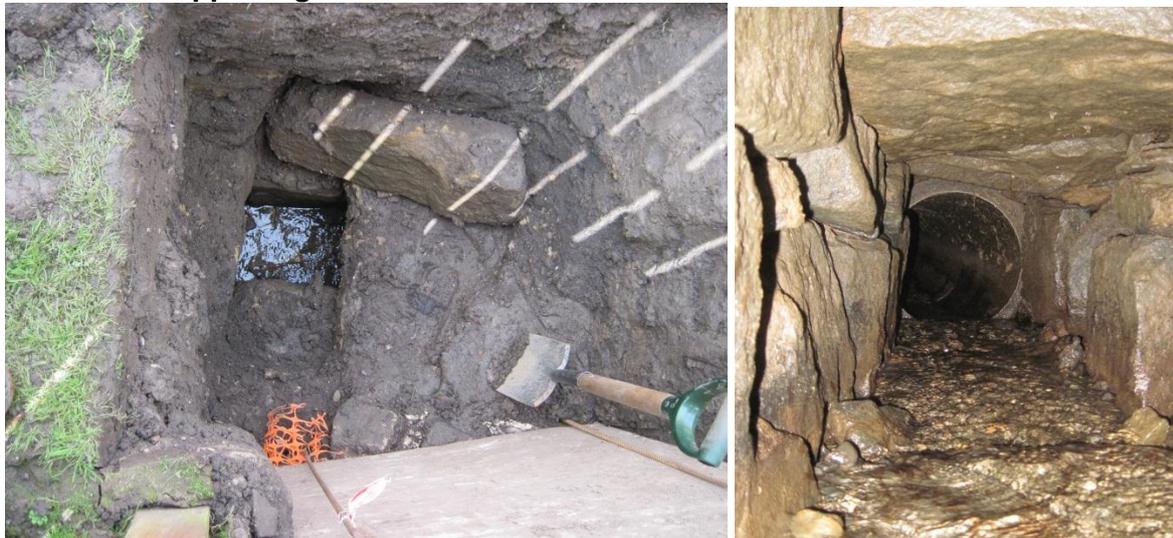
On closer inspection of the culvert, it was found that there were blockages that were causing

water to back up and subsequently flood the properties.

The photo on the left shows the Wash Burn watercourse after excavations within the garden of a residential property. The photo on the right shows part of the culverted section of the Wash Burn. Here a square stone channel falls into a circular concrete pipe.

**NCC**  
*Exercised:* Carried out Flood Investigation Report. Have investigated further the route of the Wash Burn through Alwynside, have removed blockages within the culvert and have installed manholes on two sections along the watercourse.  
*Proposed:* Keep an eye out on the functionality of the culvert in the future.
