Appendix B – Summary Sheets by Route Section

Route Section 12 **Longframlington to Longhorsley**

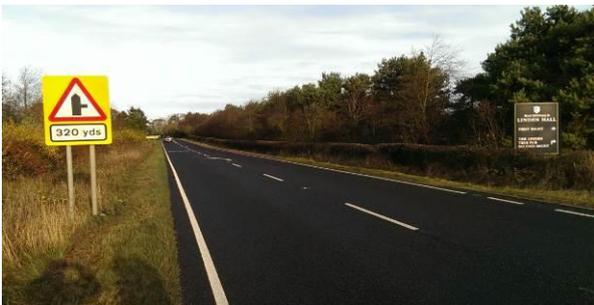
- The current signage for the junction is inadequate. **Photograph 1** highlights the junction warning sign in the nearside verge. There are actually two junctions ahead leading to Linden Hall both for different vehicle types.

Photograph 1:
View showing northbound approach to junction

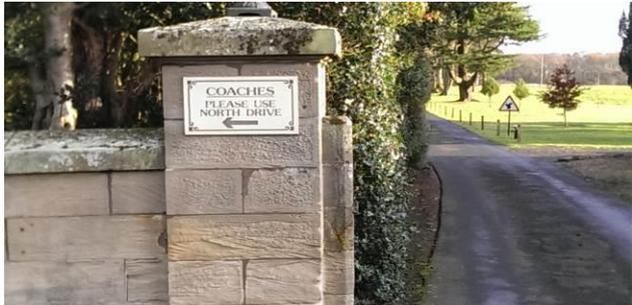
- An additional sign is placed on the entrance to the first junction requesting coaches to use North Drive (**Photograph 2**). This is confusing to the driver and a goods vehicle was observed during the site visit, pulling into the first junction then reversing onto the carriageway and moving to the next junction.

Photograph 2:
View showing entrance to Linden Hall Sign for coaches

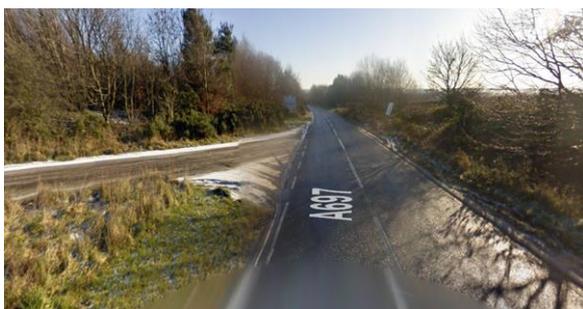
- The Fatal and the slight collisions relate to turning right out of the southernmost access to the layby resulting in hitting oncoming traffic.
- The Layby in its current layout is unsuitable for right turning vehicles, especially for HGV’s entering the A697 on a steep incline when they are unable to reach the required speed to follow in line of traffic.
- No junction warning sign in advance of the layby to warn drivers of existing vehicles.

Photograph 3:
View showing southbound approach to layby

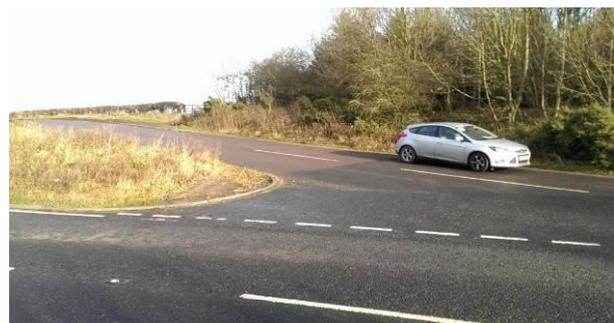
Photograph 4:
View showing layby exit

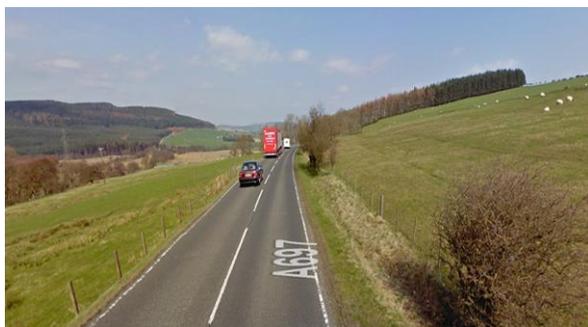
Photograph 5:

- Of the three collisions two are travelling North and one south. Loss of control whilst a motorcyclist is negotiating the bend is the cause of the serious collision.
- The Fatal collision was in fog and mist conditions and the vehicle is swerving around and enters the opposite side of the carriageway.
- The slight is again in adverse weather conditions as snow is on the ground. With visibility impaired the use of marker posts is integral to providing guidance to the driver where road markings may otherwise be covered.

View showing northbound approach to cluster at bend

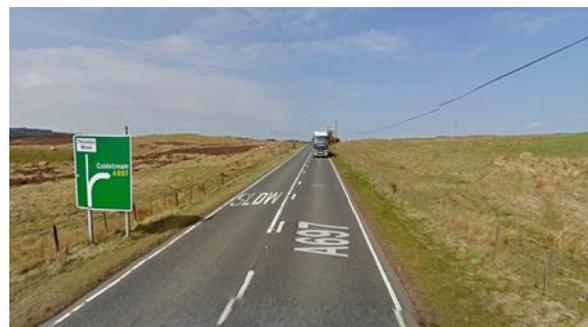
Photograph 6:

View heading Northbound towards Thrunton Wood

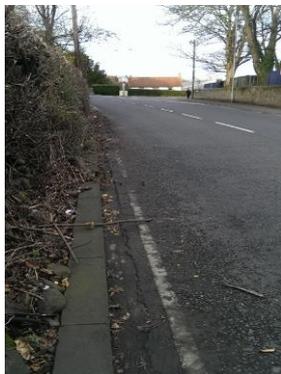
**Photograph 7:**

- Within the village of Wooler there is one slight collision and it relates to a car hitting the hedge on the nearside heading northbound and overturning. Photograph 7 shows the close proximity of the retaining wall with vegetation that has been cut back, yet is still forms an imposing structure on the carriageway, as well as some of the offcuts strewn on the ground. The road width is 8.4 metres in width so there is potential to move the vehicle further away from the edge of the carriageway and improve the entry into the oncoming bend.

View within Wooler with encroaching retaining wall

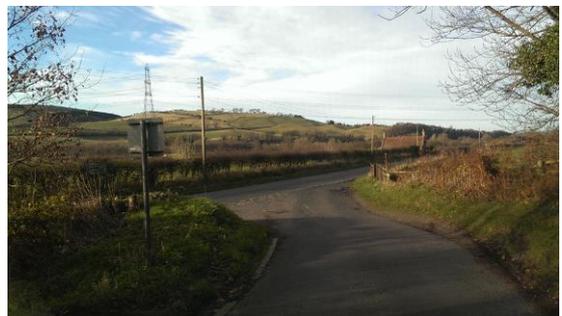
**Photograph 8:**

- There was a fatality at Tower Martin junction where a driver has pulled out of the junction directly into the path of the oncoming vehicle. At present there are no signing related instructions to either give way or stop at the junction. In addition the alignment of the road markings lends itself to approaching the junction without having to slow. An emphasised bend would be more beneficial than the current layout.

View on approach to Tower Martin Junction

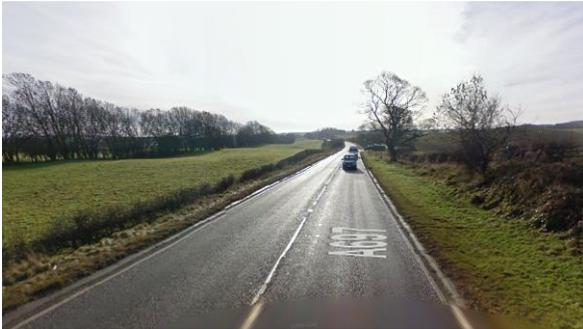
- South of Roseden is a series of bends where a slight collision has transpired as a result of loss of control at the bend. The vehicle left the road and collided with trees. This is an indication of travelling at speed. The Double Bend warning sign at this location was also missing at the time of the site visit.

Photograph 9:
View beyond Roseden heading Southbound

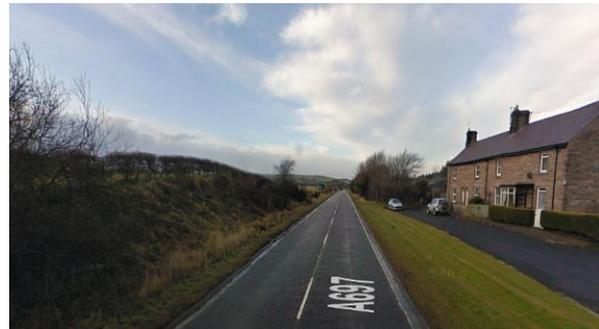
- A second goods vehicle entered the opposite carriageway for unknown reasons outside Station Cottages and collided with the oncoming vehicle. No causation factors could be determined from the collision data provided.

Photograph 10:
View heading Northbound adjacent to Station Cottages

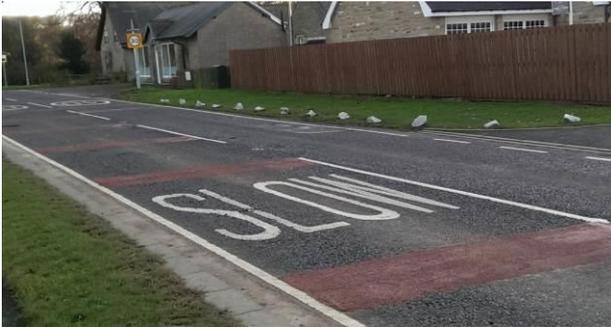
Photograph 11:
View heading Southbound into Powburn Village

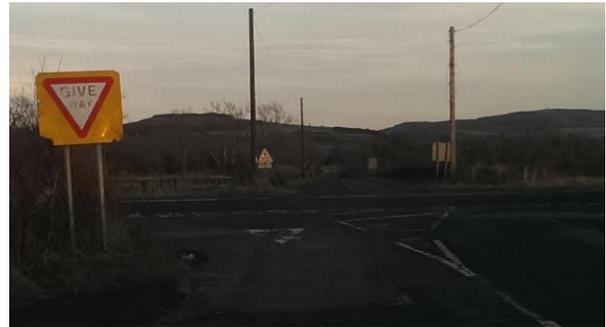
- There was a serious collision at the Glanton crossroads where the driver enters the A697 turning right and collides with an approaching vehicle. The road markings and signage are both in poor condition and need replacing.
- Two collisions have been attributed to driver error and no other causation factors have been found.
- One serious collision takes place within the village during dark conditions on the bend. The street lighting is inconsistent as it should be lighting the outside of the bend
- One slight collision involves overtaking a pedal cycle on the approach to the village and no mitigating factors could be found.

Photograph 12:
View on approach to Glanton Crossroads

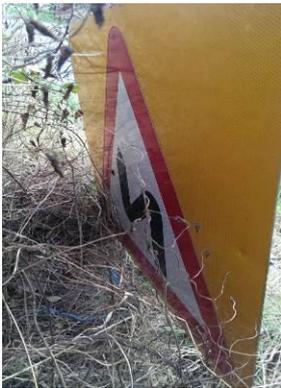
**Photograph 13:**

- The HFS is no longer aiding the driver and is potentially having an adverse effect due to the sporadic layering.
- The double bend warning sign (**Photograph 13**) in advance of the bend has been damaged now resides in the verge no longer mounted to the poles.

View showing double bend warning sign in verge

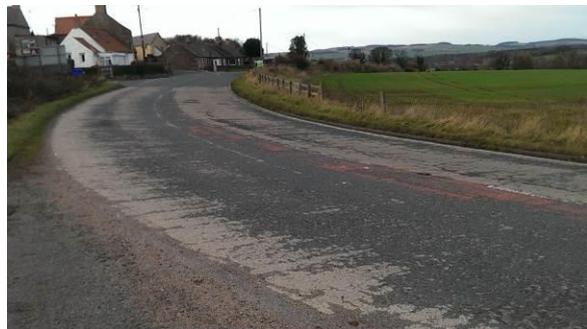
**Photograph 14:**

- When entering Humbleton there are a series of bends with settlements on either side. High Friction Surfacing (HFS) has been provided in the past but its current condition would suggest it hasn't been refreshed for some time. The uneven spread of surfacing presents a tyre differential in terms of frictional grip and this can have an impact on drivers when driving, especially for goods vehicles with heavy loads.

View showing High Friction Surfacing on Humbleton bend

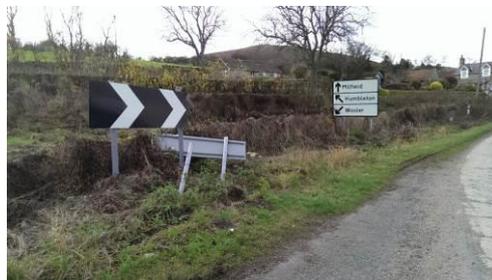
- Vegetation is overgrown and is obscuring any signs currently present.
- Chevron boards have been damaged possibly due previous collisions

**Photograph 15:** View showing damaged Chevron Boards and Northbound stack type sign

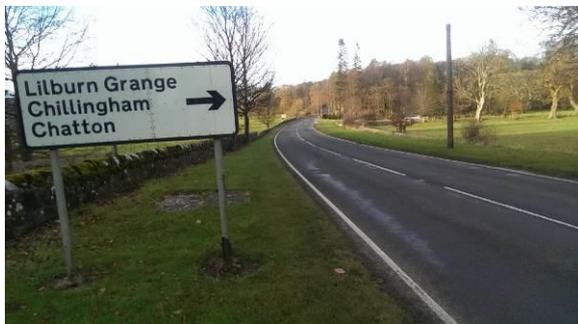
- The slight collision at the Ilderton junction references right turning with a resultant rear end shunt whilst waiting. The Advance Direction sign to this junction is too far away which lessens the impact.
- The slight collision beyond Lilburn is a loss of control on a bend at a location where the bend warning sign is missing.
- The rest of the slight collisions are predominantly loss of control related and are an indication of excessive speeds.

Photograph 16: View showing ADS distance to Lilburn junction

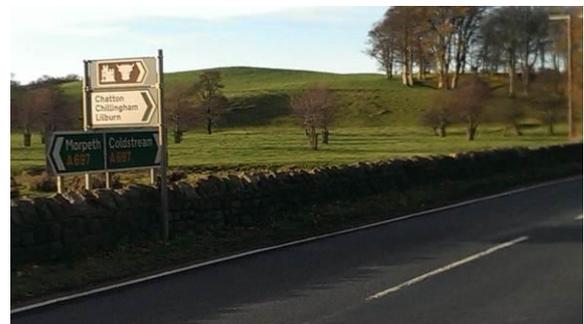
- The serious and slight collision relate to right turning manoeuvres into Lilburn Tower. The serious was a rear end shunt and the slight involved an attempted overtake whilst the right turn was being completed. The additional slight was purely driver error as the motorcyclists boot got caught between gear and brake.
- The advance direction sign is a significant distance away from the junction and loses effect. Both the Advance direction sign and the Direction sign display inconsistent information referencing different place names which leads to confusion.

Photograph 17: showing inconsistent text with ADS

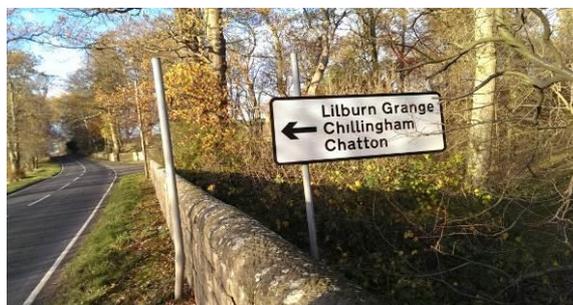
Photograph 18: View showing ADS facing wrong direction detached from pole

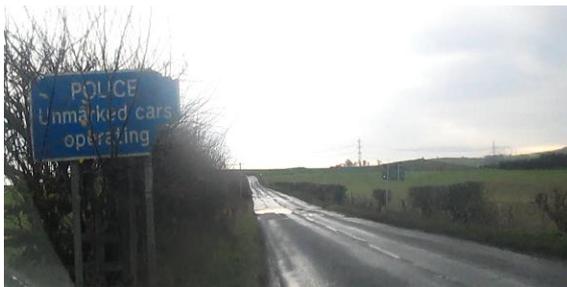
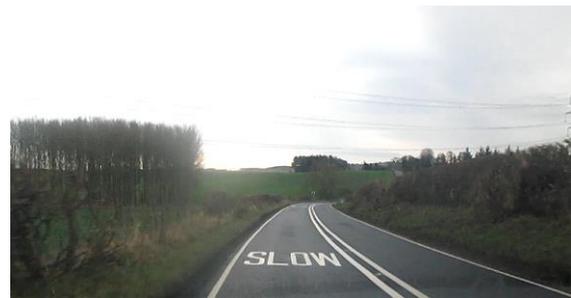
**Photograph 18:** View showing damaged information sign**Photograph 19:** View heading Southbound showing existing lining
