BUILDING FRONTAGE IMPROVEMENTS

STATION ROAD - ASHINGTON

THE PROJECT SO FAR...

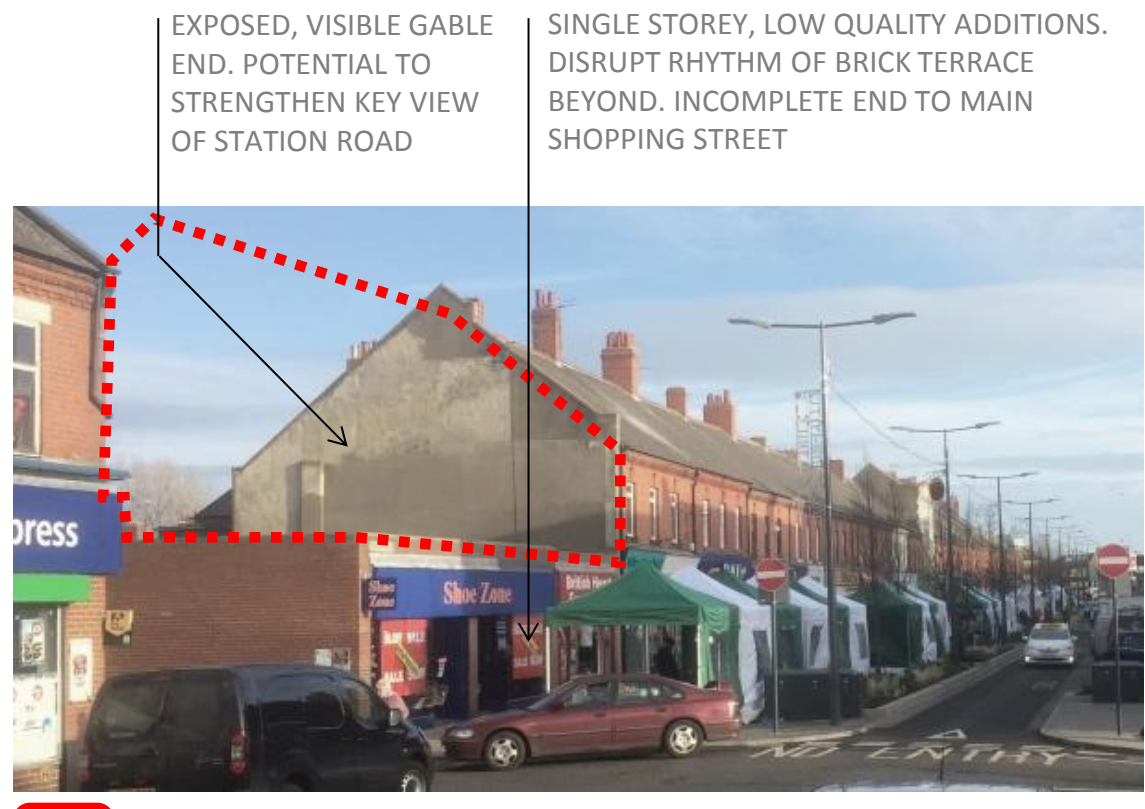
- 1**
- POTENTIAL FUTURE DEVELOPMENT SITE - 2 STOREY ADDITION
 - ARTIST INPUT TO IMPROVE GABLE END
 - SIGNAGE AND LIGHTING TO PROVIDE A FOCAL POINT TO THIS KEY POSITION ALONG STATION ROAD

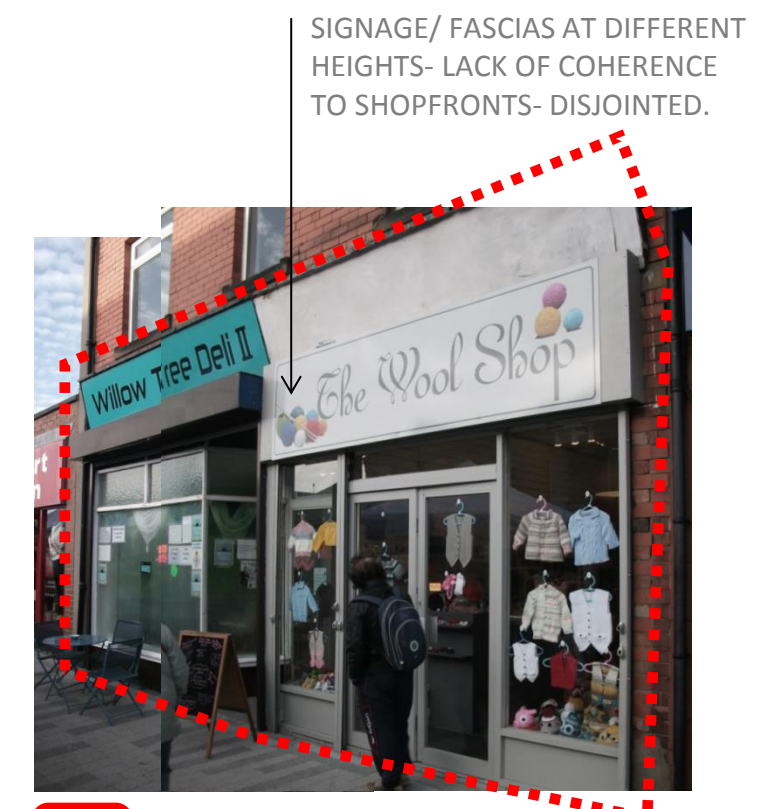
- 2**
- POTENTIAL FOR NEW SHOP FRONTS TO UNITE THE TWO SHOPS WHILST MAINTAINING THEIR OWN SEPARATE IDENTITIES

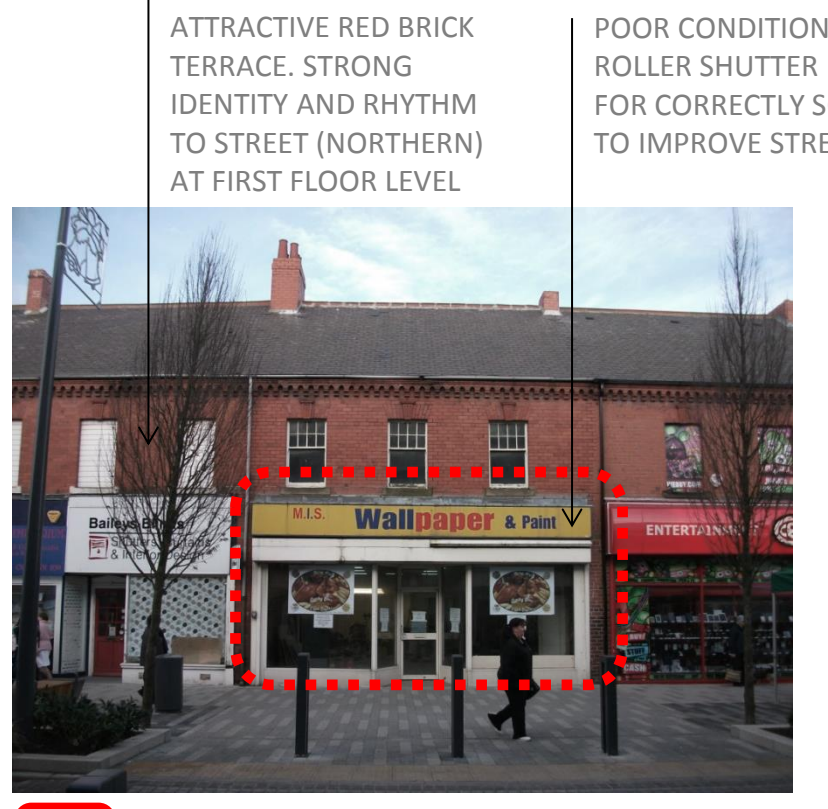
- 3**
- NEW SHOP FRONT FEATURES TO IMPROVE STREETSCAPE

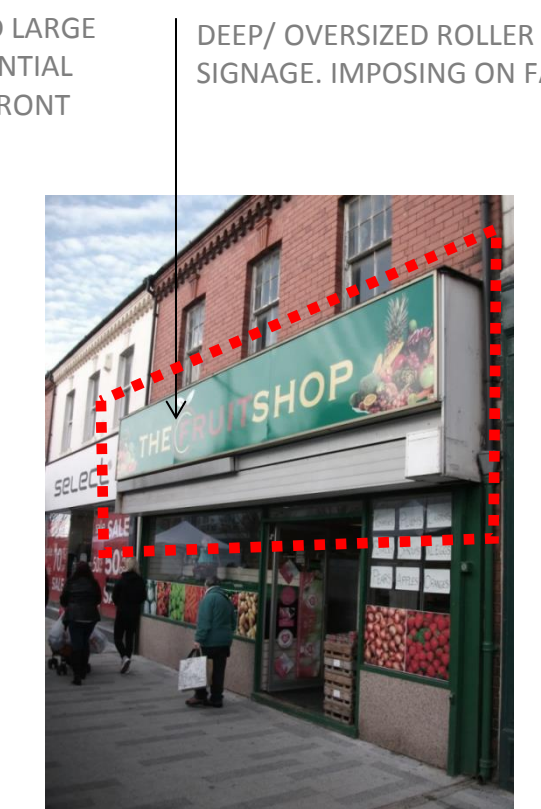
- 4**
- POTENTIAL FOR A NEW SHOP FRONT WITH INTEGRATED ROLLER SHUTTERS AND CORRECTLY PROPORTIONED SIGNAGE. POTENTIAL TO INTRODUCE RAMPED ACCESS INTO THE SHOP

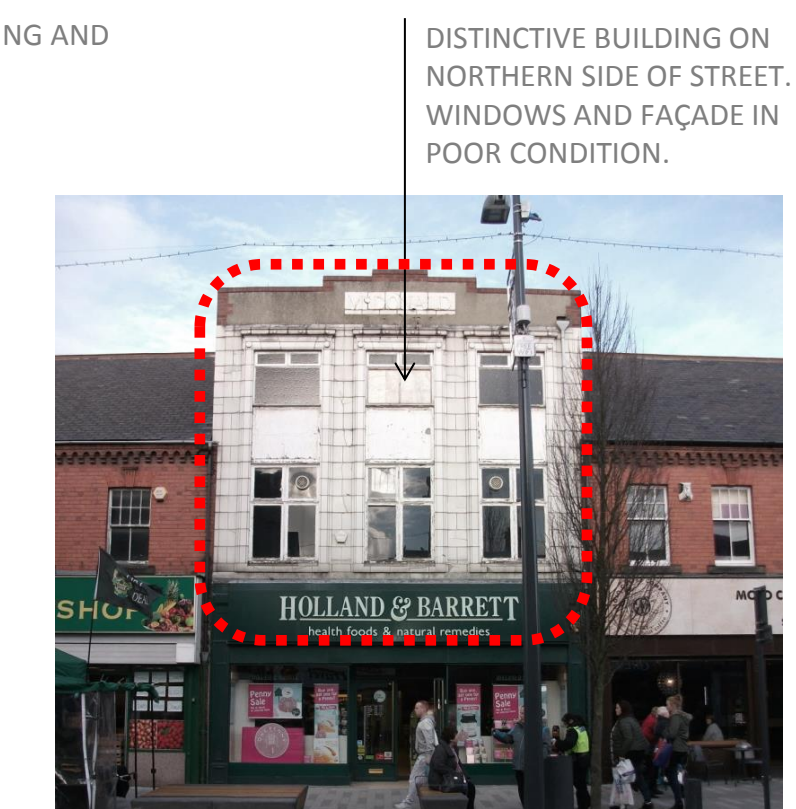
- 5**
- REMEDIAL WORKS TO THE WINDOWS AND FAÇADE TO IMPROVE THE CONDITION OF THE BUILDING

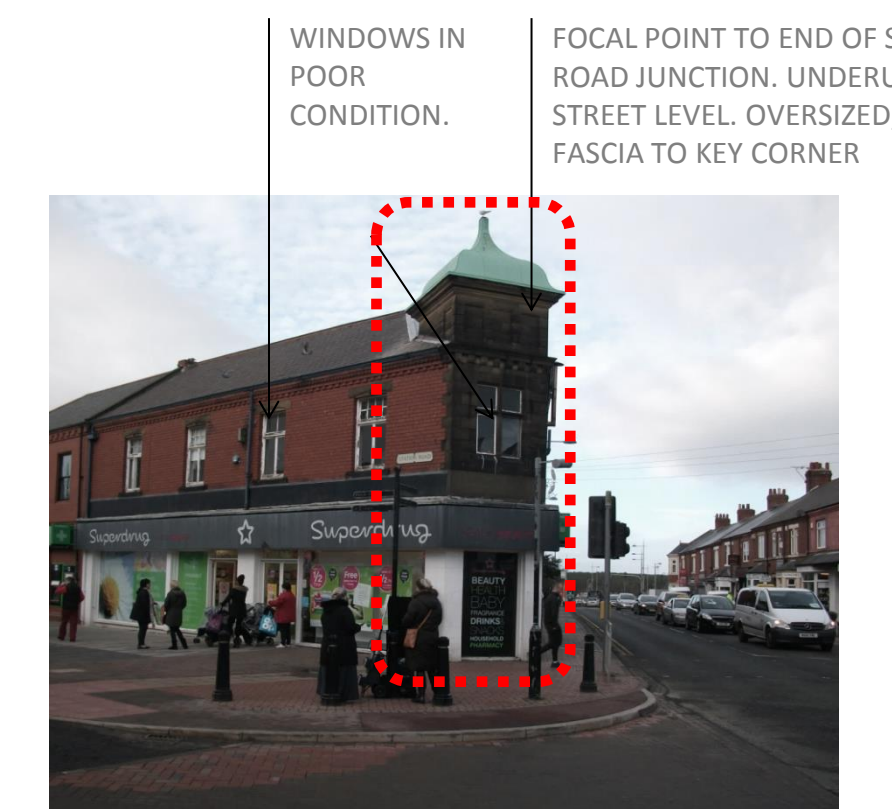
- 6**
- REMEDIAL WORKS TO UPPER FLOOR WINDOWS. CLEAN UP STONEMWORK, REINSTATE A NEW SHOP FRONT TO THE CORNER UNIT. CREATE A FOCAL POINT TO THE PROMINENT LOCATION. POTENTIAL TO INTEGRATE EXTERNAL LIGHTING

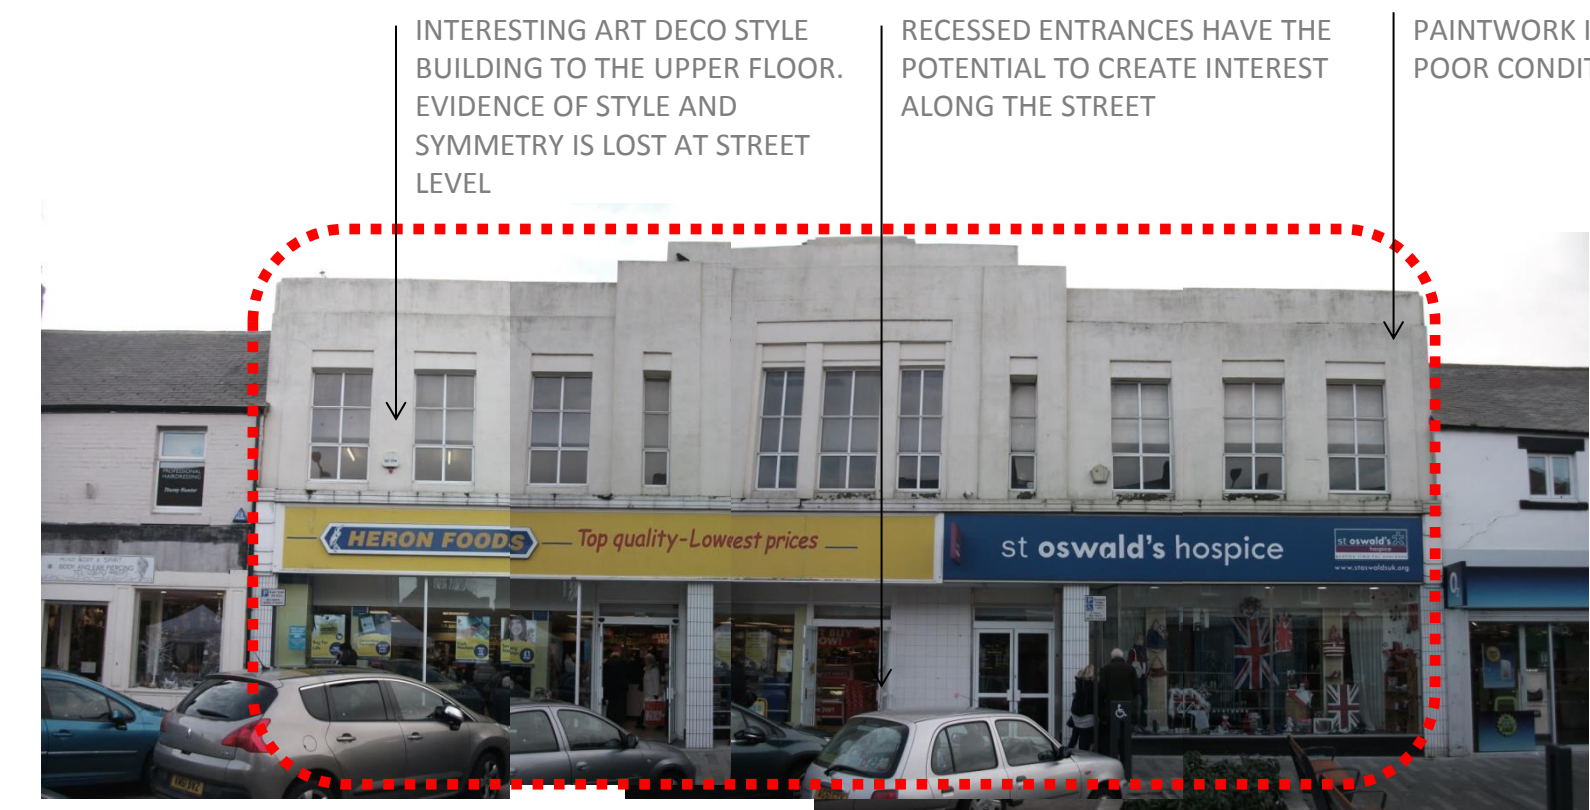
- 7**
- REFURBISH UPPER LEVEL FAÇADE AND WINDOWS. REINSTATE SHOP FRONT PROPORTIONS AT GROUND FLOOR LEVEL TO REFLECT THE SYMMETRY OF THE BUILDING ABOVE

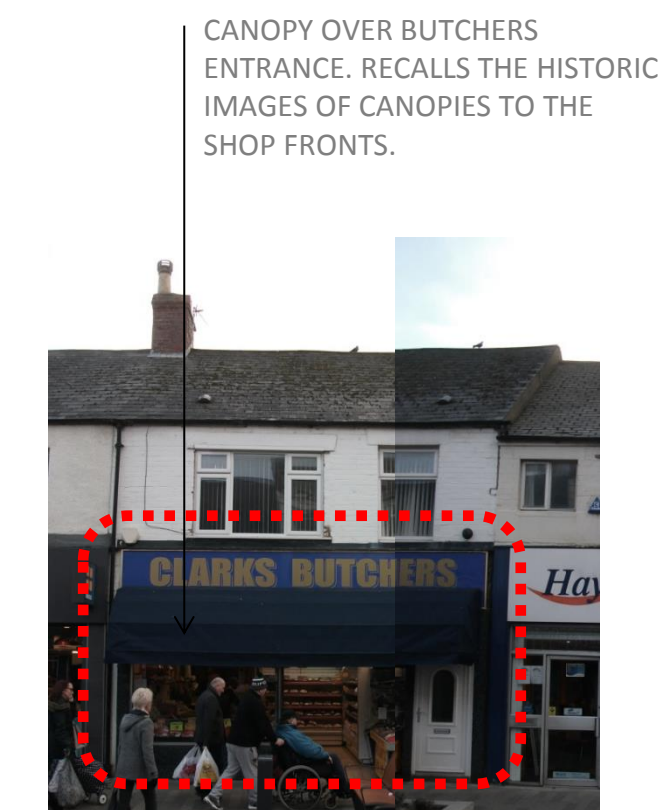
- 8**
- REINSTATE SHOP FRONT TO IMPROVE PROPORTIONS AT STREET LEVEL. ITS POSITION ON STATION ROAD HAS THE POTENTIAL TO LIFT THE AESTHETIC OF STREET

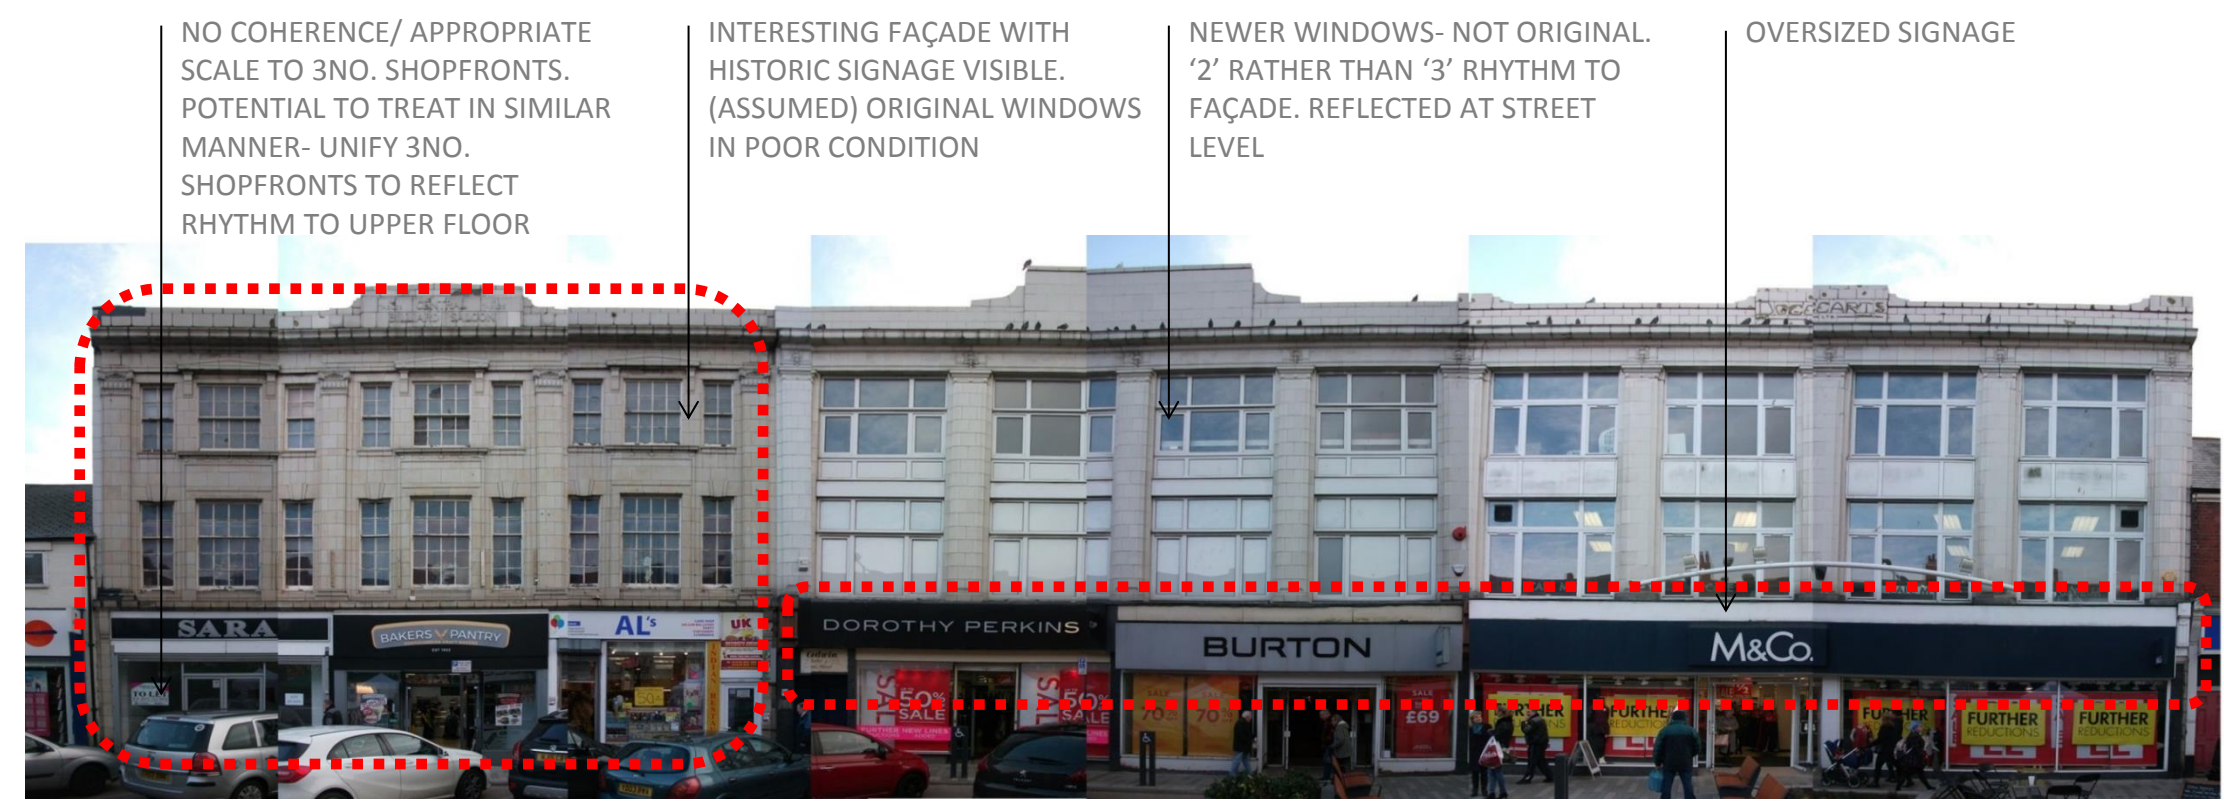
- 9**
- REFURBISH UPPER LEVEL FAÇADE AND WINDOWS. REINSTATE THE SHOP FRONT PROPORTIONS AT GROUND FLOOR LEVEL TO REFLECT THE SYMMETRY OF BUILDING. EXTEND FASCIA TREATMENT ACROSS THE BUILDING BLOCK TO GIVE A HIERARCHY TO STREET LEVEL. POTENTIAL TO INSTALL EXTERNAL LIGHTING TO PROVIDE VISUAL INTEREST AT NIGHT, UNIFY THE FAÇADE AND STRENGTHEN THE HIERARCHY OF THE BUILDING BLOCK ON THE STREET. ORIGINAL PILASTERS ARE VISIBLE IN PLACES WHICH SUGGEST THAT AN ORIGINAL SHOPFRONT MAY EXIST BEHIND THE CURRENT SIGNAGE. THERE IS A POTENTIAL TO REINSTALL THE EXISTING SHOPFRONTS

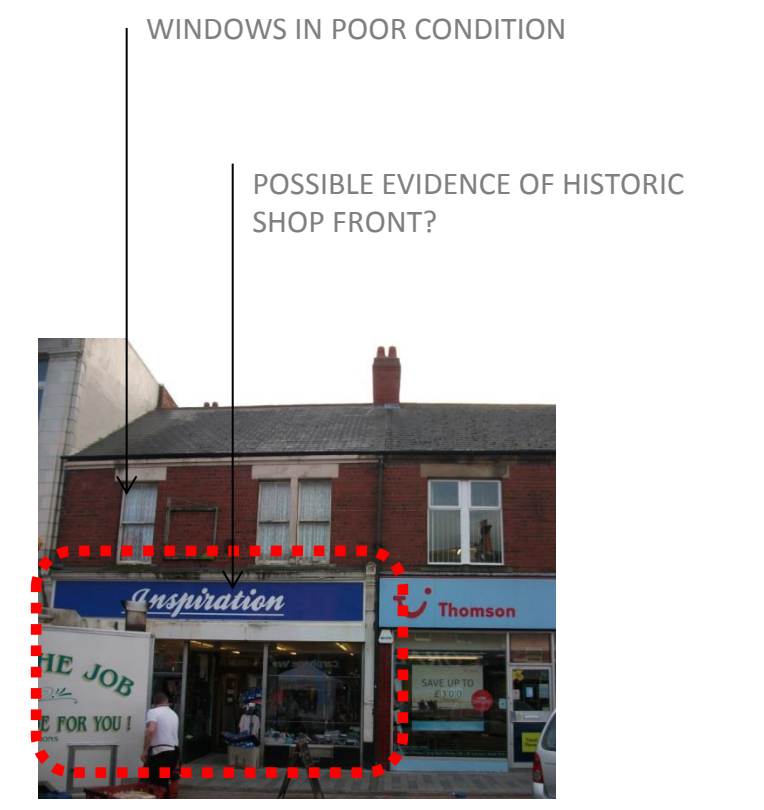
- 10**
- POTENTIAL TO CARRY OUT REMEDIAL WORKS TO UPPER FLOOR WINDOWS AND TO REINSTATE THE ORIGINAL SHOP FRONT
