Ovingham Bridge Blog – April-May 2015

What's happening inside the tent?

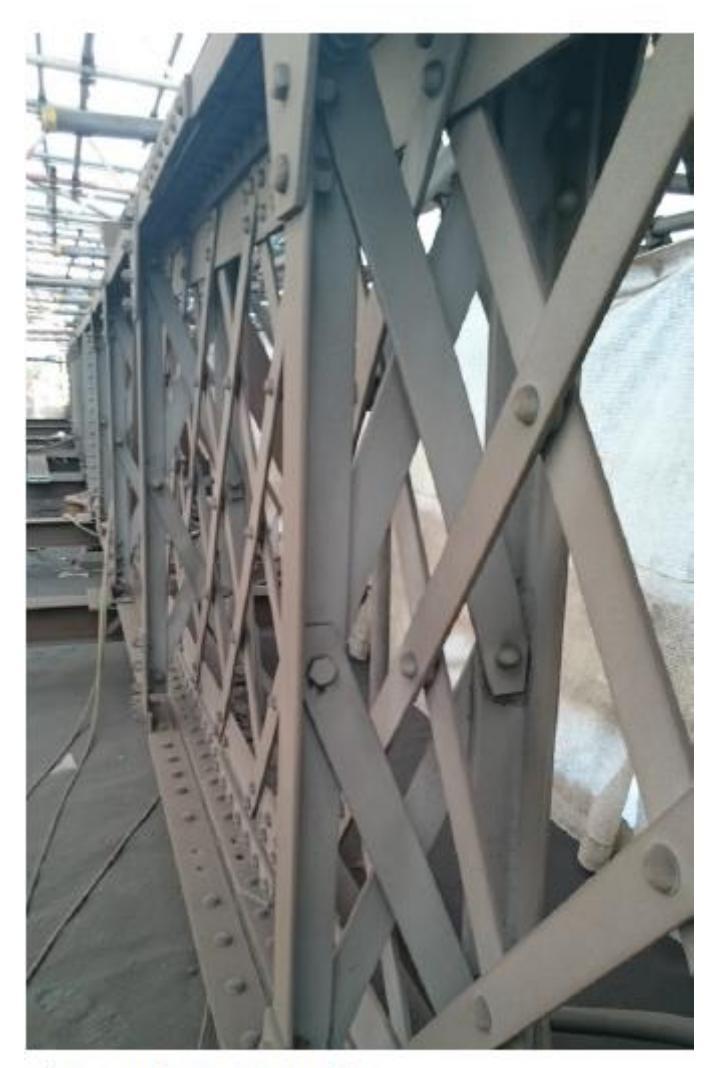
Painting the truss requires certain standards of preparation to be achieved. It's like painting your house, preparation is the key to a good finish. So the truss revealed after the wet grit blast has rusted again. In order to apply the primer to the bridge it has to be blasted to achieve bright metal. See the photos below, at the ends of the tent there is a margin of wrought iron which has not been blasted next to a blasted section. Note the difference in colour. The metal with the grey appearance will receive the primer.

Photo taken 28 April General view along truss showing blasted truss

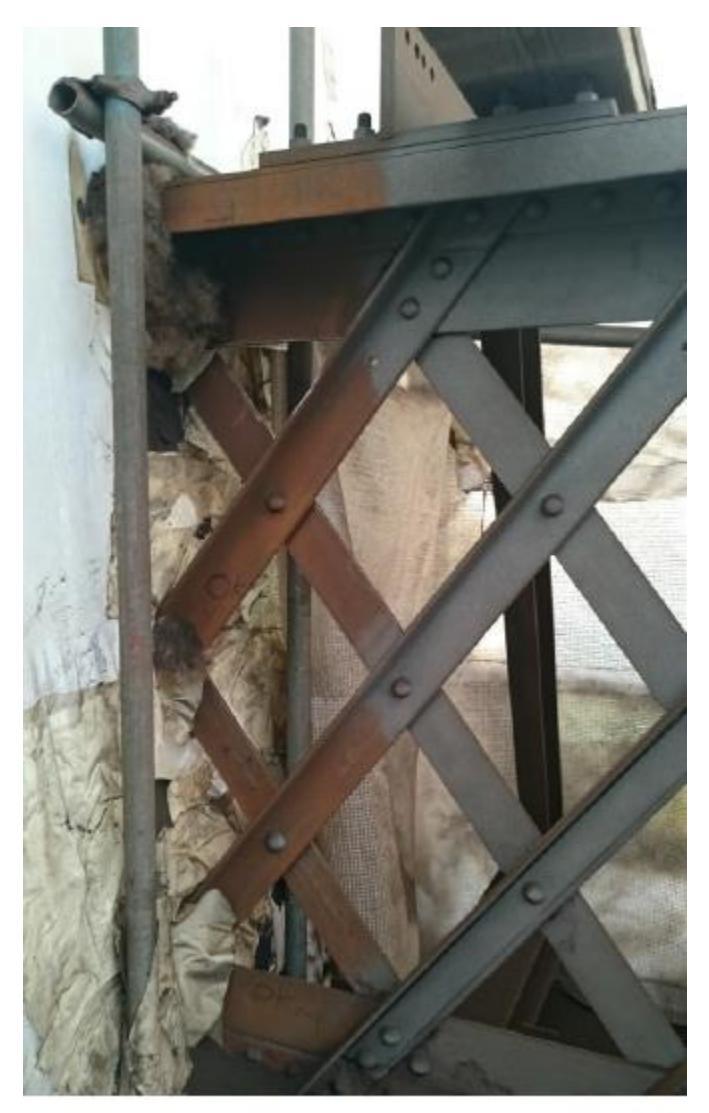
Photo taken 28 April Grit blasted truss next to rusted truss.

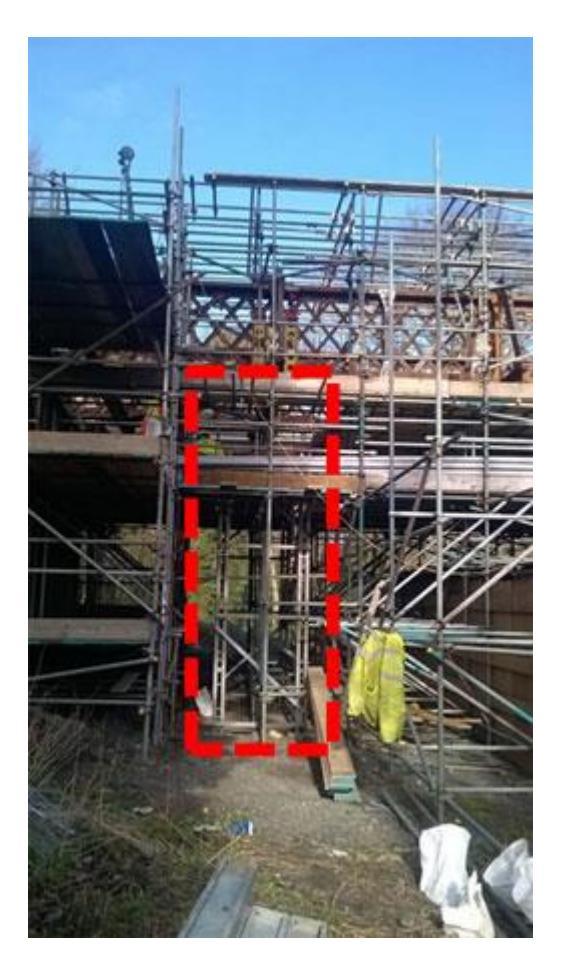
Mystery explained – both trusses are supported from the riverside footpath level by a jacking tower. The jacking tower inside the red dashed box is built from a concrete foundation installed before the scaffolding went up.

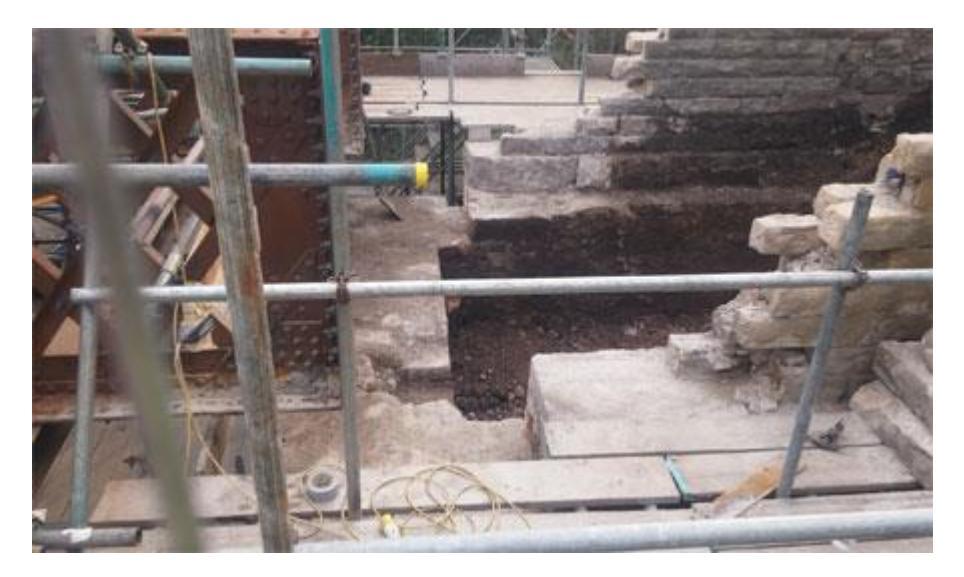
Photo taken 8 April, showing the removal of the bearings and the stonework beneath

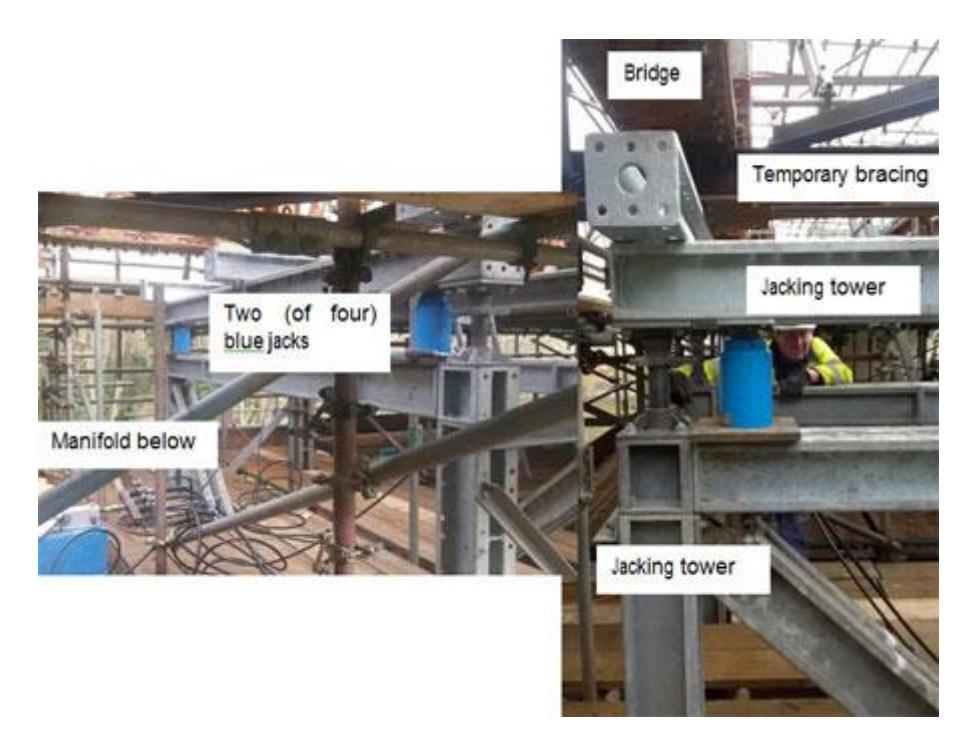
The blue jack is hydraulic, there are another three jacks in the each of the other corners of the frame. They link to a manifold which ensures all four jacks lift evenly. The hydraulic jacks are only used to make the initial lift. The screw jacks hold the truss at its jacked level while the abutment works are carried out. Once the abutment is complete, the hydraulic jacks will be installed again and they will lower the truss onto its new bearings.

In order to jack the truss, it has to be braced. The load path, which for 130 years has resulted in vehicle and bridge loading being transferred to the ground via the end of the truss, has been changed temporarily. In its temporary condition there is only the bridge weight (without the roadway) to transfer to the ground via the jacking tower. This equates to 3 tonnes/truss, or the weight of a vehicle which is permitted to use the bridge. The truss is sitting approx 10mm above its old position. It has to go back to its original level \pm 25mm (1").
