Archaeology in Northumberland

Volume 21

Foreword	1
Welcome	1
Hexham Abbey House	2
Flodden Finds	2
World War Two Graffiti: recording Winston	3
Hadrian's Wall, Melkridge ... or Clayton's Wall?	4
Coquet Island Lighthouse: surveying the monastic cell	6
Flodden Finds	9
Limekilns and Lobsterpots.	9
Recent sites in South-East Northumberland:	
pit alignments and settlements	10
Glanton: Alndale Hall prefabricated chapel	13
Rothbury Bridge: making repairs	14
Cockle Park Tower: renovate and record	15
Portable Antiquities in Northumberland	18
Historic Area Improvement Schemes: Berwick-upon-Tweed.	20
Hartburn: St Andrew's Church	22
Northumberland's Shipwrecks: secret treasures	25
Holmes Linn, Allendale: conserving a lead mine	26
Kirkhaugh Bronze Age Cairn:	
Northumberland's earliest gold object.	28
Flodden Finds	29
Dukesfield Smelters and Carriers Project:	
excavating Dukesfield smeltmill	30
Haggerston Dovecote: hidden depths	34
Tow House, Burncliffe: a cruck-framed barn	35

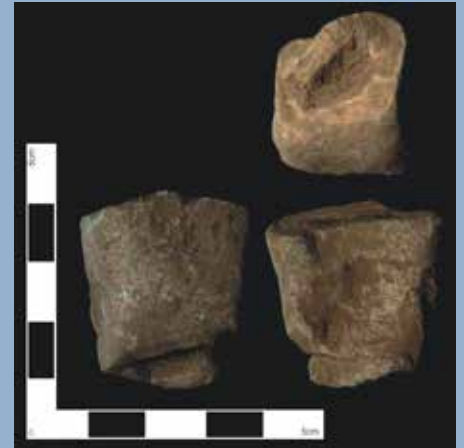
This lead object was found on the middle slopes of the northern side of Flodden Hill below the earthworks that form the most prominent surviving feature of the Scottish Camp.

Discovered with a metal detector the object is formed of 5mm thick folded lead and is believed to be a powder measure. Such measures would have been an essential part of a gunner's kit, whether working with one of the 20 or more large cannon James IV's army travelled with or with an early long gun or *arquebus* (the predecessor of a musket).

The size of this measure suggests it might have been for a smaller artillery piece (James' inventory included 3 inch guns, though it is unclear whether these travelled to Flodden) or an arquebus. Louis XII of France had sent James IV a consignment of arquebus before the battle, though sources are contradictory as to whether they were with the Scottish army on the 9th September 1513.

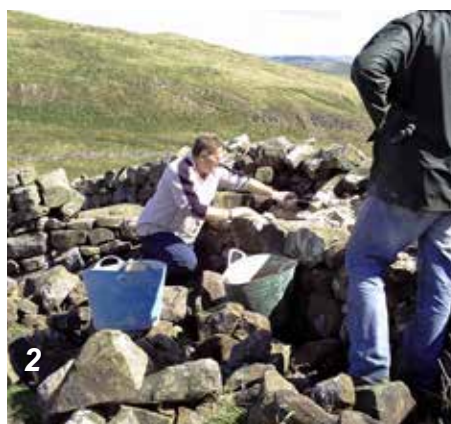
2

Following conservation assessment by Countryside Consultants, which identified areas of future weakness and structural instability, Heritage Consolidation Ltd undertook the consolidation works (Fig 2). This comprised mostly rebuilding sections of collapsed walling, alongside minimal building interventions to ensure the stability of the remaining fabric, and the establishment of a natural soft capping of moorland grasses on the wall-tops, which was retained as a benign protection to the masonry below. The masonry repairs and pointing were undertaken using hydraulic lime mortar.

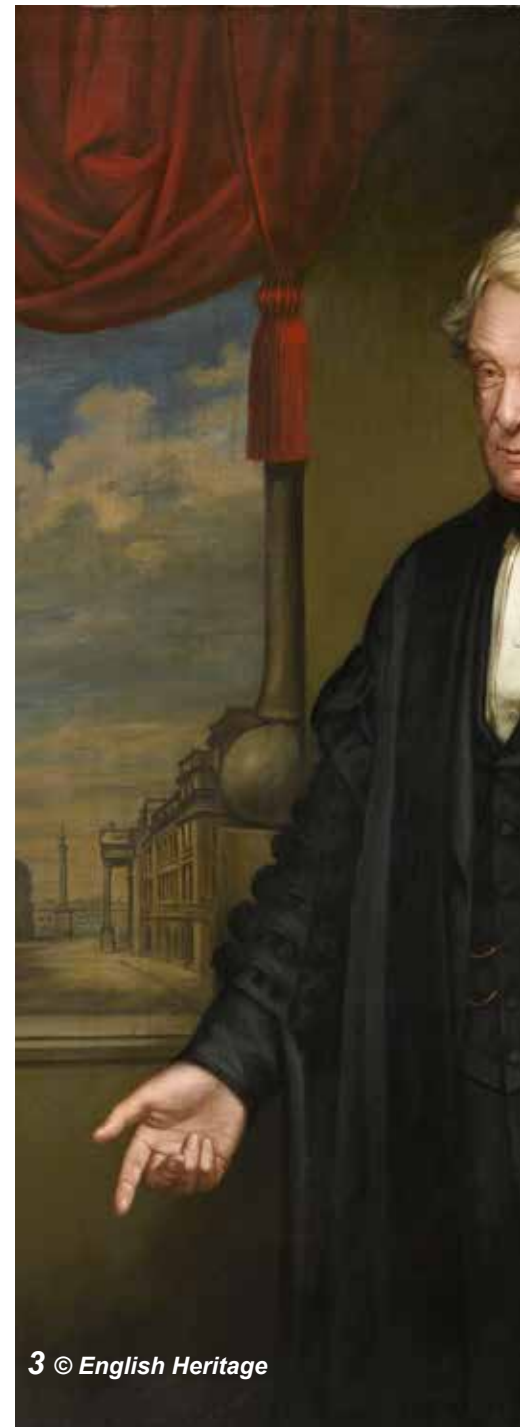
3 © English Heritage

From 1834, John Clayton (Fig 3 by Edward Sawyer), who was a keen antiquarian, began buying property around Steel Rigg to preserve the Wall, at a time when it was little understood about the Wall or its origins. Clayton managed the farms he had acquired and succeeded in improving both the land and the livestock. His successful management produced a cash flow which could be invested in future restoration work, which he carried out on parts of the Wall. Workmen were employed to restore sections of the Wall, generally up to a height of seven courses; approximately 2.5km of the wall were rebuilt. His dedication to Hadrian's Wall proved invaluable to its later preservation.

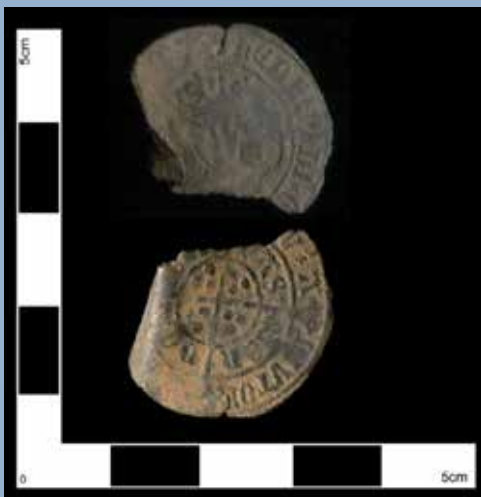
This damaged, but nevertheless well preserved 1/2 Groat (worth 2 pence) was minted in silver during the reign of Henry VII. Even as late as 1513, 6 years after the death of Henry VII a lot of the coinage in circulation in Henry VIII's England and James IV's Scotland would have been minted during Henry VII's reign.

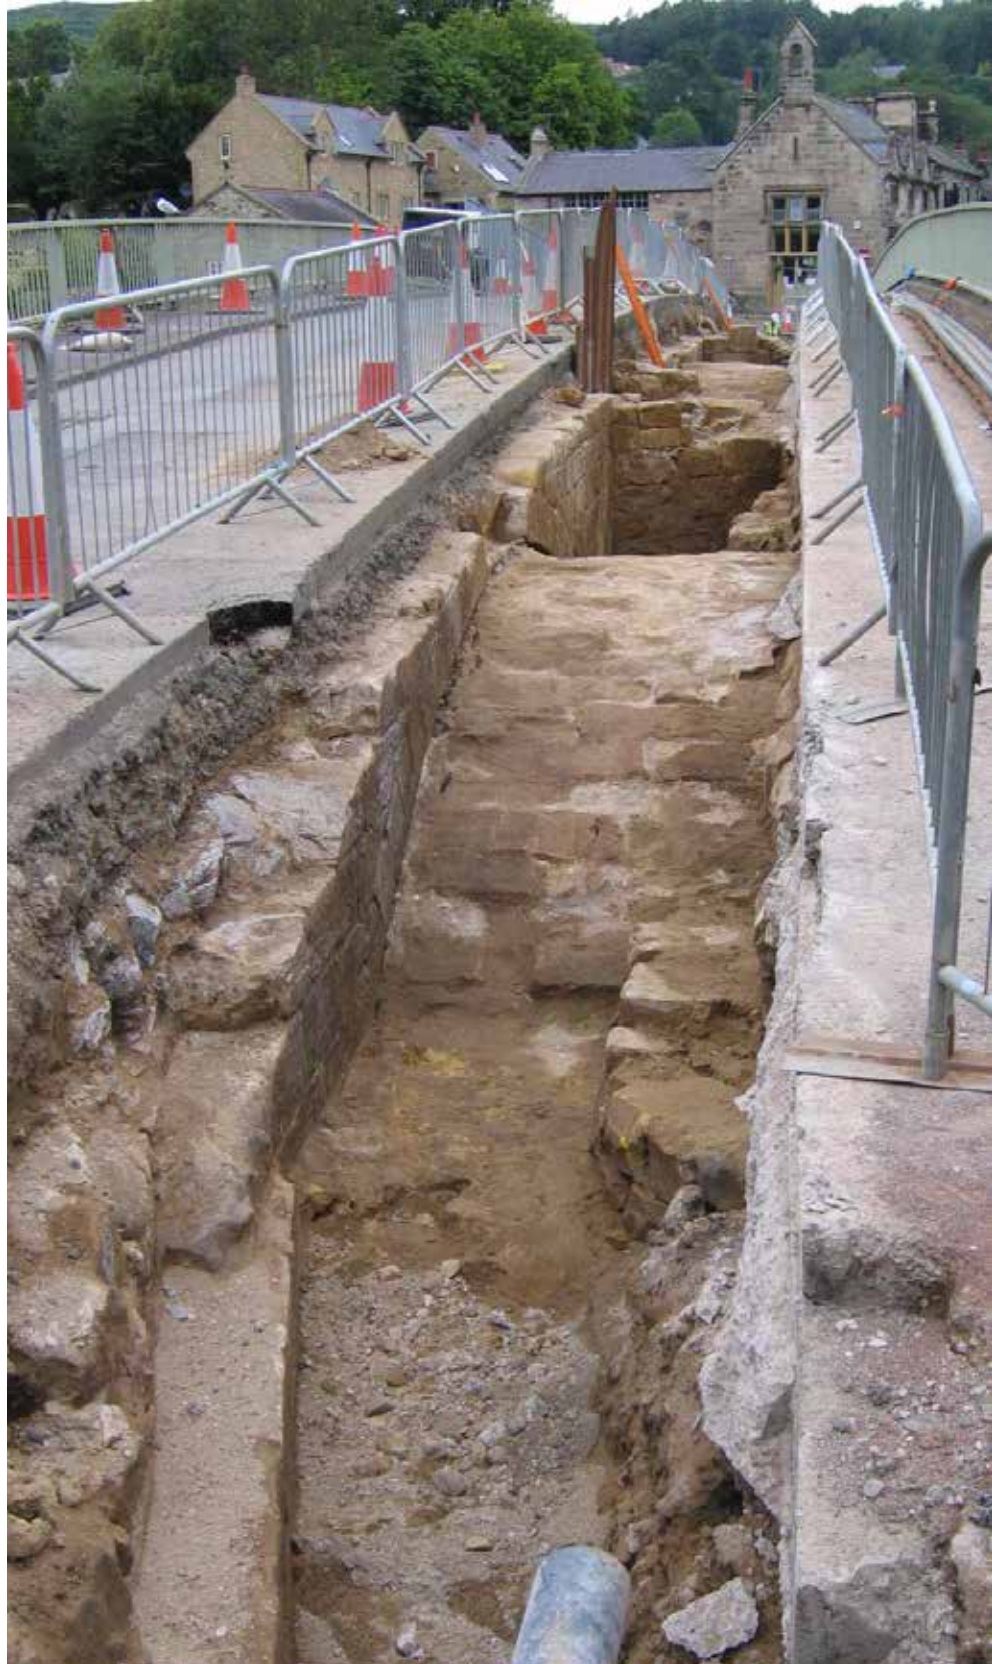
The photo (right) shows the medieval eastern wall of the bridge adjacent to the left side of the trench with the curved barrel arch extension in the foreground belonging to the 18th century widening of the bridge. The figure (below) shows how archaeologists have been able to make a detailed recording of the eastern elevation of the medieval bridge. The impressive masonry rib arch spans of the original medieval bridge were also exposed providing a further valuable insight into the construction of the bridge. The strengthening works were undertaken with considerable care by the Highways Department to ensure the historic remains of the bridge were preserved in situ.

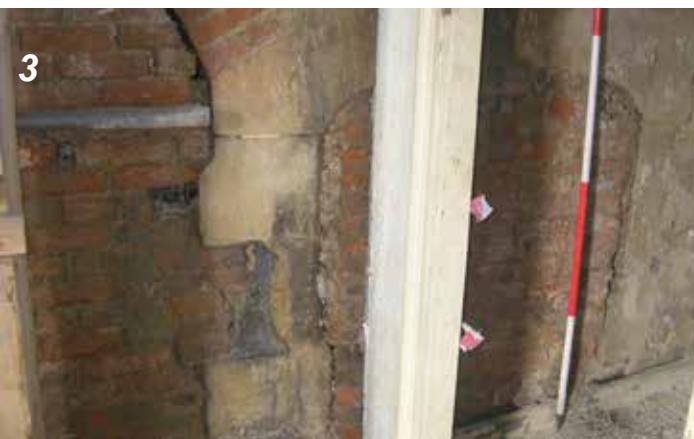
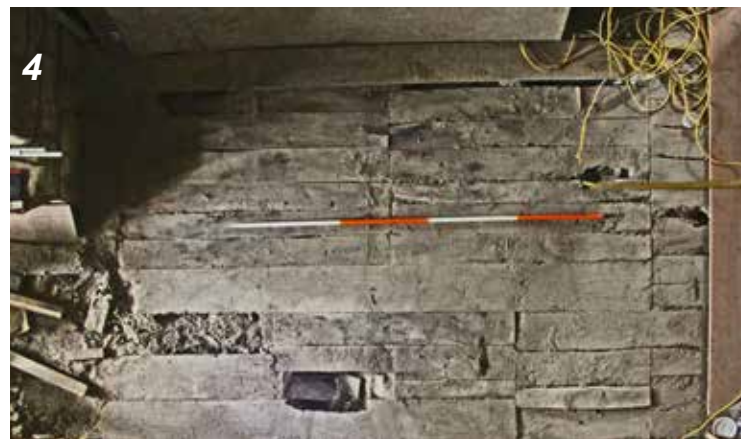
The west wall of the room presented a series of extremely interesting features. There is a small and plain fireplace (E33) with directly above it, a small window (E20) formed within the central light of a 17th-century three-light mullioned window. This is spanned by a roughly three-centred arch in brickwork, its springing at the south end being cut into an earlier column of alternating blocks which must have formed the internal south jamb of the 17th century window. Where the lintel of this should have

been there was an overhanging (and dangerous) area of large blocks (now rebuilt). The northern springing of the brick arch was notched into the north end of the lintel of an earlier fireplace (E37), now cut across by the west jamb of the doorway into the room; this looks of 17th century date, and has a Tudor-

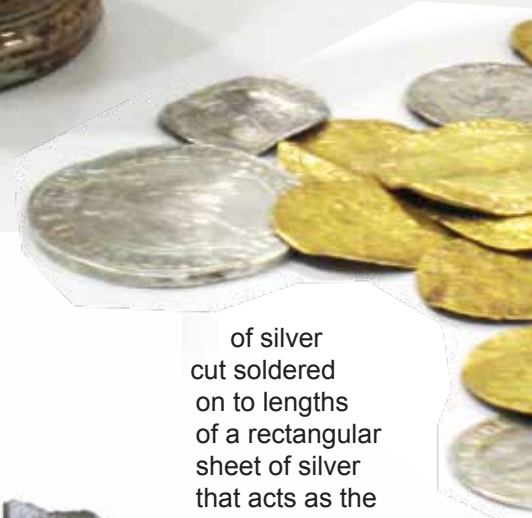
Also from the Alnwick area, though a different part, are two discoveries of silver pendants dating to the 17th century (NCL-912218 and DUR-3B7822). Both pendants are oval, made of two sheets

of silver cut soldered on to lengths of a rectangular sheet of silver that acts as the siding of the pendant (Figure 3). Both faces have been inscribed on each pendant in a very similar way, if not exactly matching. One face bears IHS, an abbreviation for Jesus, while the other face is inscribed with MA or MRA for Maria. The construction of the pendant suggests that it might be a reliquary pendant or Agnus Dei worn by a Catholic.

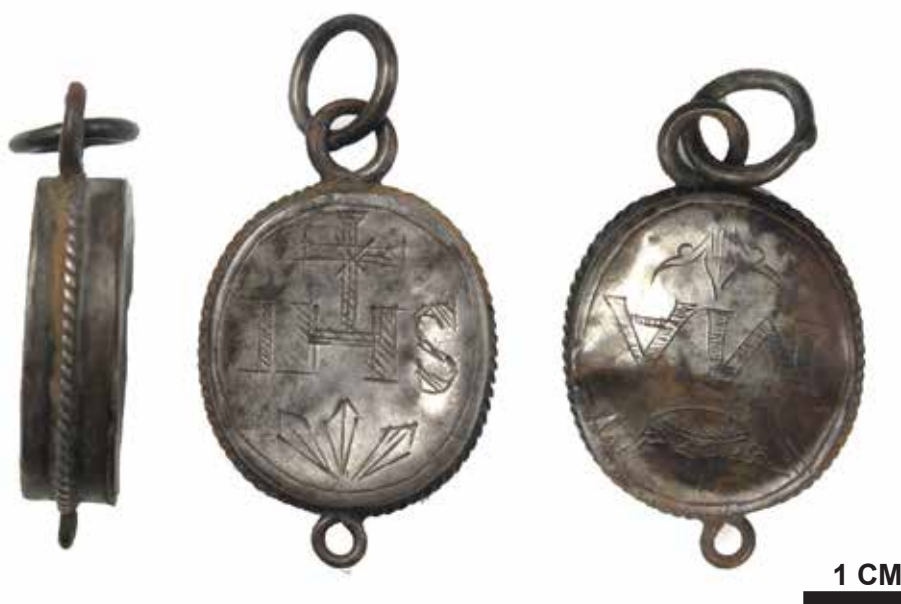
3

and to his surprise found ten

gold and seven silver coins in the bottom of the jug (Figure 2). The coin hoard is interesting, composed as it is of a number of English, French, Papal, and Burgundian issues. The latest coin is a sixpence of Elizabeth I dating to 1562 and, based on the degree of wear of the various coins, it seems the hoard was deposited shortly after 1562. What

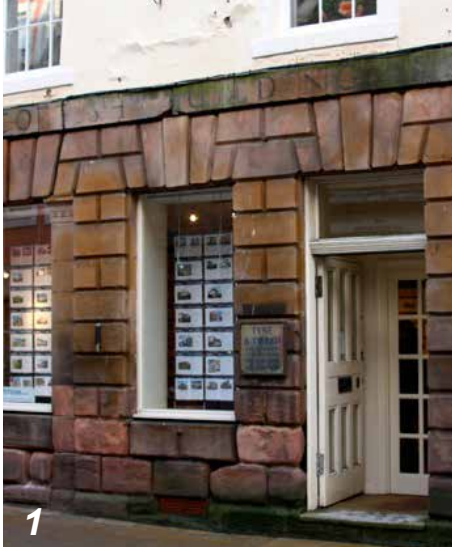
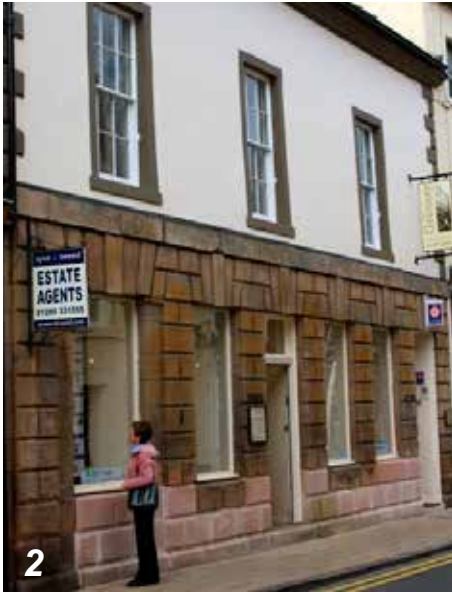
1 and 2. Before and after, stone repair on the Tyne and Tweed building, Bridge Street

The Bridge Street Area Partnership Scheme attracted a lot of interest and enquiries from traders, tenants and building owners at the very outset (being closest to the flagship Granary project) and four building repair projects have been successfully completed during 2011-2012 (see photographs of Bridge Street completed schemes – 'before and after' Figures 1, 2 and 7,8) with a further large building project commencing in May 2012.

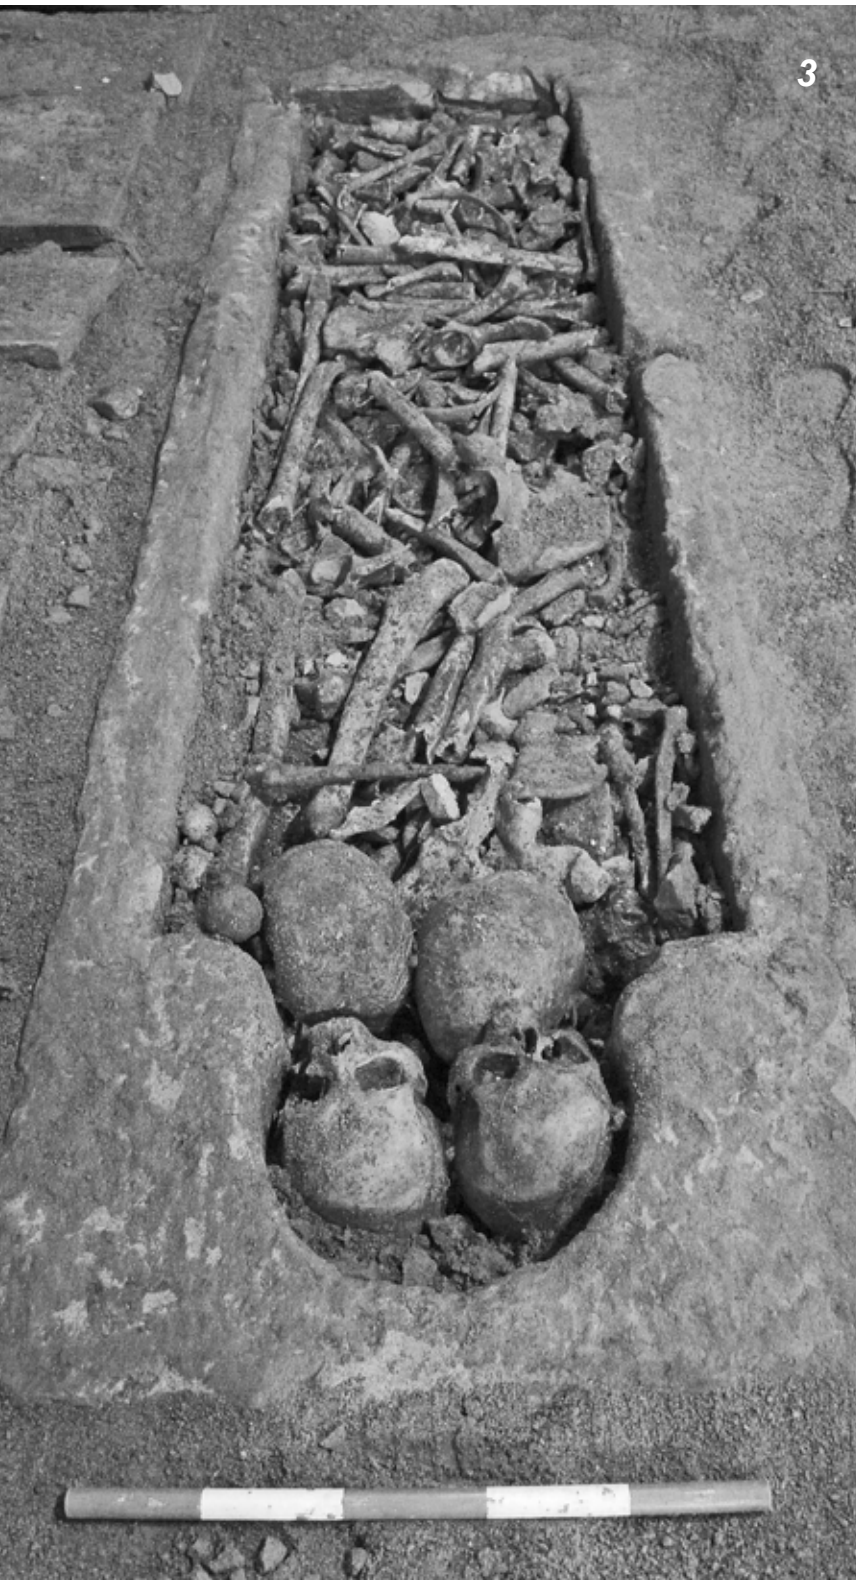
In Area 7 a sarcophagus containing human remains was uncovered and subsequently resealed (Figure 3).

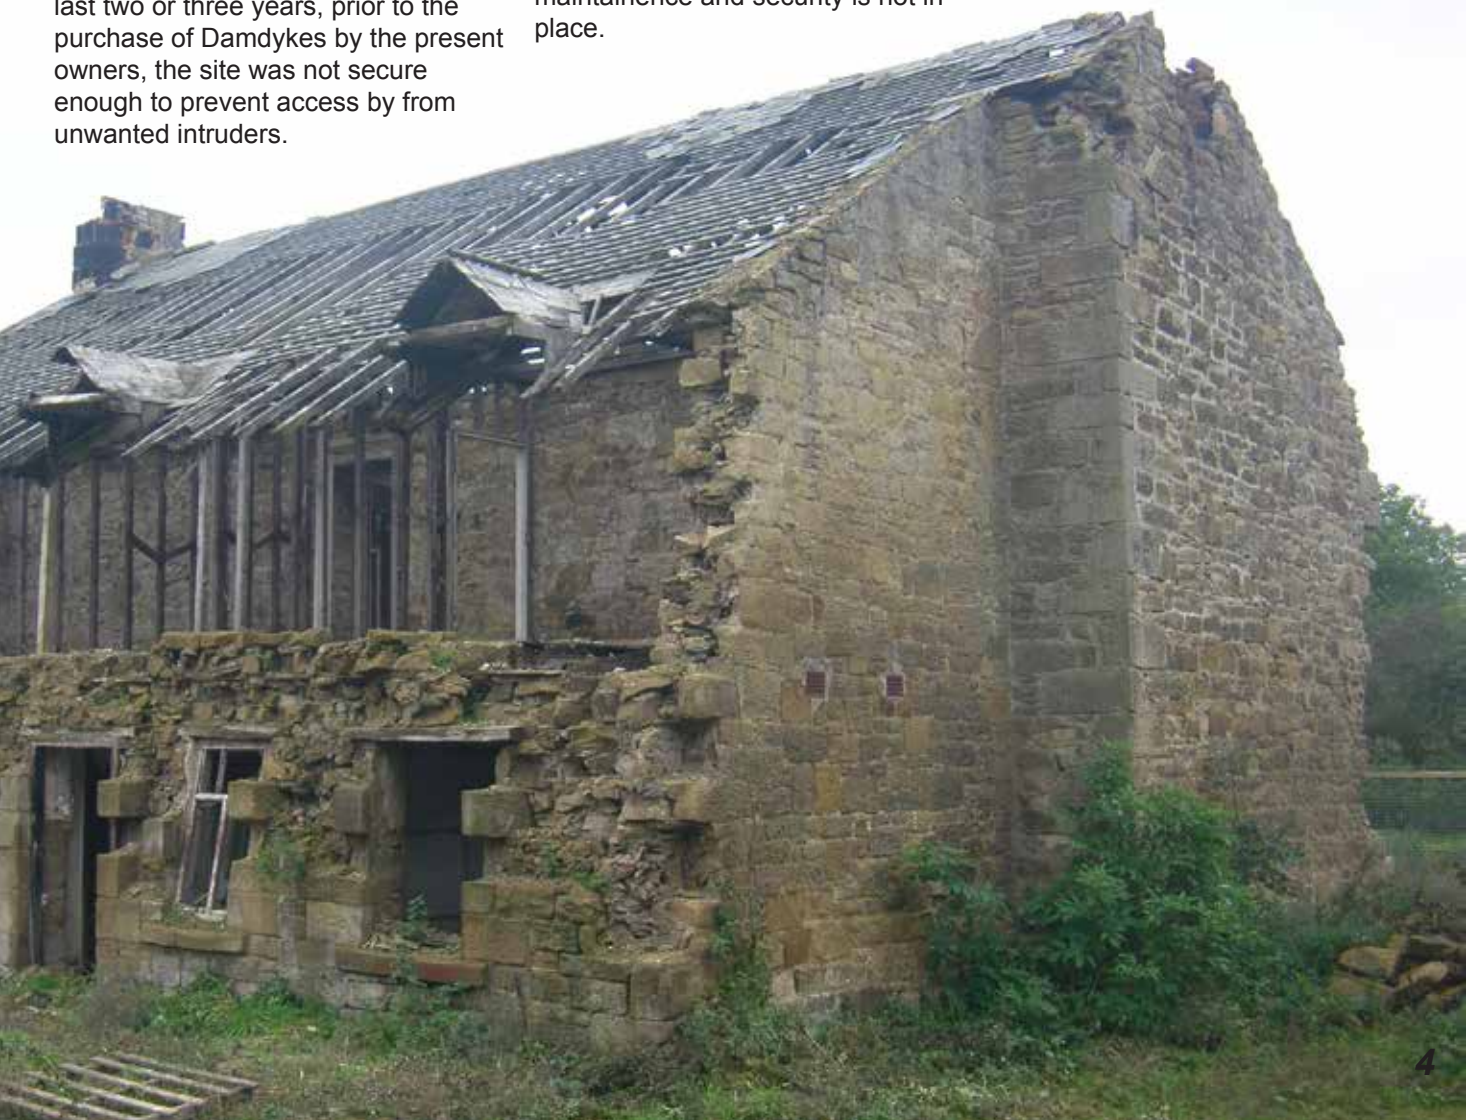
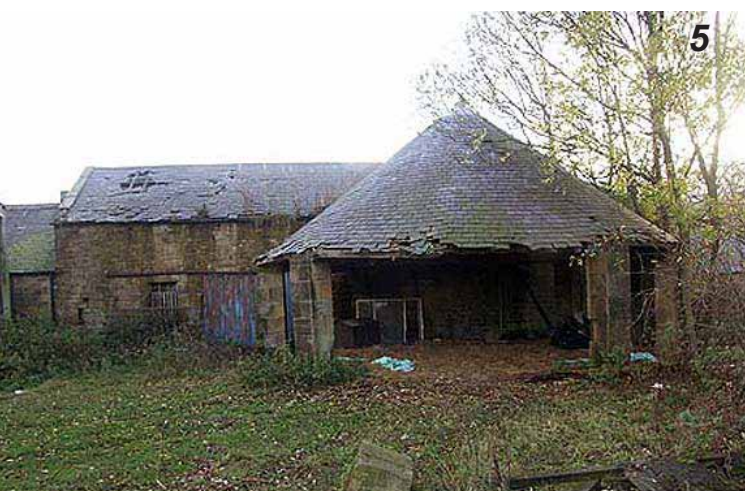
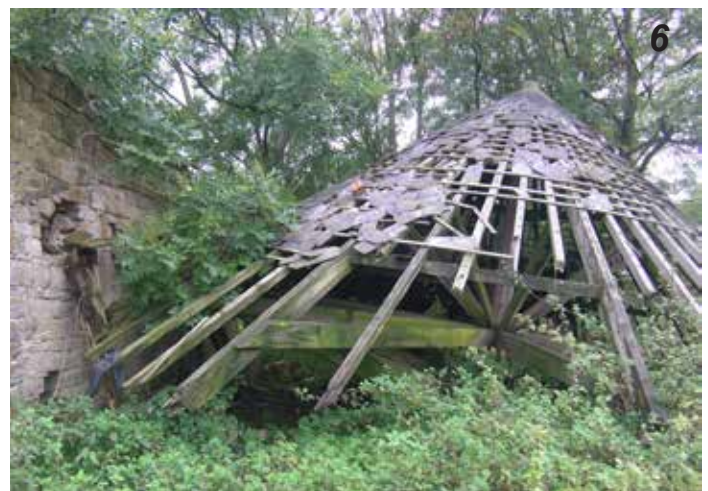
1. OS maps 1860s 1890s & 1920s
2. South frontage of the house prior to abandonment
3. House viewed from SE prior to abandonment
4. House viewed from SE in 2010 following 2 years of neglect
5. Gingang viewed from the north prior to vandalism
6. Gingang roof following illegal removal of supporting piers

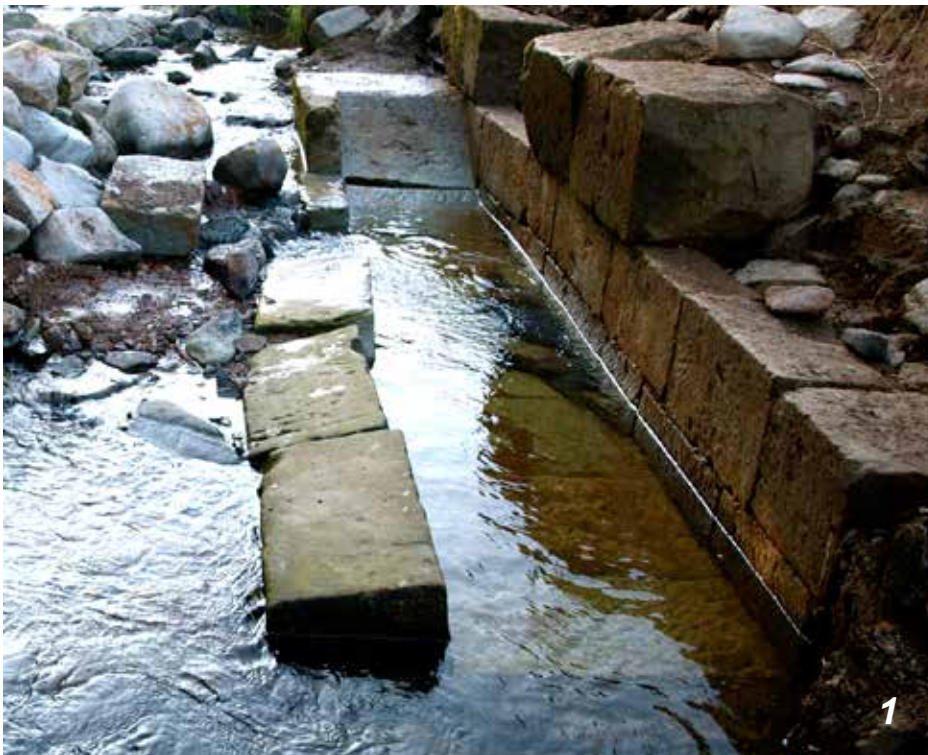
50cm wide, while abrasions on the pit walls show its diameter was about 3.4 metres (Fig 2). A curved concave block at the pit entry shows it housed a low breast-shot wheel. The water impacted it about halfway up its lower quadrant before flowing under it; the wheel fitted the sides of the pit closely and it was turned by both the weight of the water held on the blades and the final flow beneath.

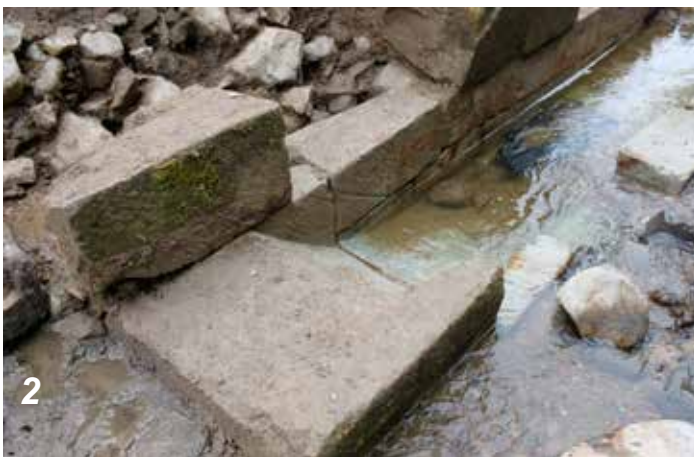
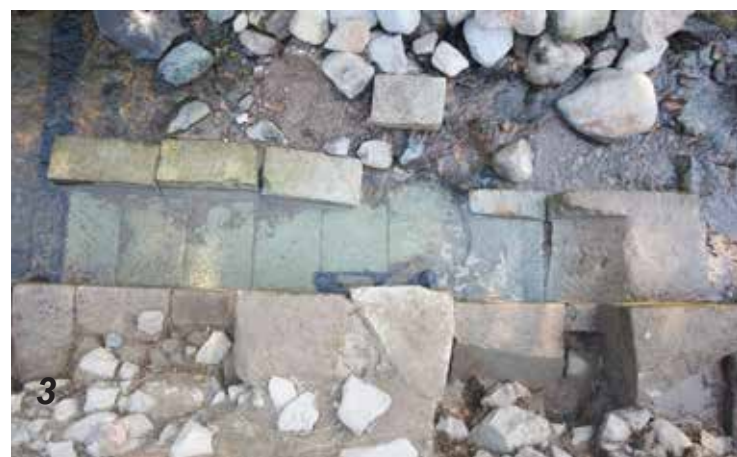
On the riverbed about 60 metres upstream we unearthed a massive wooden 'floor', consisting of three large timber baulks lying across the stream with wooden planks joining them and the remains of posts both at the ends and in the middle of the baulks (Fig 4). The structure weighs over 1000kg and it's still in situ; we identified where the bank had been cut back to accommodate one of the baulks, and some adjacent small stakes may have been used to support the bank during construction. The wood is a mixture of oak and ash, and dates to the same period as the wheel pit. Several theories have been advanced, but it seems most likely that the structure is the floor of

a sluice system that fed water into a leat for the mill. A rebate on one of the timber posts hints at the presence of a gate, and the flat floor would have helped cut off water flow cleanly and prevented scouring. Calculations show that even with moderate river levels, the structure could have captured enough water to power the mill.

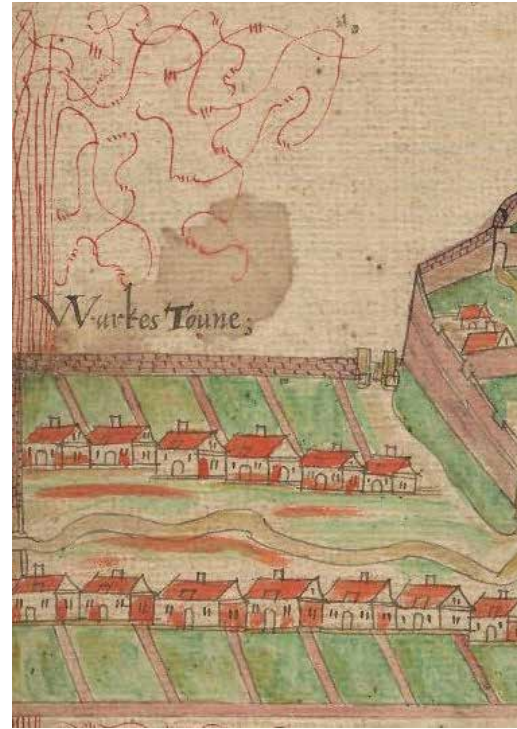
Wark-on-Tweed

The village of Wark developed within the outer ward of the castle and was certainly present there by the time of the first available detailed plan of the site, produced around 1560. Most of the village is sited on, or north of, the kaim, but over the last two centuries there has been some additional development to the south, along the Cornhill-Carham road which may also have developed later as a through route by-passing the village core. By the end of the 19th century there were 35 freehold properties in the village, a similar number to the present day and probably a fair estimate of the total at the end of the 16th century. The greater part of the village is confined to the Outer Ward east of the castle mound.

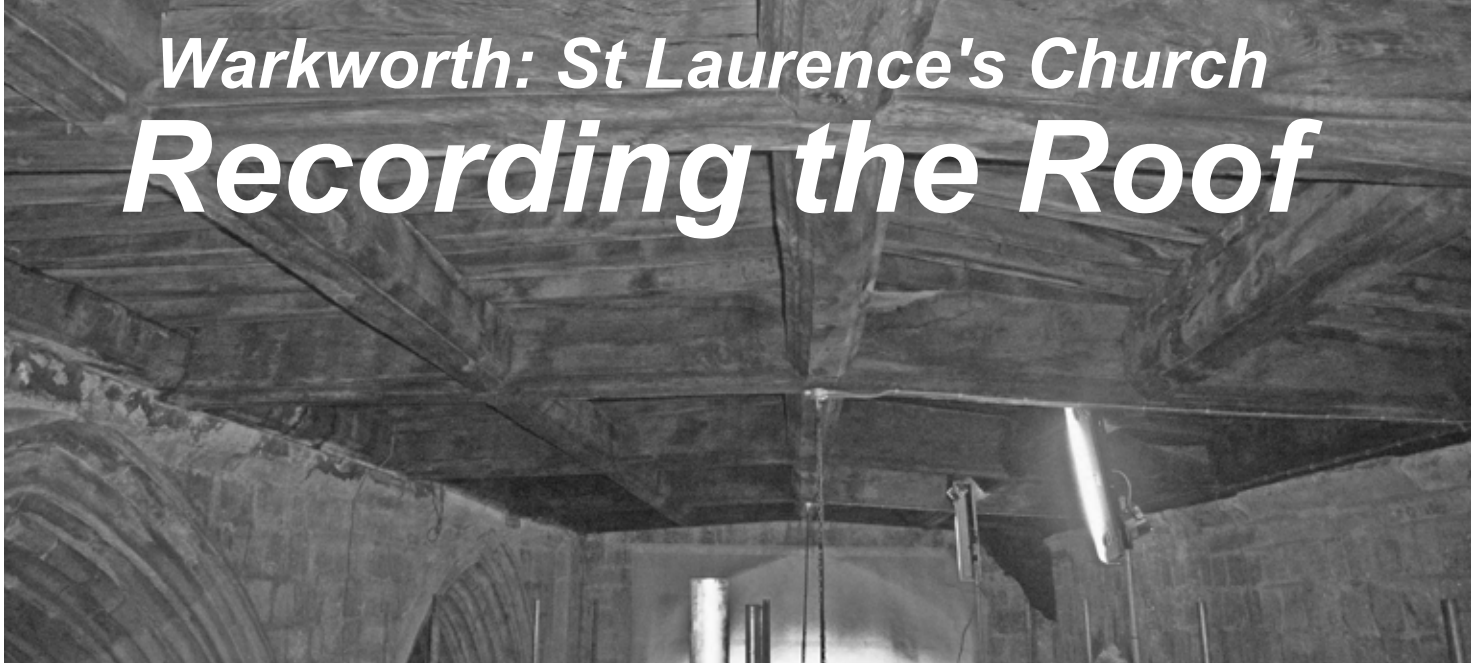
Warkworth: St Laurence's Church Recording the Roof

During an extensive programme of repair and conservation in Spring/Summer 2009 limited access became possible to the roof structure of the south aisle of St Laurence's Church which had suffered damage due to the continued structural movement that has plagued the building.

Seen from below the ten-bay frame appears to be of the characteristic low-pitched type in which roof boarding is laid directly on the backs of the slightly-cambered tie-beam, and additionally supported by a central 'ridge' with a purlin on each side (c.f. Hexham Moot Hall). These timbers, and the wall-plates on either side, are all moulded with a simple concave outer member and a wave moulding. Each of the panels framed by these moulded timbers is spanned by six plain square-section north-south joists.

Other elements that are clearly relatively recent are the combinations of wall-posts, stub tie and bracket that offer additional support to the outer ends of tie-beams 1, 5, 6, 7, 8 and 9, secured to the tie-beams by cast-iron straps. These odd features at the roof/wall junction are clearly a measure to counter the structural movements caused by the settling and tilting of the north wall - which have had the effect of pulling the rest of the church over, except the newer south aisle, which stayed put, hence pulling its roof from the south nave wall - which have here

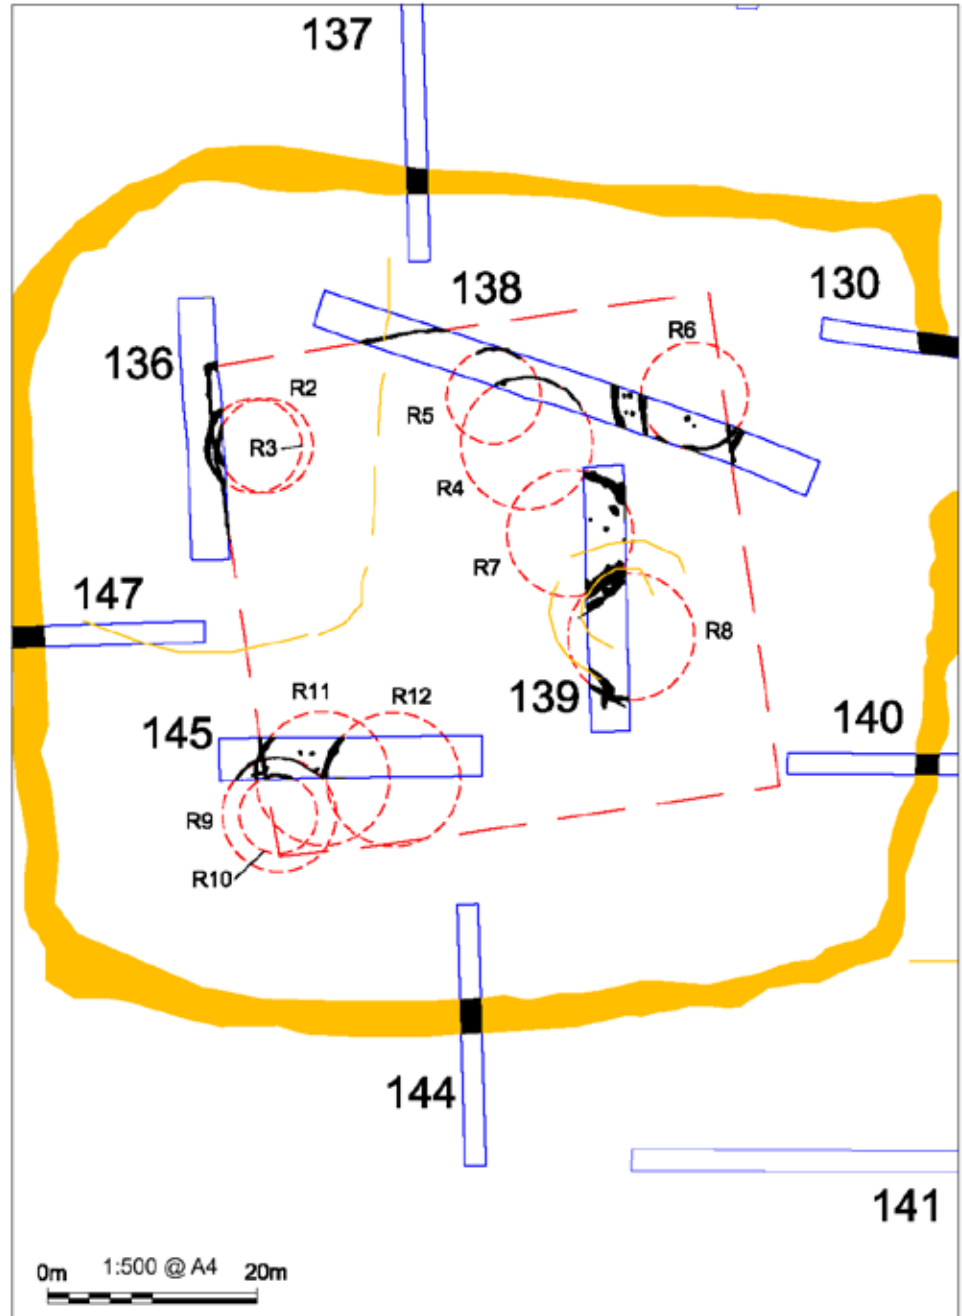
Plan of Hood's Close inner enclosure
(geophysical survey in orange)
