People and Planning Northumberland Local Development Framework

Bedlington Conservation Area Character Appraisal

January 2011

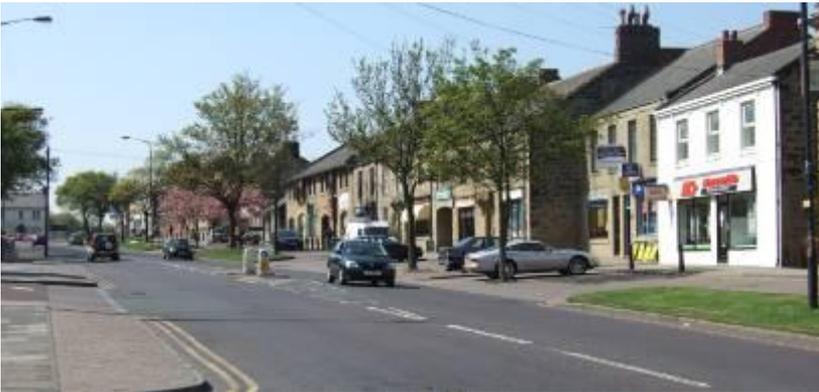
Above: development steps up the bank along Front Street. Below: the ridge top is pronounced on the south side of Front Street West

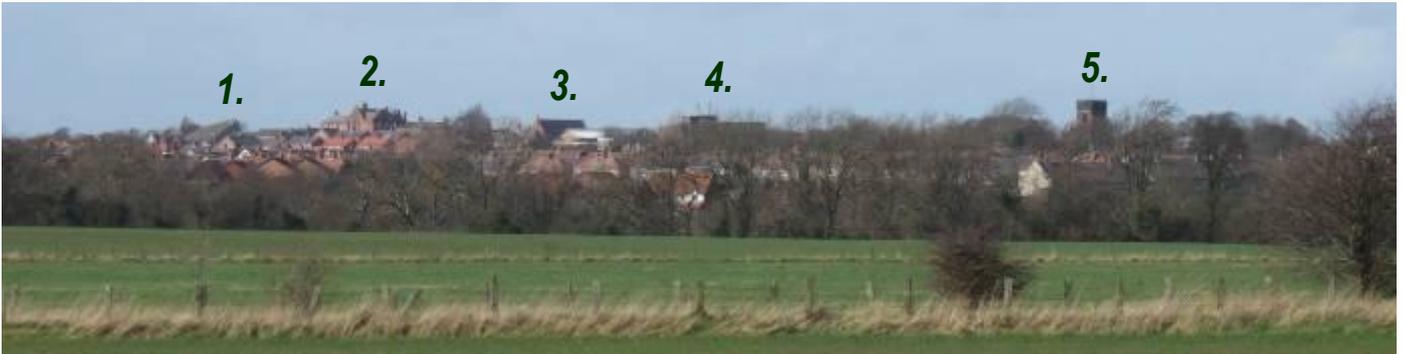
Bedlington from the south showing the skyline formed by: 1. RC Church (outside the conservation area), 2. former police station and courthouse, 3. Trinity Church, 4. Council Offices, and 5. St Cuthbert's Church with its wooded churchyard and adjoining vicarage gardens (protected by TPOs – see page 73)

3.15 The town is not particularly prominent in the landscape from further afield but five building groups provide a modest landmark skyline on approach from the south. The tower of St Cuthbert's Church is the most prominent, followed by the former Police Station & Courthouse, a tall building on an elevated site. These are joined by the steep pitch of Trinity Church, the complex roof slopes of the Catholic church (outside the conservation area to the west), and – the least suitable – the stumpy flat roofed tower of

the Council offices, bristling with antennae. Protecting this view from development in the conservation area's setting will be important.

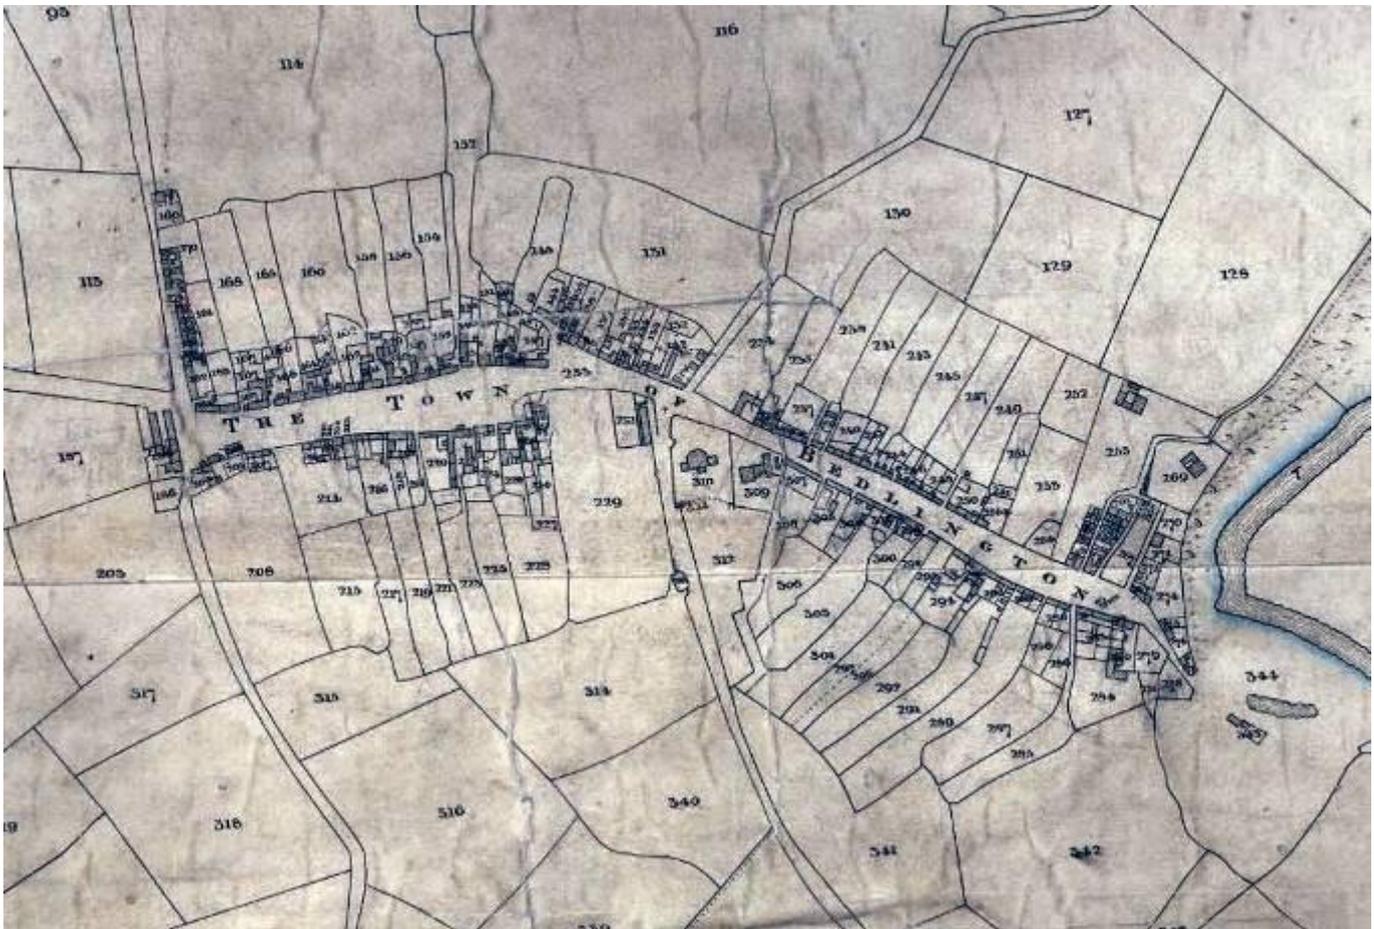
Tithe Award Map of 1843

4.17 St Cuthbert's church is shown with the extraordinary plan that was created out of the old church in 1818. The old north wall was pulled down and replaced with a large semi-circular extension, complete with galleries. This had the effect of re-orientating the worship space to north-south, completely contrary to the time-honoured east-west of most Christian churches throughout the world. The reason given for this strange expansion was the growth in working population at the booming Bedlington iron and engine works but the real growth of the town did not come until the second quarter of the nineteenth century (in 1801, there were 789 people in the town, but by 1821 it had more than doubled to 1,862). This unusual arrangement at the church lasted nearly 100 years as it was not until 1912 that the extension was demolished and the original orientation restored.

4.20 Already by 1860 two large burgage plots behind the north side of Front Street East, had been given over to two long terraces of miners houses, each complete with a nettie (separate toilets block) and narrow allotment plot. On this map they were both called Bell's Place but by the Second Edition of c1897, one had become Old Colliery Row. The presence of a United Presbyterian Chapel at the end of one of the rows

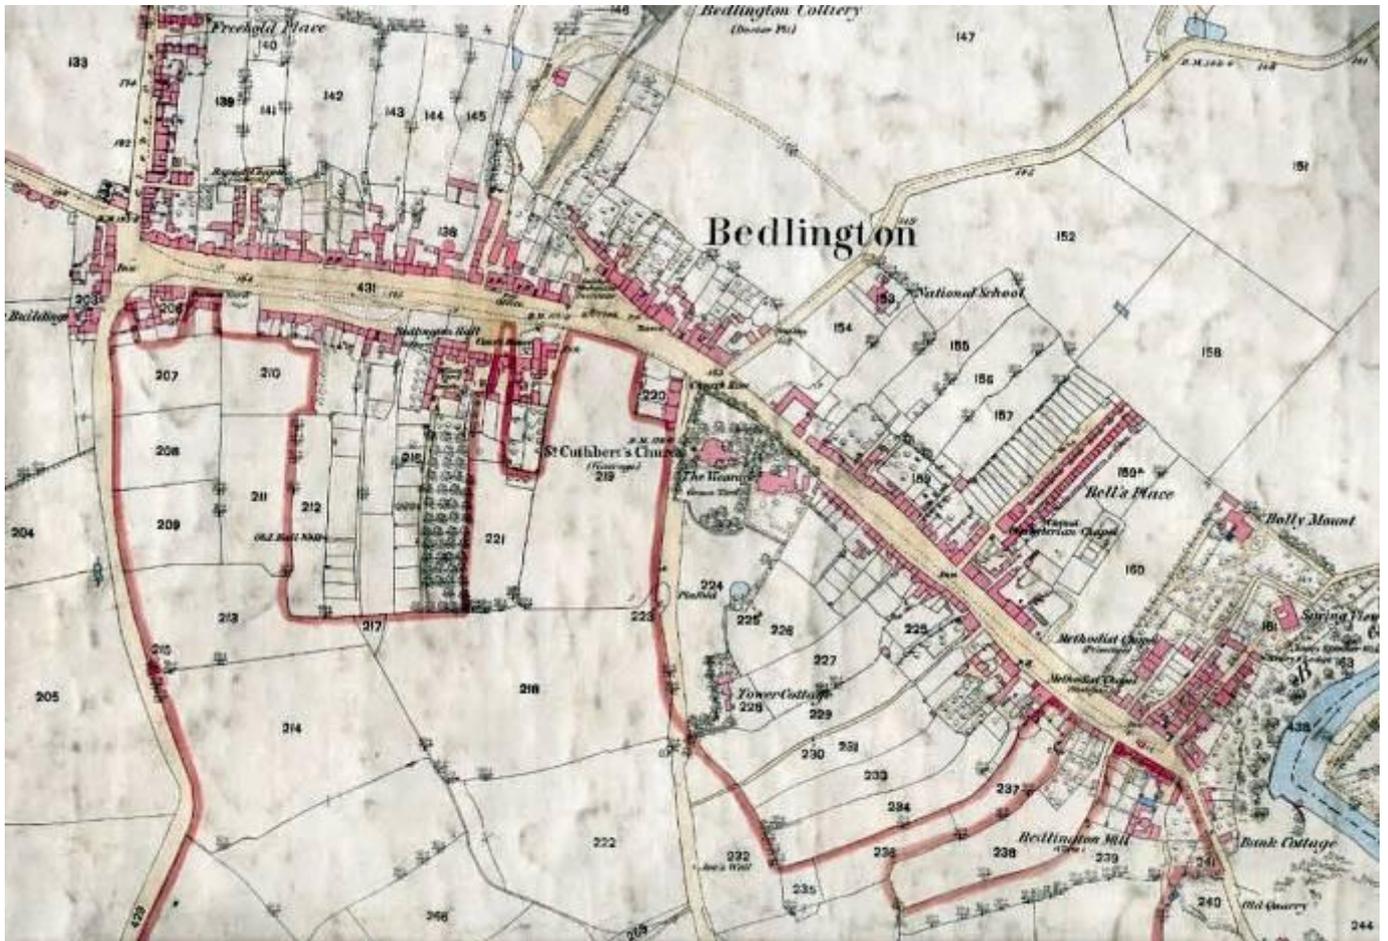
First Edition OS Map c1860

4.21 By 1860, Bedlington Old Hall was now in the ownership of the Bedlington Coal Company, having been sold by the Bishop of Durham in 1844 to the Barrington Coal Company. Both companies used this ancient building to house miners. Further along Front Street West is shown the court house, now the community centre. Church Row at the top of Church Lane comprised more industrial housing for the growing population. The Post Office at the time was between two pubs on the north side of Front Street West, and the Mechanic's Institute, founded in 1850, occupied a property on the north side of the Market Place.

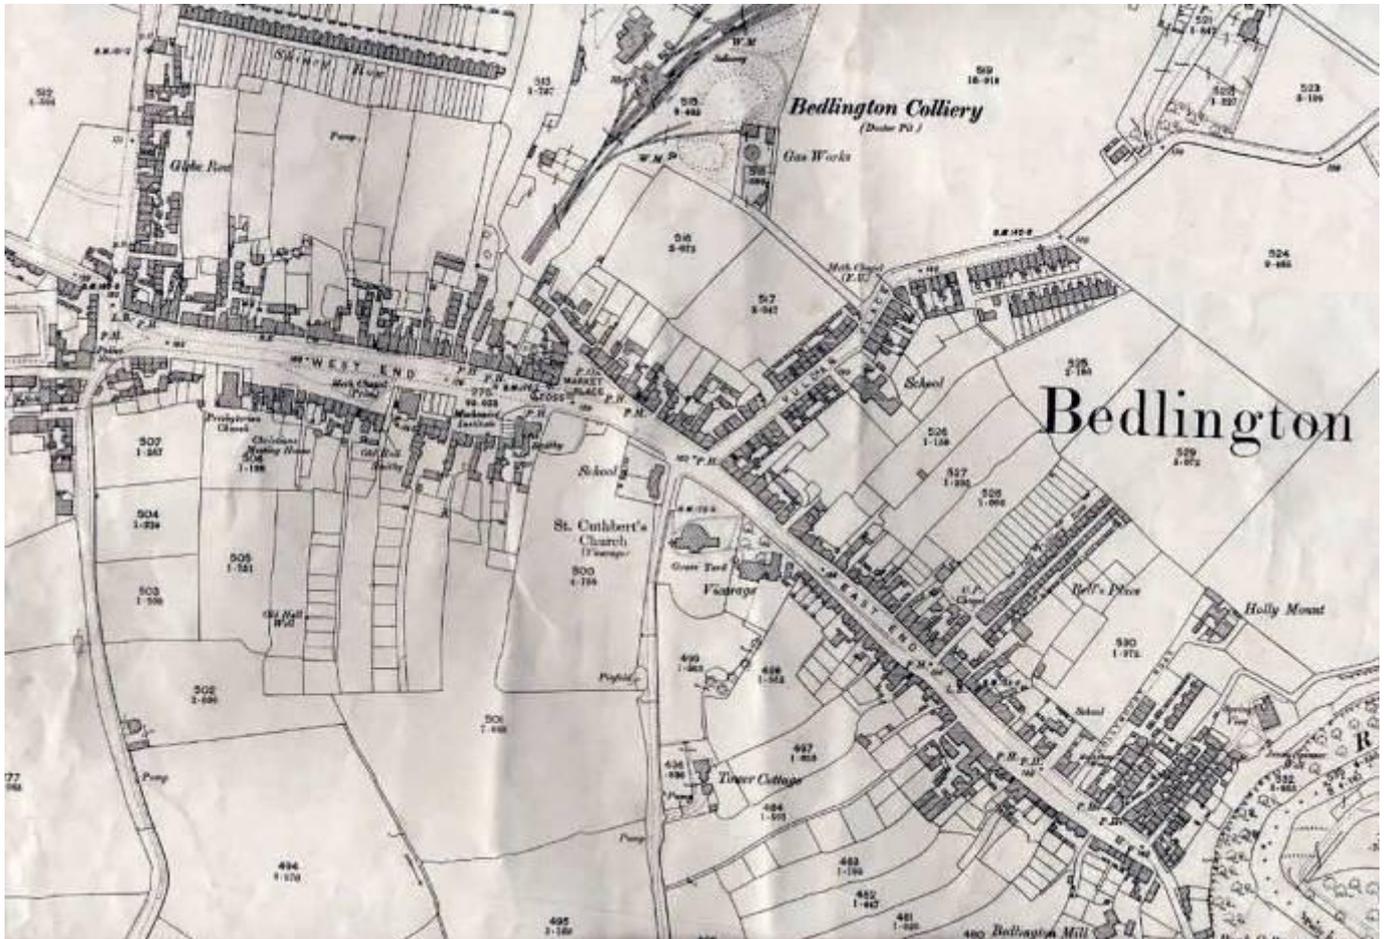
Second Edition OS Map c1897

4.26 At the top of Church Lane, Church Row was replaced by the village infant's school in May 1874. Both sides of Front Street East, which up to now had contained some gaps between buildings, were now completely developed. More of the grounds of Holly Mount have been sold off for workers housing and the old drive up to the house had become Hollymount Road. Vulcan Place, likely named after the Roman god of fire to commemorate the two blacksmiths shops that operated there, had been developed with more upmarket terraced houses, indicating the rising housing expectations of the townspeople.

4.27 The post office was now in the Market Place which, although now more built up on its west side, remained undeveloped on its south side. To the north, in 1876, a coal-fired gas works was built within the Doctor Colliery site. Finally, the west end was still ahead of the east end in the pub and inn count, but at six versus eight, the latter was beginning to catch up.

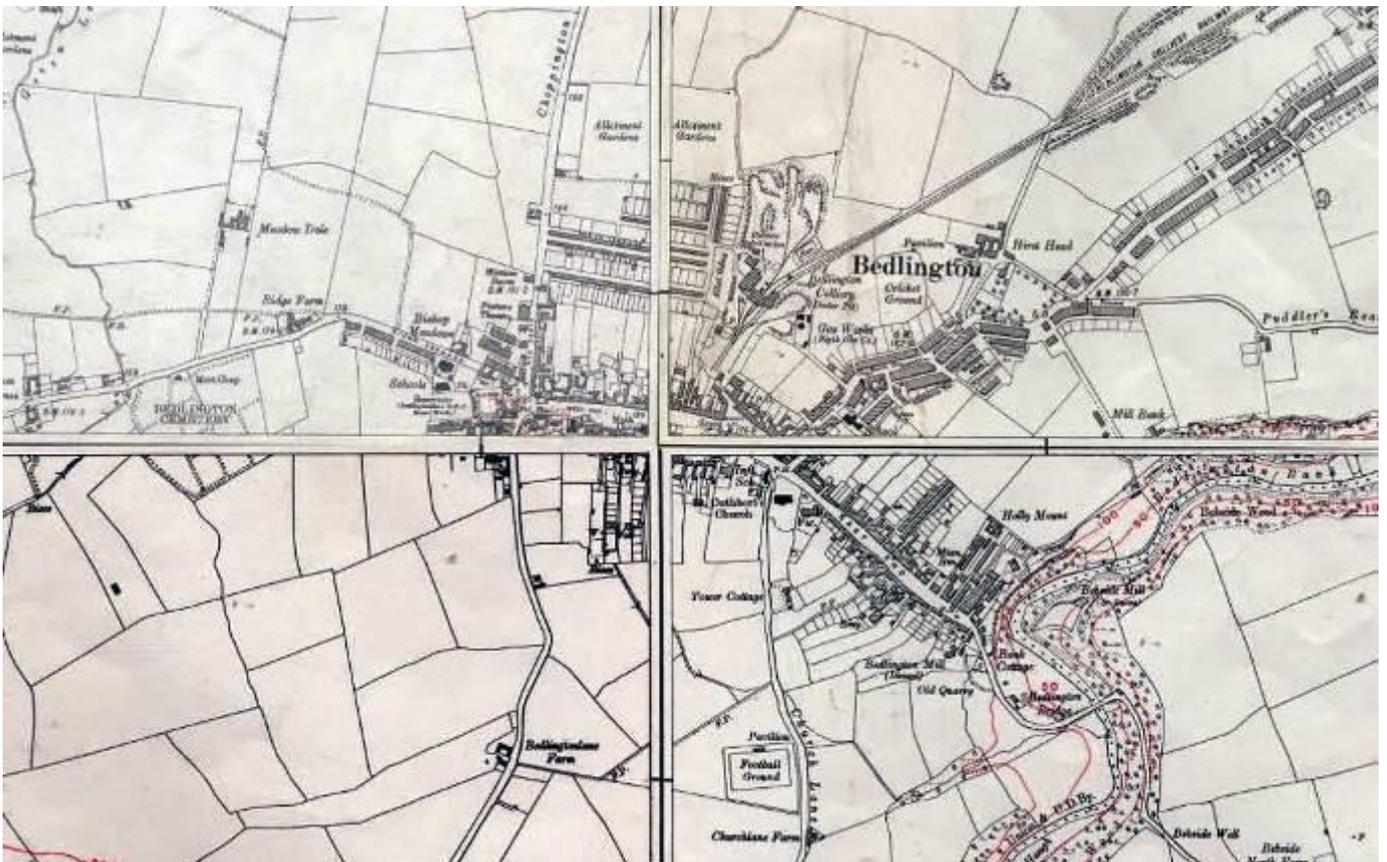
Third Edition OS Map c1920 (composite)

4.36 The east end had also seen change. Bedlington Mill had long gone and much of the south side of Front Street East was demolished in the last quarter of the twentieth century to be replaced by terraces of housing in a rather self-conscious traditional style but with natural stone façades. Fortunately, the terraces were packed together to maintain the continuous enclosure of Front Street East on the south side, but one or two gaps were beginning to appear in the north side.

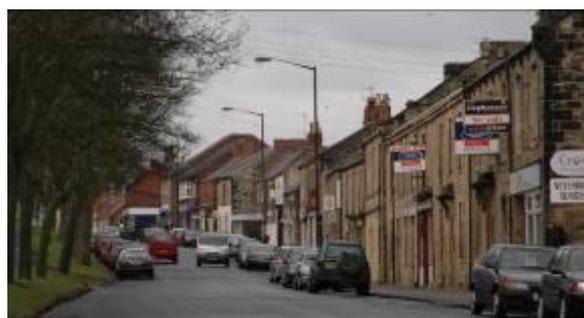
The north side of the street has a back-of-pavement development pattern, set behind public open space at the west end

5.4 On the north side, nearly all development is pushed to the front of the plot and presents a sharp back-of-pavement urban edge. This edge has the appearance of extending in an almost unbroken line along the entire length of the conservation area on the north side, in the west half being set back behind the grassy banks which separate the pavement from the highway.

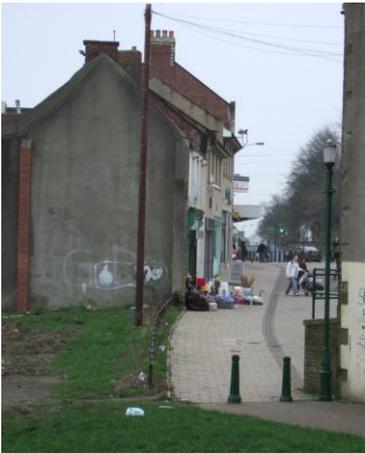
The tight pattern is broken by gaps on Market Place and Front Street East

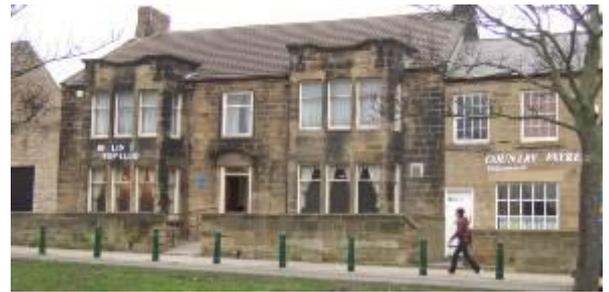
Modest front gardens slightly relax layout on the north west side

5.5 In addition, there are modest front gardens which relax this layout near the middle of Front Street West, its widest part. This layout is highly distinctive of the northern side of area and an important part of Bedlington’s coherent character. The grain is tight with narrow plots packed in, although this historic character has been eroded in places by adjoining plots being combined to create larger development sites (e.g. Nos.42-44 Front Street West and Nos.10-14 Market Place). This erodes the historic integrity of the place and encourages large footprint developments which fail to respond to the closer grain of historic buildings.

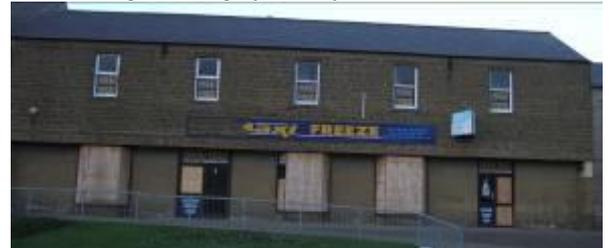
Combining adjoining plots to make larger sites erodes historic grain

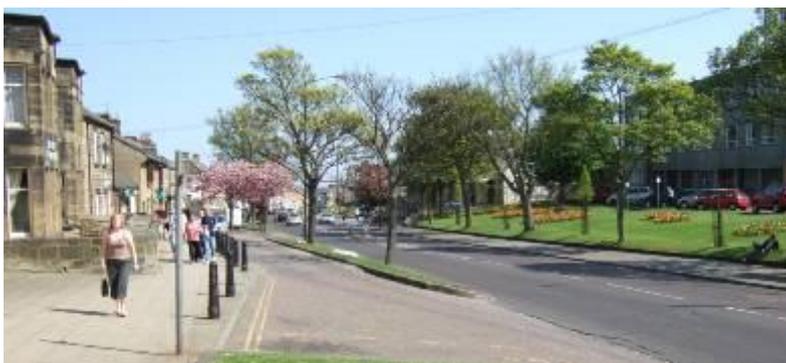
West end south side comprises individual buildings set back behind an arc of open space, most green, some eroded to hard surfaces

than the south. This undeveloped sloping land survives as a significant and distinctive arc of open space, almost the entire length of the south side of the conservation area. It has, however, been eroded in places – in Front Street West, two nineteenth century churches

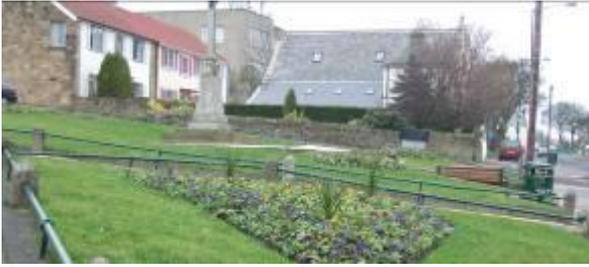
One or two 'public' buildings step forward of this set-back line

(Trinity Church and the former Primitive Methodist church) were confidently sited forward of this line, an arrogance usually forgiven these days for the period and building type; meanwhile incremental development at the town’s original courthouse (now the community centre) and adjoining inn (now the Sun PH) has pulled this point slightly further forward than the remainder. At the far west

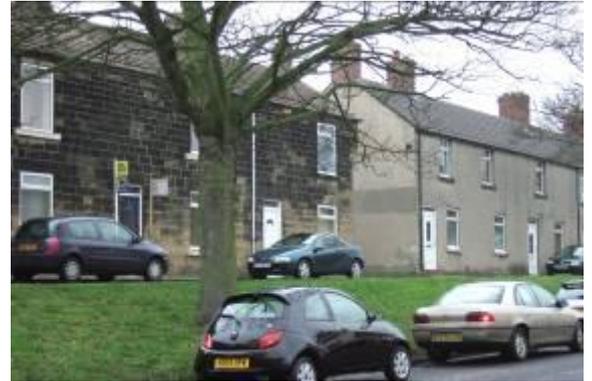
Most of the south side's east end reverts to back-of-pavement but still behind an arc of green open space

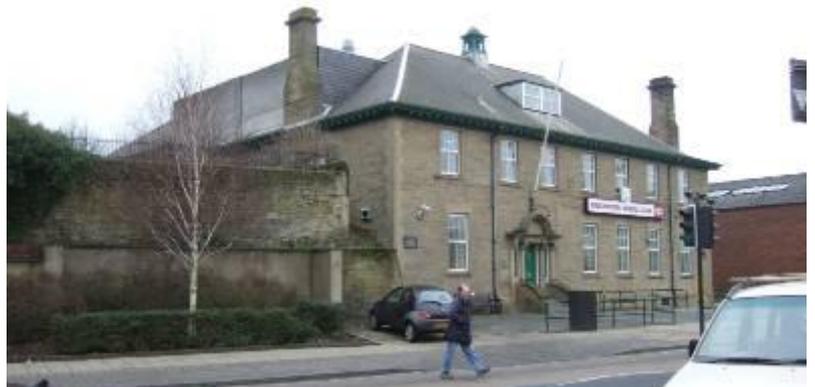
Earlier development pattern in the middle of the south side was high up behind retaining walls (eg. churchyard); later, the ridge was excavated to create plots opposite Market Place

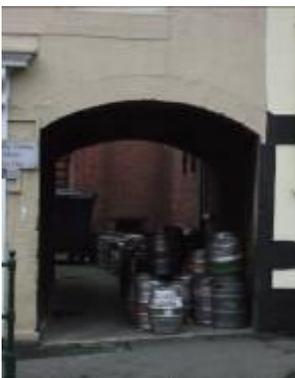
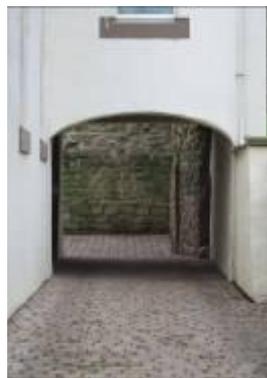
Carriage arches are included in some of the back-of-pavement layouts as; originally, rear access was not possible

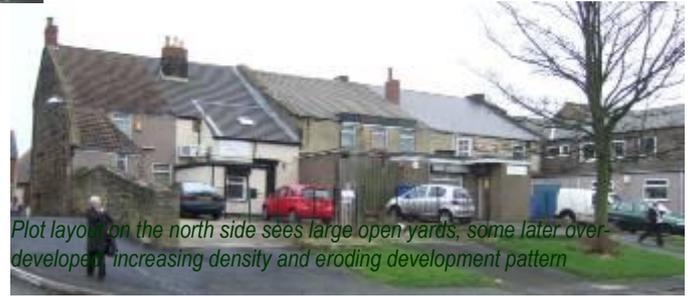
Plot layout on the north side sees large open yards, some later over-developed, increasing density and eroding development pattern

the conservation area, with only one main building on each plot and large areas of yard or garden behind or in front of it. Some of this density has been eroded over the years with backland development and infill, to the detriment of the area's historic development pattern. Access to the rear of each plot would originally have been from the front (carriage arches are included in the layout of many of the unbroken terraces) or off side alleys. This largely remains the case and some sites are essentially landlocked, but several back lanes were formalised during twentieth century re-ordering north of the town (unfortunately 'cleansing' much of the character and setting to the rear as a result).

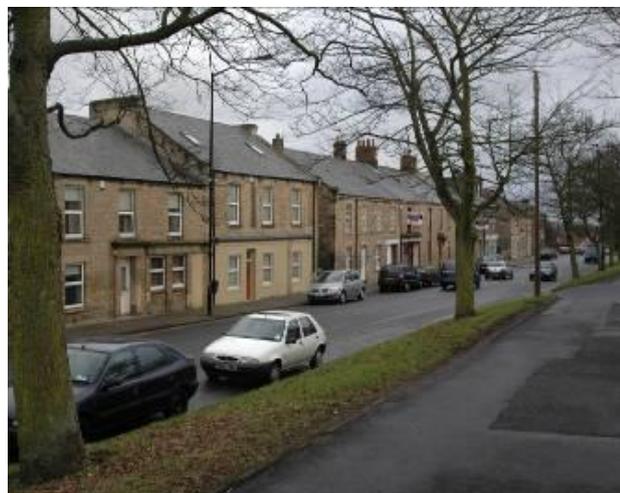
Views within the conservation area are linear, channelled by the tight development pattern and enlivened by street trees and topography

5.10 Although the main street climbs east to west out of the River Blyth valley and up a sandstone ridge, there are few hill top vistas or panoramas due to the mostly tight enclosure of buildings along each side of the street. Occasionally, it is possible to get glimpses of distant views through the narrow gaps along the

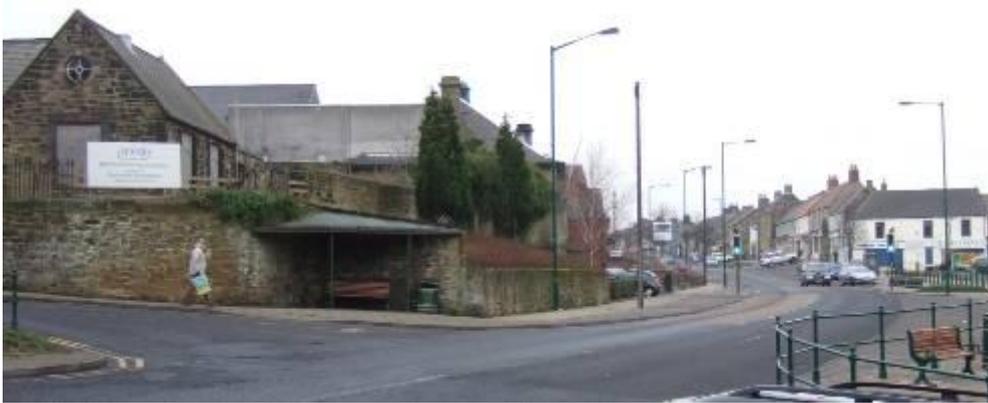
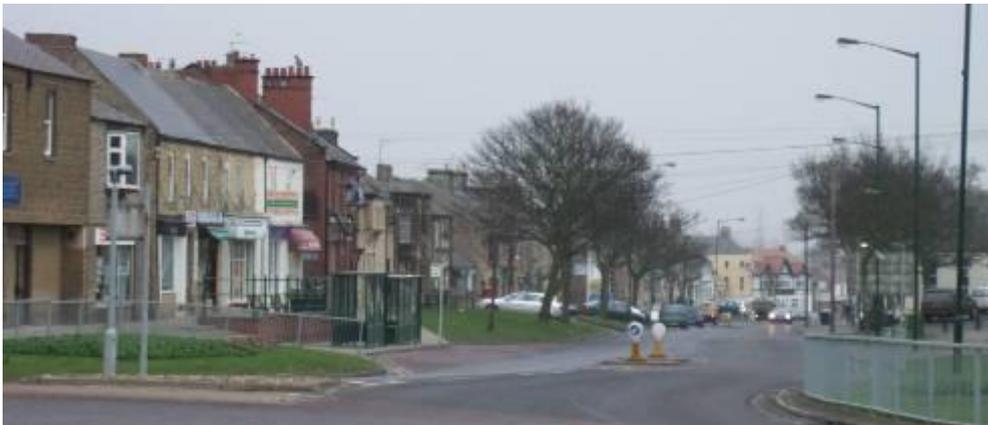
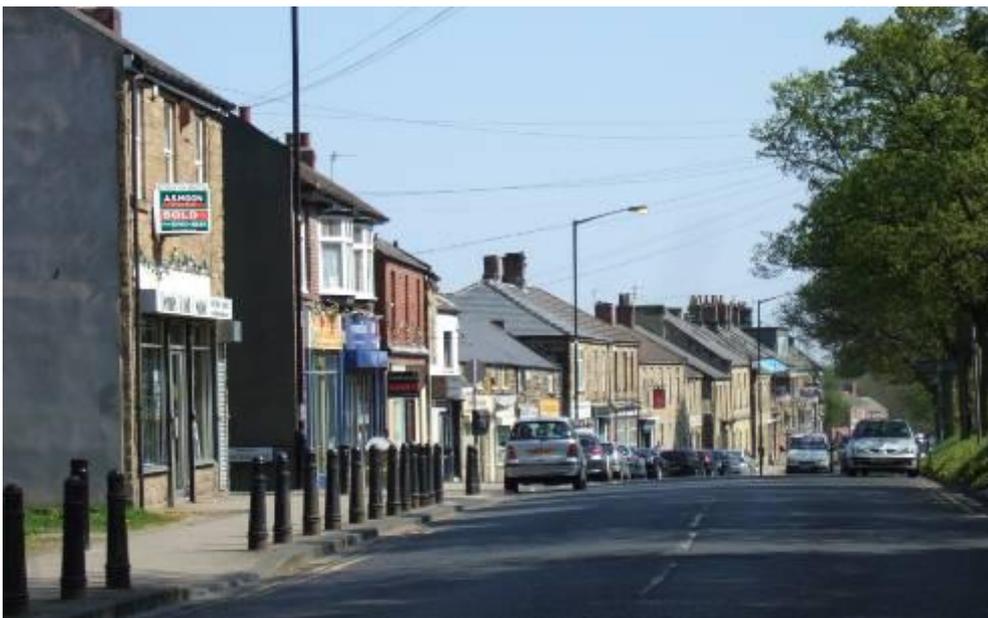
Top: topography is prominent at the centre of the conservation area. Middle: the Market Place elbow creates long inviting views into the area from the far west end. Bottom: views fall away along East End Front Street

5.11 The only key views, therefore, are those to and away from Market Place along Front Street, in both directions. Visual containment is almost unbroken, creating strong enclosure. The composition and protection of these views is critical to the character of the conservation area as they define its experience. The long, funnelled views are always lively, the ends of each view defined by confident historic buildings at the west end, heavy river valley tree cover to the south east, and, in the middle at the Market Place elbow, a varied sequence of views of historic buildings seen at an attractive oblique angle and enlivened by topography.

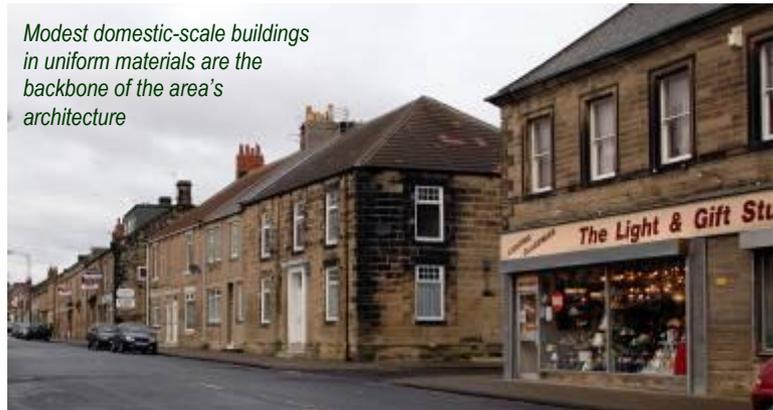
Modest domestic-scale buildings in uniform materials are the backbone of the area's architecture

6.6 Most of Bedlington's buildings are pre-1918 and have a modest residential scale and a uniformity of style and materials. This predominant building type provides the backbone of the special interest of the conservation area, few having any particular outstanding qualities but which together provide a coherent and significant layout and form.

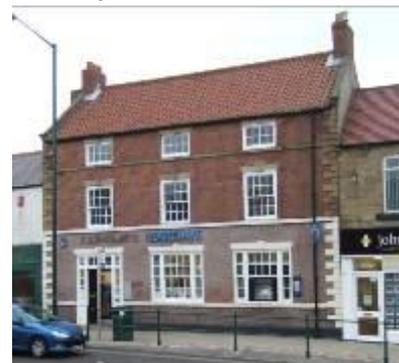
Barclay's Bank is another converted Georgian townhouse

principal among these are the pubs, such as The Grapes PH (formerly the King's Arms), a Victorian pub converted from a grand early eighteenth century stone townhouse. There are other large former townhouses now in commercial use, e.g. Barclays Bank in a late eighteenth century house in brick with decorative stone dressings. Like many older towns, Bedlington has boasted many pubs

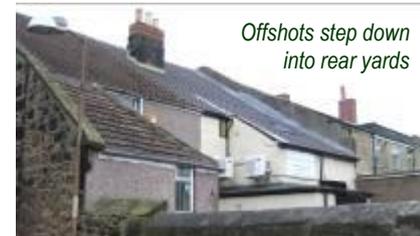
Offshots step down into rear yards

Most are simple rectangular boxes, taller than they are wide, generating a very straightforward appearance. Most are two bays wide and usually asymmetrical, some are three and symmetrical (usually the former farmhouses, townhouses or pubs). Many have shorter, narrower rear offshots. Most buildings are in a series of short formal terraces which step down the topography, but many, particularly around Market Place, are individual buildings which happen to be built up against one another, creating informal conjoined rows with slight variations in height and scale which are attractively inconsistent. These

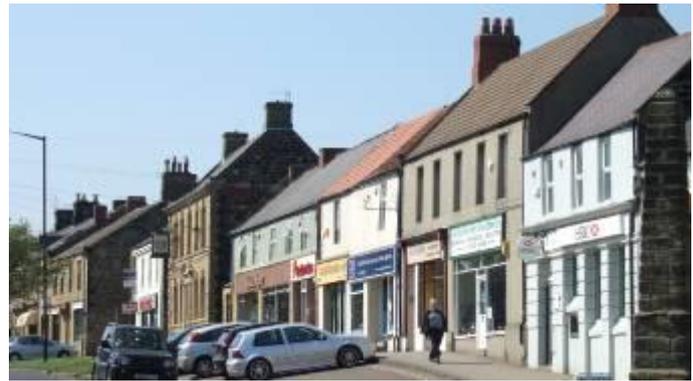
A variety of straightforward, mostly two-storey pitched roof buildings create uniformity despite variations in scale and grouping

6.11 The dominant built form in the conservation area is the two storey domestic scale building with a dual-pitched roof. Some have a third storey in the attic and a few are fully three storeys with a pitched roof.

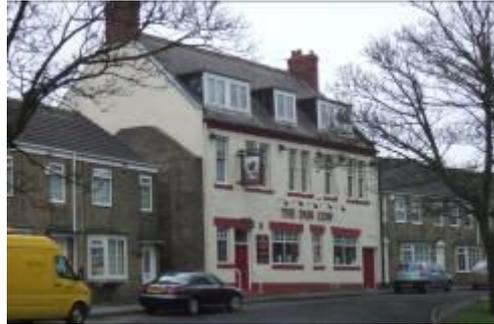
Gable ends are often prominent features

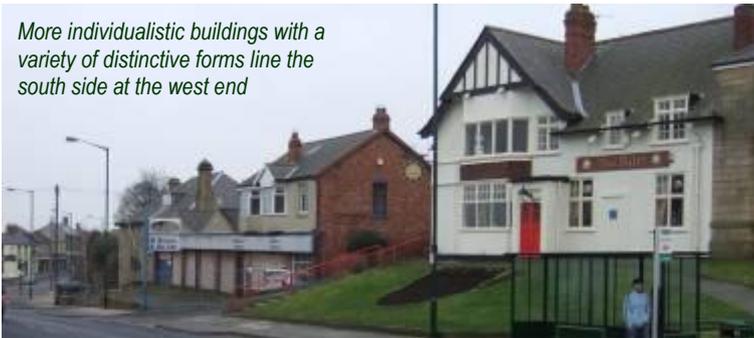
More individualistic buildings with a variety of distinctive forms line the south side at the west end

6.12 In amongst these domestic-scale buildings, and mostly on the south side, are buildings with more landmark qualities and more distinctive forms. These tend to be religious and municipal buildings including the churches and chapels, the former Police Station & Courthouse, and the

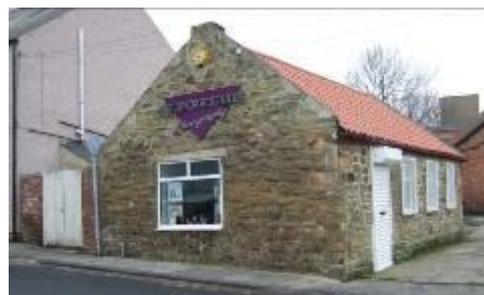
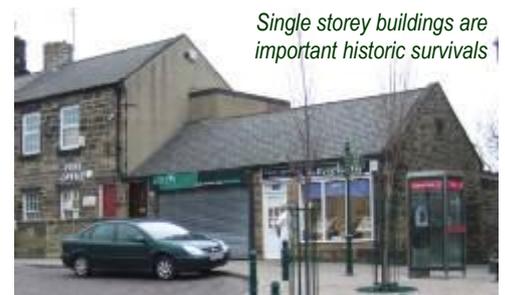
6.13 The survival of some single storey buildings is an important reminder of the area’s modest rural origins, such as the former smithy on Vulcan Place, Nos.52-54 Front Street West, and various outhouses in rear yards.

Single storey buildings are important historic survivals

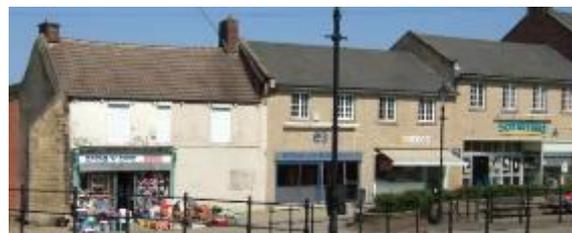
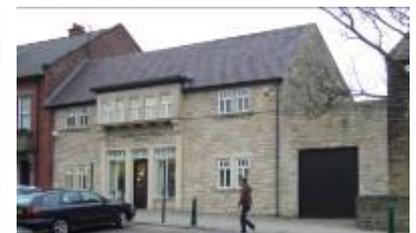
6.14 Several buildings from the late twentieth century have successfully responded to the basic form, height and scale characteristics of the area, including the front range of Market Place’s supermarket and adjoining shops, and the Co-op Funeral Service.

Several late twentieth buildings have successfully interpreted the basic form, height and scale of the area

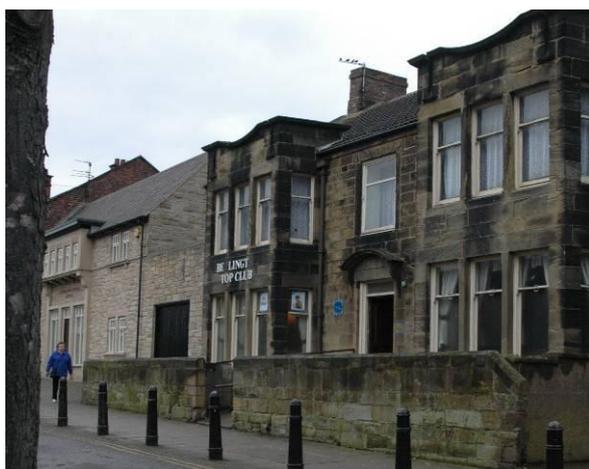
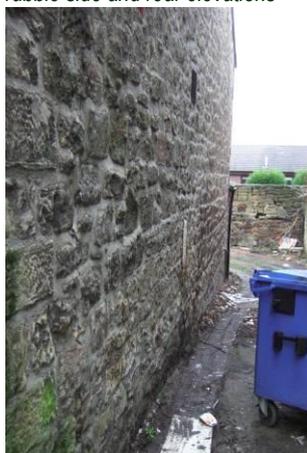
Smart front elevations often have rubble side and rear elevations

6.17 By far the most common walling material in the conservation area is local yellow Carboniferous sandstone. Early and much of the later stone would have been quarried locally, there being two small quarries on the south side of Front Street in the late nineteenth century. Stone on front elevations is mostly in

squared blocks with rough surfaces, often with a pecked finish, and laid in regular courses. It is generally the case that the later the building, the more square and crisp the blocks, but very smooth dressed ashlar are rarely found. Side returns and rear elevations, where presentation was historically less important, are usually random rubble stone.

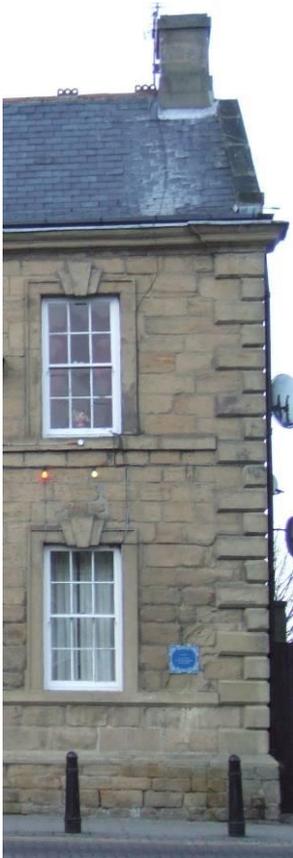
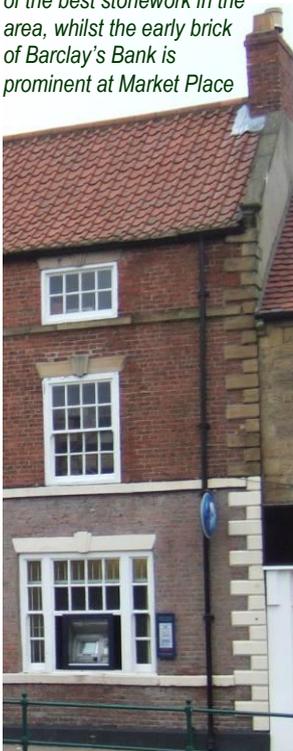
highly decorated for the area, including The Grapes PH's keyed openings, moulded plinth and rusticated quoins and, of course, St Cuthbert's Church's tracery windows and shaped tower buttresses.

The Grapes PH has some of the best stonework in the area, whilst the early brick of Barclay's Bank is prominent at Market Place

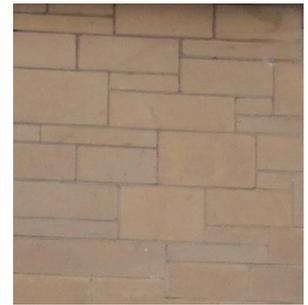
6.21 Although natural sandstone has been specified in some modern schemes, not all of it has been appropriately dressed or laid: some is mechanically cut leaving lifeless elevations with no texture; some has artificial texturing which looks too regular to truly reflect random blocks; some uses squared blocks in irregular interlocking patterns rather than in uneven coursing. Masonry used at the 1960s Council Offices is natural but includes a green stone cladding alien to the area. Masonry in the self-consciously pastiche late twentieth century terraces at the south east end of Front Street is well chosen.

Although generally well-chosen, some modern stonework can be too flat (top: machine cut) or laid in a 'forced random' way

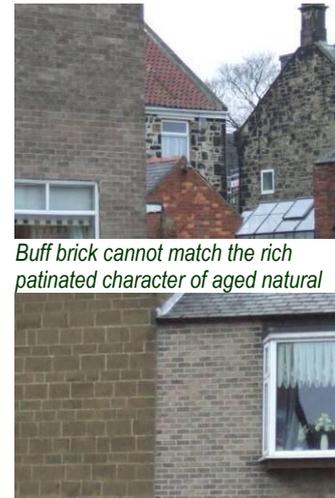
Buff brick cannot match the rich patinated character of aged natural

bricks in later Victorian, Edwardian and twentieth century buildings. Several mid to late twentieth century buildings and additions use uniformly toned buff bricks which attempt to mimic aged sandstone but which, without its texture and liveliness, leave visually flat and bland elevations. In contrast, earlier mottled bricks have attractively stained and weathered with warm, uneven tones. Most brick is laid in English garden wall bond (usually 5 rows of stretchers to 1 of headers) or, in later buildings, in less visually interesting stretcher bond. Most historic brick buildings also use local sandstone for detailing and decoration. Brick colour in the recent Lion Garage is well chosen.

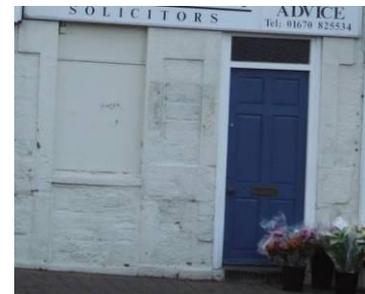
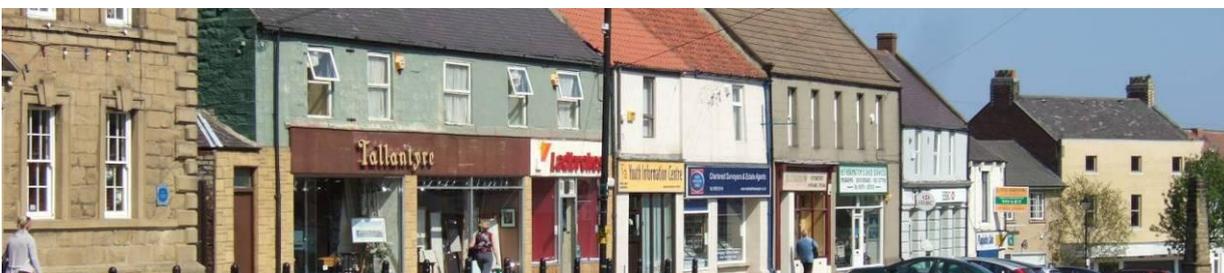
Render and masonry paint 'flatten out' historic appearance, harm unity and detract from the authentic appearance of the street

6.24 Render, where it is found, is often a modern expediency and is rarely used in a historically accurate way (e.g. Nos.70-80 Front Street West). Earlier random rubble stone buildings may well have been covered in a variety of rough or smooth renders, lime-rich to allow the building to 'breathe'. Such finishes do not survive, exposed stone being the preferred aesthetic since the mid-nineteenth century. So where render is used today, it tends to be modern cement-based (thick, hard and smooth) or pebbledash, both of which iron-out the visible texture of masonry beneath and result in a much flatter, bulkier character to walls and mouldings. Render can therefore create a bland scene of chunky overcoats shrouding historic character beneath, mostly notably at No.9 Market Place, its modernised frontage disguising historic character. Render should be avoided but, where it is used, it should be painted in muted, flat, earthy tones – pastels, bright and bold colours tend not to

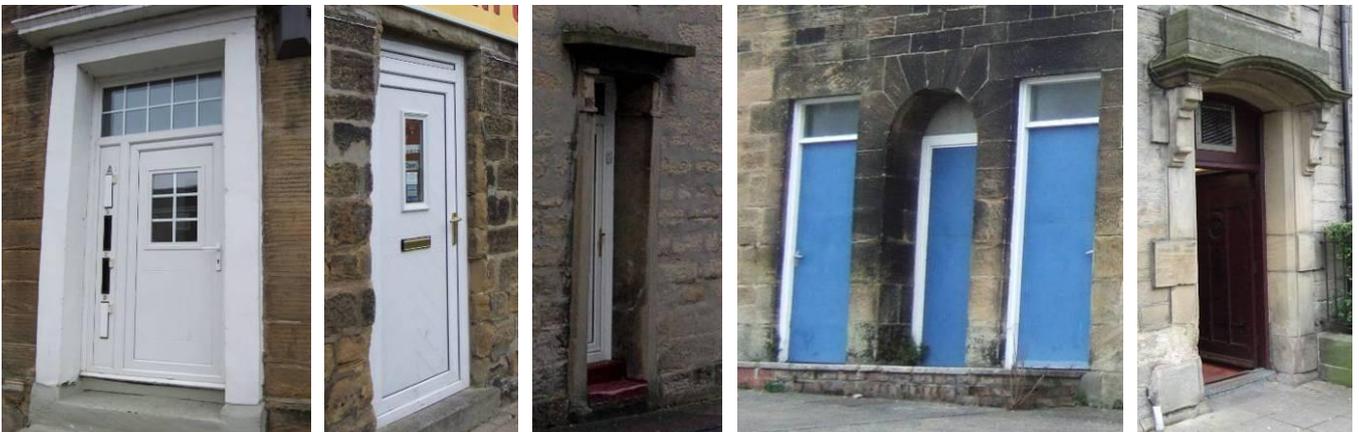
A variety of simple and more ornate doorways with replacement doors in timber and plastic which are harmful to historic integrity and appearance

6.26 Of the doors themselves, some original ones survive mostly panelled (e.g. No.24 East End Front Street, a particularly attractive feature in a decorative stone doorway), but with some earlier, plainer ones being plank doors. Many doors have, however, been replaced with modern reproduction styles in stained hardwood or plastic, many with glazing, and which do not reflect the authentic architectural history of the area. Original doorways tend to incorporate an overlight above the door rather than glass in the door itself.

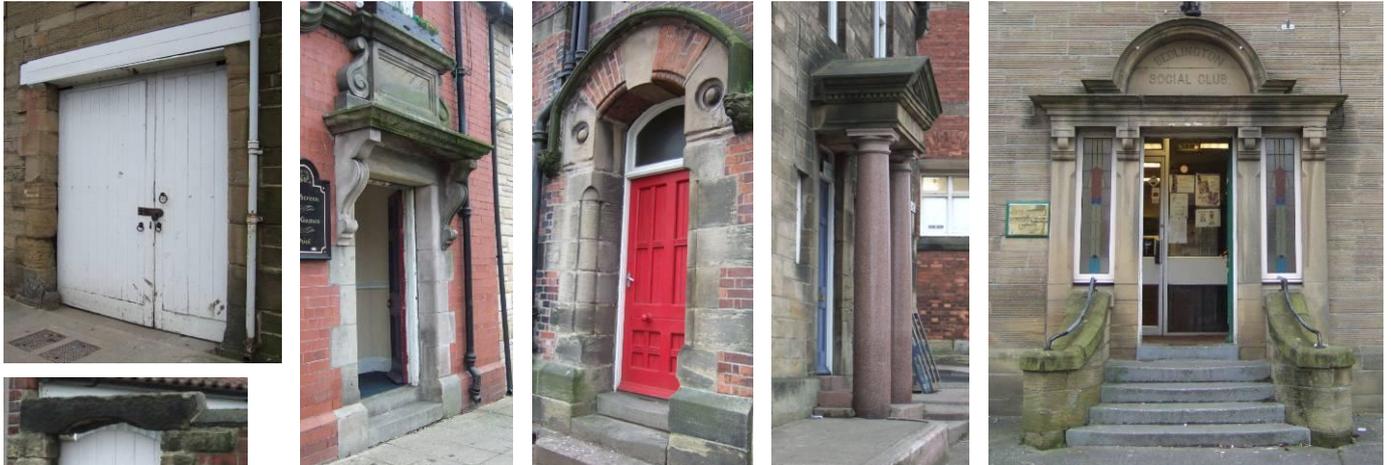
Top left: carriage doorway. Bottom left: back yard gate. Above: landmark buildings make particular play of doorways

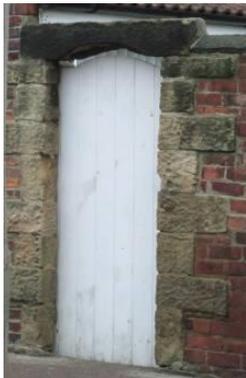
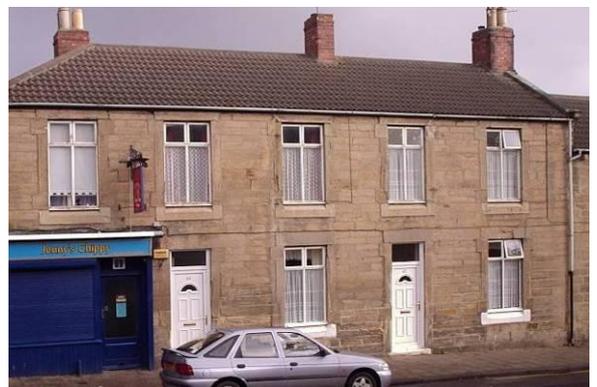
Window openings are strongly vertical and generally evenly spaced across elevations. Many have replacement windows

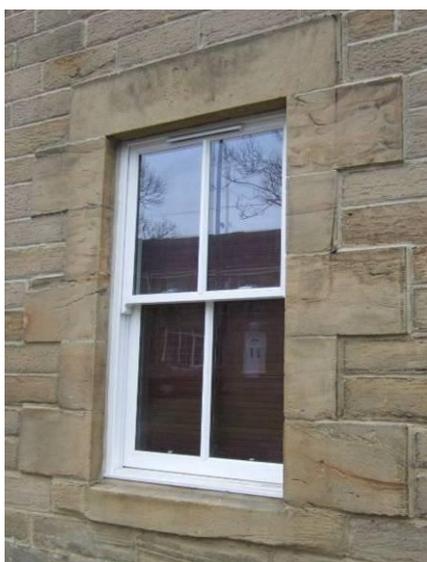
Variations on this type of window surround are distinctive of the late-nineteenth century terraces

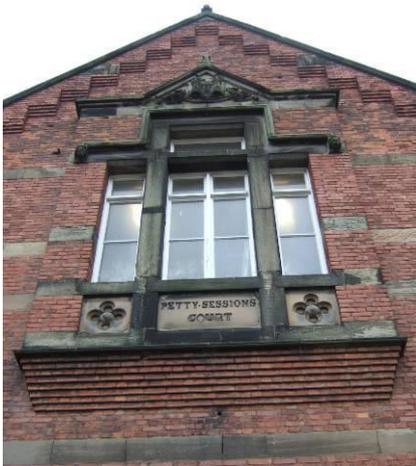
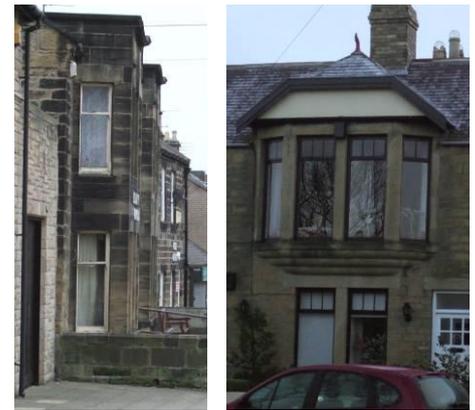
Left: landmark buildings make special play of large decorative windows. Above: bay windows are rare

6.29 Bay windows are not a common feature of the area's modest architecture but they can be found on some of the later and landmark buildings. They are often a late Victorian or Edwardian feature, seen for example in the Sun Inn, the former Police Station & Courthouse, the Edwardian building at the core of the

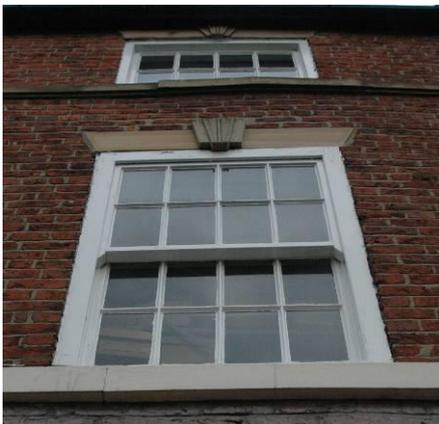
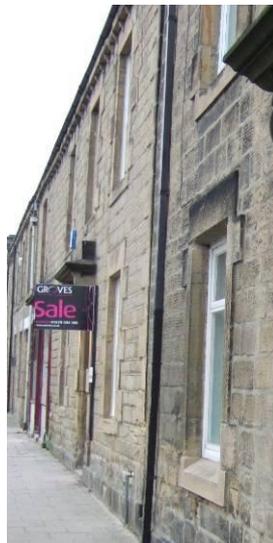
Above: Original or early windows are rare in the area and should be protected and maintained. Right: window (and door) reveals are important to appearance in oblique views along streets

6.30 Of the windows themselves, relatively few historic now survive, making those which do all the more important to the architectural character of the area. Some historic ones are early replacements, still in themselves of significance. Traditionally, all windows would be set back from the face of the building in a reveal, adding life and character to elevations – this is harmed where modern windows are pulled forward to be flusher with the building's face. The area's simple

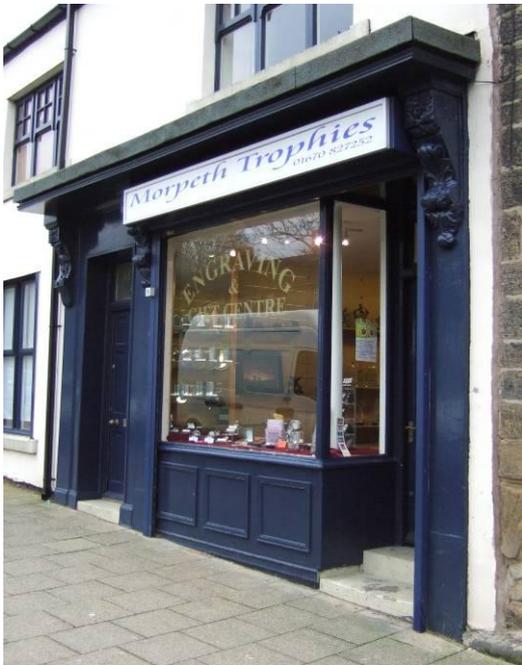
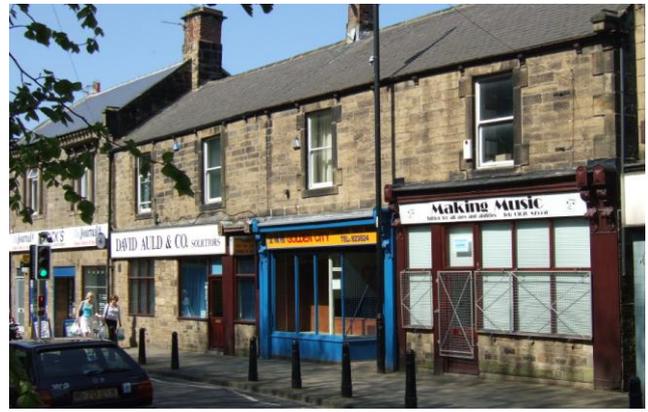
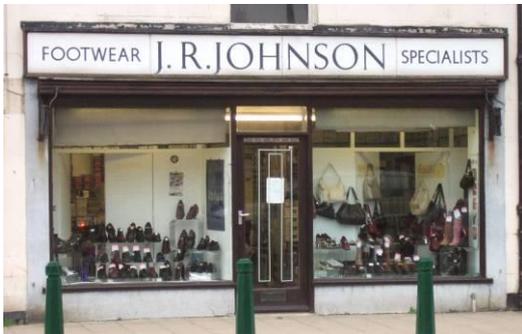
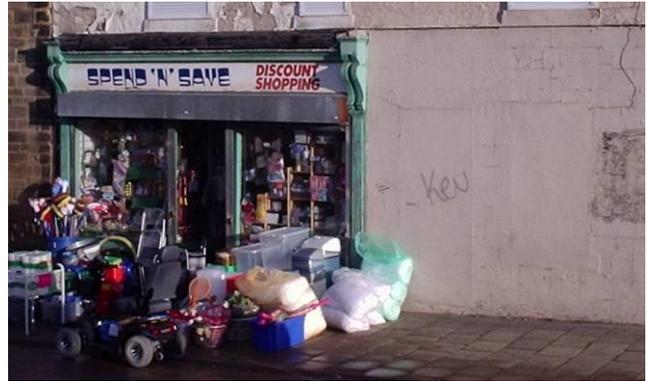
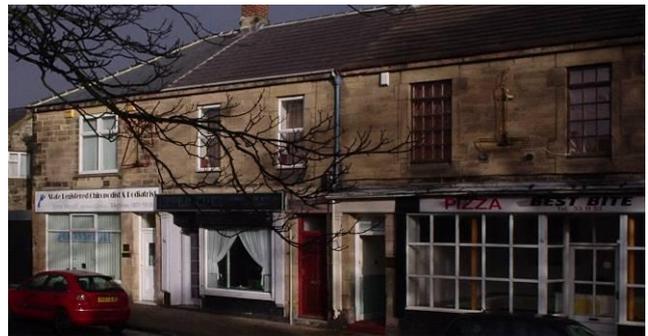
Left top: a virtually intact shopfront at No.70 East End Front Street. Left bottom: a good quality mid-twentieth century shopfront at No.7 Market Place. Right top and middle: good shopfronts with alterations and loss. Right bottom: a variety of shopfronts along East End Front Street.

East End Front Street, No.15 Market Place and No.1 Brown's Buildings. There are many others with surviving component parts but which have been incrementally modernised, perhaps with new windows, fascia or stallriser. Although modified, the stone bank front at the former Gibson family buildings at Nos.36-38 East End Front Street is rare and particularly special, demonstrating high quality for the time.

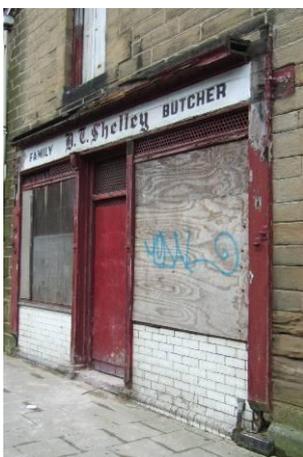
This disused shopfront was removed when the building was converted to residential use
