People and Planning Northumberland Local Development Framework

Bedlington Conservation Area Character Appraisal

January 2011

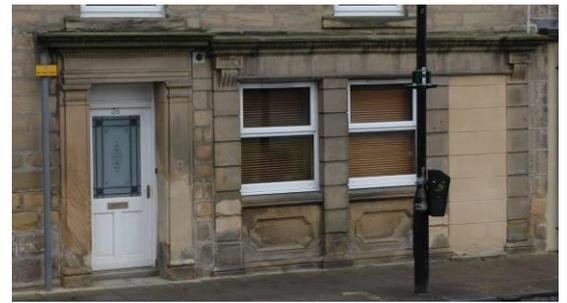
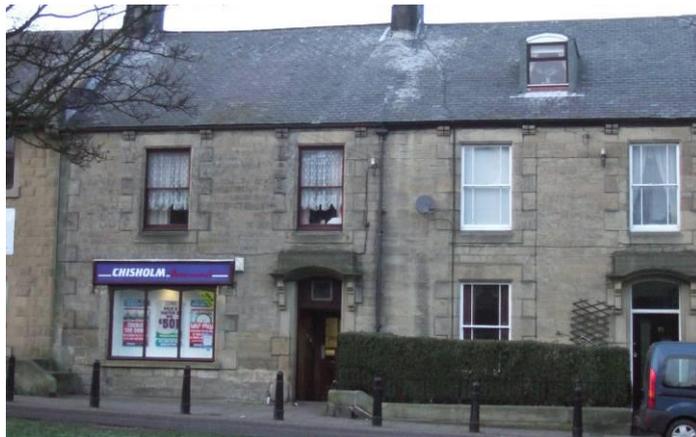
Above and right top: hole-in-the-wall type shopfronts have been converted from original domestic windows. Right bottom: modern interpretations of these

6.34 The key characteristic of the second type, of which there are many in Bedlington, is a lack of pilasters and entablature which means the shopfront is essentially only a window above a masonry stallriser.

Examples include Nos.50 and 54-60 (even) Front Street West, modern interpretations of these at neighbouring Nos.62-64. There are several others on East End Front Street, including most of Nos.60-64. Some, however, use applied pilasters and fascia to give the impression of a more complete joinery feature,

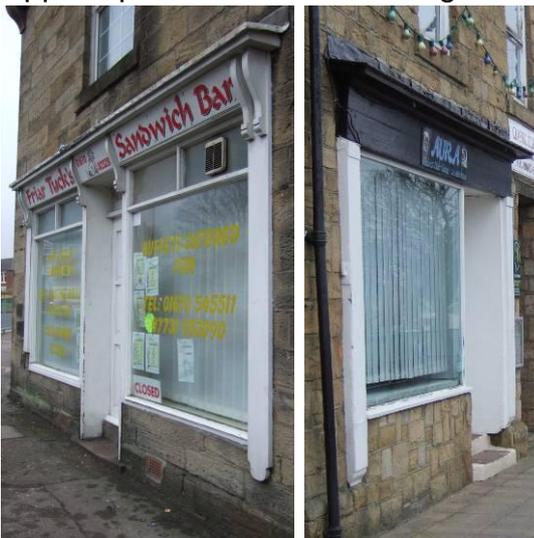
such as at No.1 Brown's Buildings on Ridge Terrace and Nos. 22-32 Front Street West.

Pilasters applied at Ridge Terrace and Front Street West

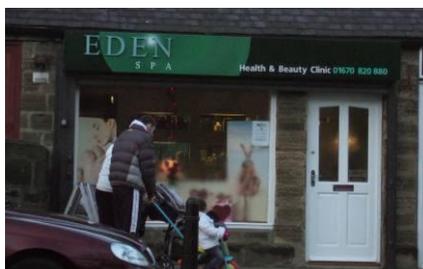
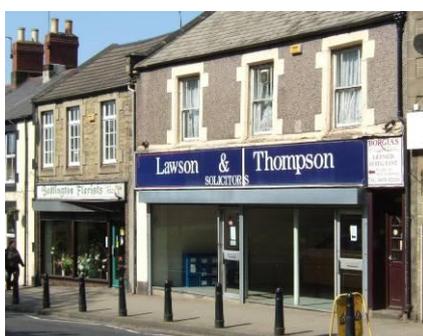
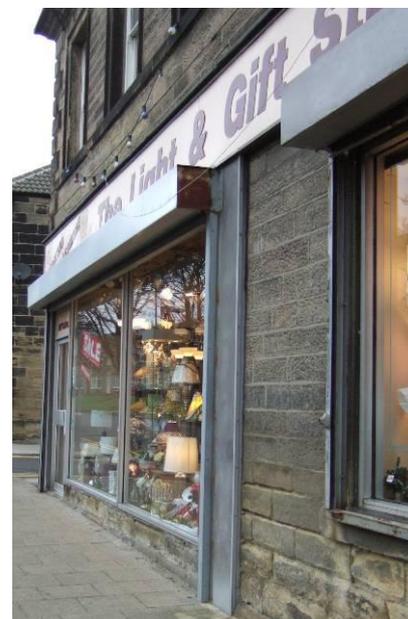
Modernised shopfronts can be very visually intrusive, as can externally housed roller shutters

that cannot match the quality of the original. Many are also in poor repair. Over-sized signage often in plastic and external shutter boxes, whether 'concealed' by additional timber fascias or not, detract from traditionally designed shopfronts. These are a pervasive feature of both types of shopfront in Bedlington and would benefit from comprehensive enhancement involving reducing the impact of signage and incorporating shutter box behind fascias. Such work, along with replacement traditional shopfronts where lost, could dramatically improve the appearance of the conservation area.

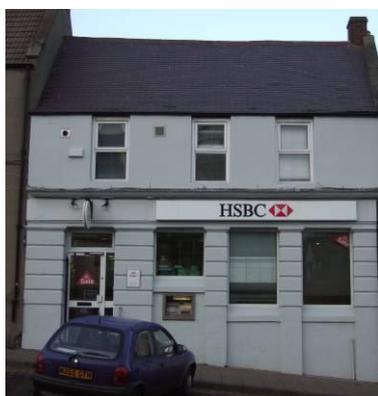
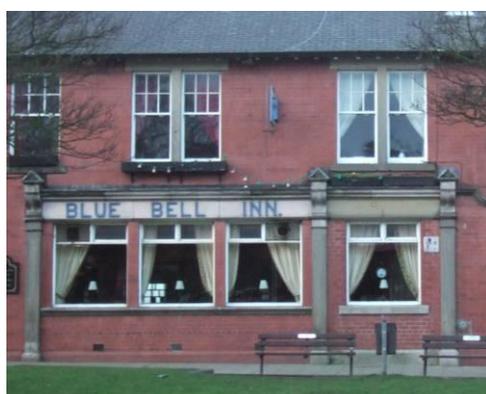
The bank front is a powerful addition. The pub's 'shopfront' has been infilled with domestic windows

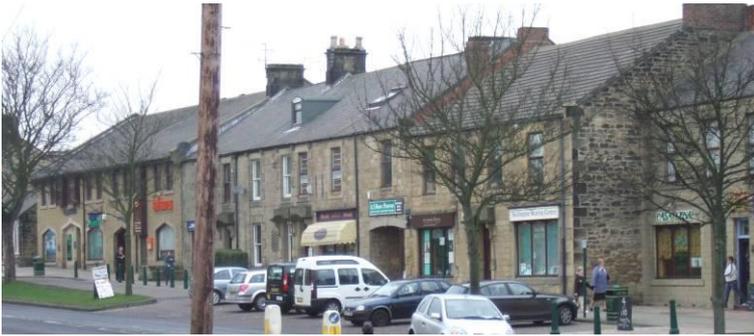
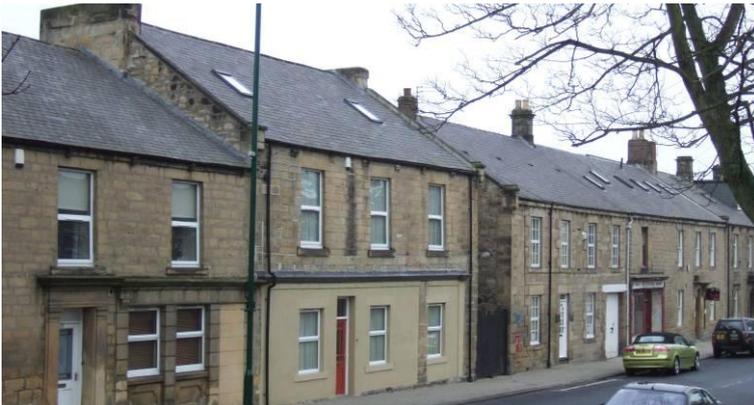
The topography makes the area's roofscape quite visually prominent. Gable ends are typical but hips are also used in later buildings

6.38 Because of the changes in level in the area, roofs can be quite prominent in views. Many remain unaltered, apart from a change in materials, and the generally simple dual pitched shape is a key part of the area's architectural character. Slight variations in form and pitch add variety to groupings, whilst a change in pitch on offshot roofs adds variety to form at the rear. Blank gable ends are a key characteristic but hipped returns are found on some later domestic-scale and landmark buildings where they are used as a polite feature to turn a corner (e.g. Northumberland Arms PH) or as part of a particular style (e.g. Bedlington Social Club's hipped roof with swept eaves). The two chapels on the south side at the west end have transverse pitched roofs leaving the gable end dominant on the street. The flat roofs of the Council Offices group are starkly out of place in the area and are their biggest negative characteristic.

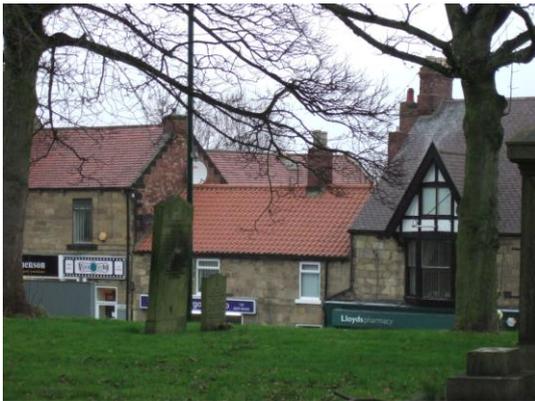
6.39 Two natural roofing materials are traditional to the area, natural Welsh slate and single lap clay pantiles. Clay pantiles are the earlier indigenous covering (and so are important, for example, to the single storey building on Vulcan Place), whilst slate followed with the arrival of the railways from the mid-nineteenth century. The visual contrast between the two is high, creating a spirited roofscape, particularly at Market Place where earlier buildings are prominent. Pantiles should generally be avoided on buildings after the mid nineteenth century unless their architectural style dictates.

Variety in roof form and natural coverings creates a lively roofscape at Market Place

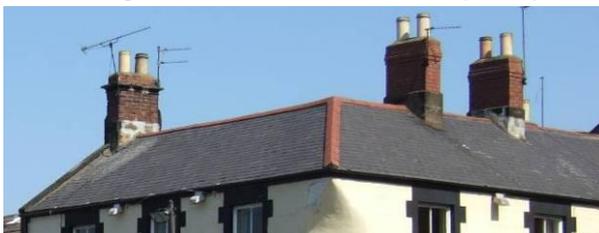
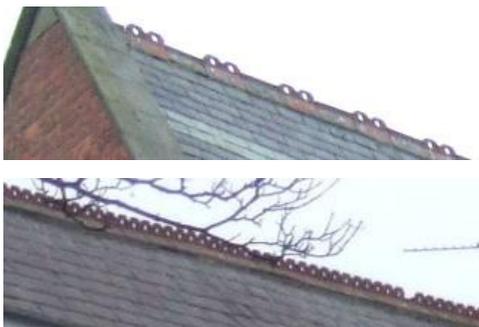
Above: red clay ridge tiles. Left: punched ridge crests on landmark buildings

6.41 Ridges are mainly red or grey clay half-pipes, blue-black angles clay tiles, or stone ridges. Others have roll-top clay tiles (e.g. the former School, some missing) or

decorative punched tiles (e.g. Trinity Church, and The Dun Cow PH). The former Presbyterian Chapel also has a damaged clay pinnacle). Valleys and flashings are traditionally lead lined but modern synthetic replacements or cement have encroached in many places.

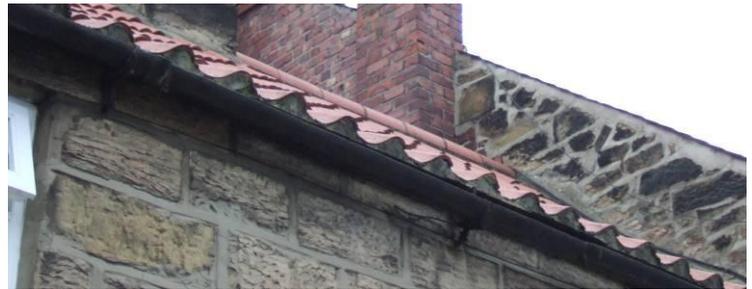
Above: plain eaves with gutter on spikes. Below: stone corbel eaves support gutters

6.44 Rainwater goods are not prominent features of the architectural design and many have been modernised. Most gutters are attached to eaves boards or corbels, a few (e.g. The Grapes PH) are concealed behind the moulded eaves. The main characteristic of rainwater goods is that most would have been cast iron (with some in timber), but most are now modern replacements, some in metal, many in plastic. This harms the architectural integrity of the building and degrades the overall quality and character of the area with man-made materials which easily fade or break. Most should be black although some could be part of a building colour scheme.

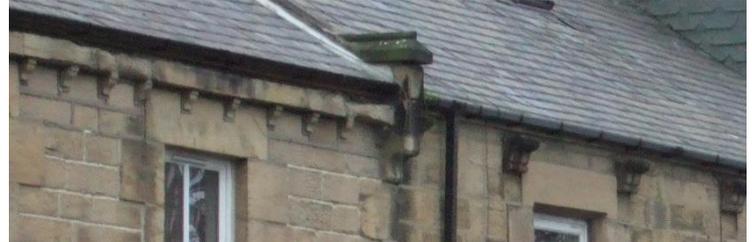
Below: smart moulded cornices or dentilled eaves on landmark buildings are rarer

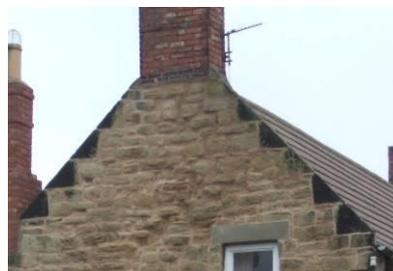
6.43 Verges are mostly plain. The earliest ones have large distinctive triangular stone verge blocks, e.g. Nos.1 Front Street West (a feature which is found across Northumberland), whilst those with overhanging eaves tending to have simple timber bargeboards to verges. A few others have flat stone watertabling with kneeler blocks (most flat, some moulded; the former Presbyterian Chapel has dramatic verge pinnacles), which sometimes, though not always, protrude above the roof plane to divide individual roofs in a group or terrace.

Triangular verge blocks are very distinctive

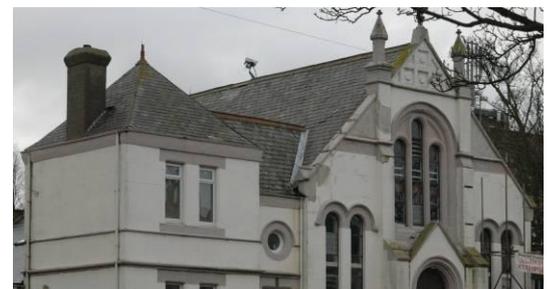
Above left: watertabling with kneeler blocks are also common. Above right: the roof of the former Presbyterian chapel is one of the liveliest in the area

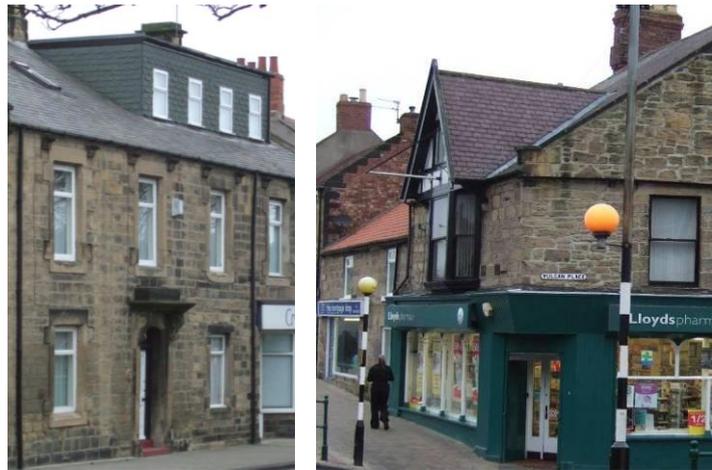
6.46 Attic space with daylight was generally not part of the original design of most of the area's buildings, most being designed with – and still having – 'clean' roofscapes, particularly to the front. Consequently, dormers are not a common feature but several late Victorian and Edwardian roofs do take on more energy with various gables and peaks to enliven them, notably the former School, the Market Tavern PH, Nos.2-4 Vulcan Place, the Sun Inn, and the former Police Station & Courthouse. A few dormers have been added, some relatively modest such as the Dunn Cow PH's early twentieth century additions, others more intrusive, such as those added to Nos.22-24 East End Front Street and the side of Bedlington Social Club (its front dormer is likely original). The low number of added dormers is significant and so new dormers should be avoided unless very carefully designed, modest in scale, well proportioned, positioned and detailed, and preferably on rear roof slopes.

Victorian buildings designed with dormers have enlivened the roofscape in one or two places, but latter added dormers are intrusive unless very carefully

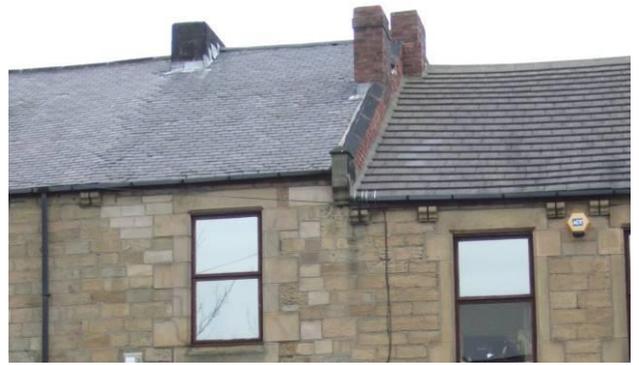
Roofscape is harmed where chimneys are capped, shortened, removed or not included in the first place

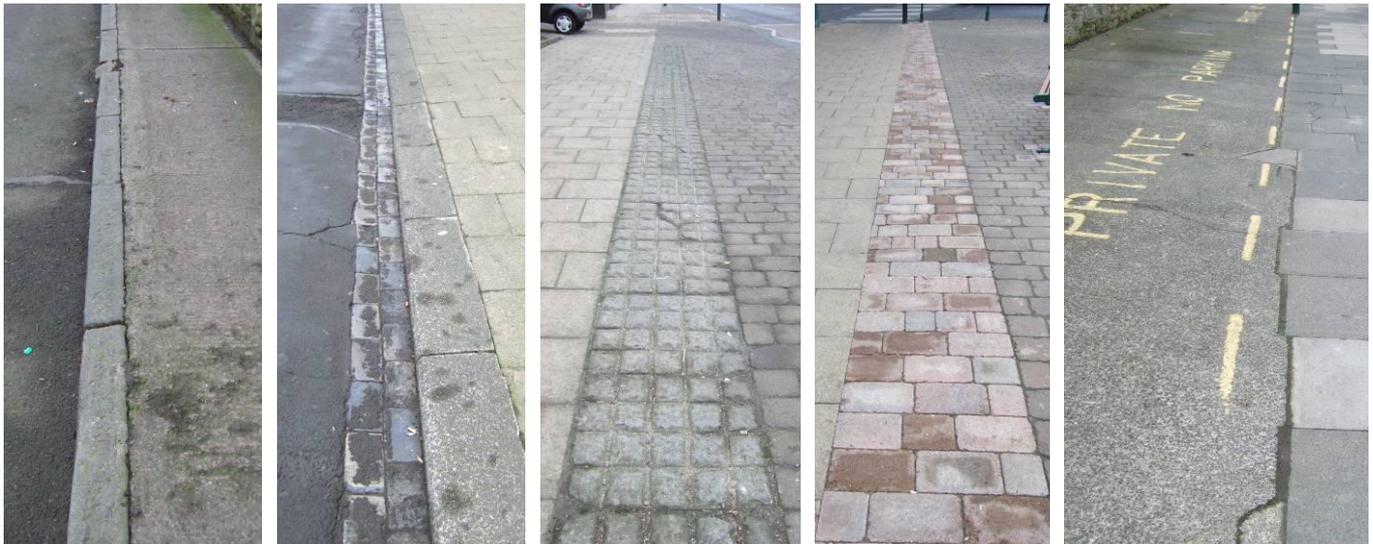
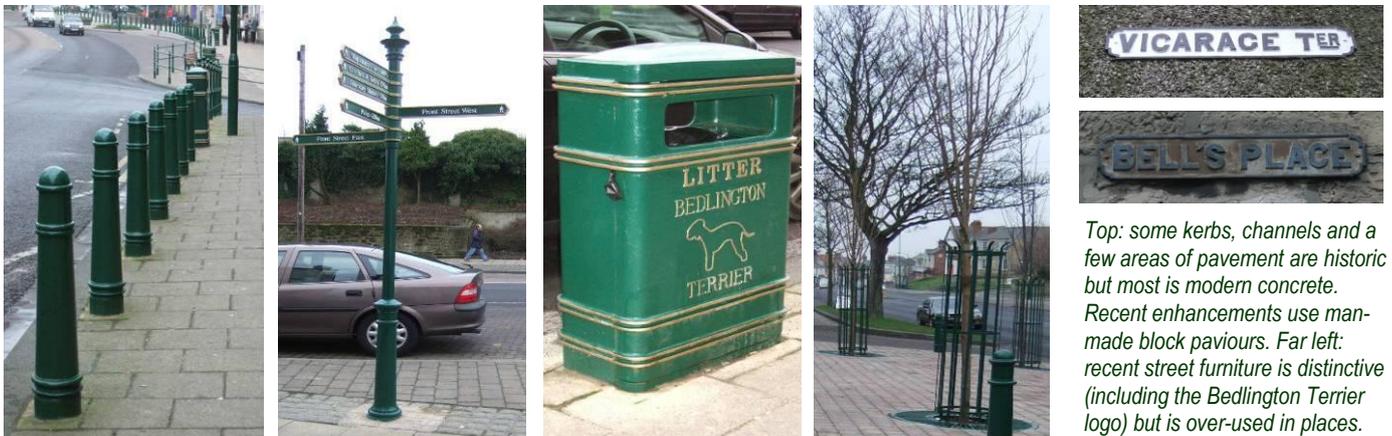
Top: some kerbs, channels and a few areas of pavement are historic but most is modern concrete. Recent enhancements use man-made block paviments. Far left: recent street furniture is distinctive (including the Bedlington Terrier logo) but is over-used in places. Below: the Trotter Memorial Fountain and the War Memorial, both listed Grade II, are key public realm features in the area

6.55 Unfortunately, because of the traffic, most of these spaces are quite heavily engineered to manage vehicle/pedestrian conflict. It seems that every surface has been allocated a purpose, planned, bordered, laid out, and often separated by rails or bollards, particularly in Front Street West. This accommodation of traffic in the main spaces of the conservation area has been taken to an extreme with the provision of a huge roundabout at the West End (and adjoining dual carriageway outside the boundary on Glebe Road) with forced changes in level hemming in historic buildings at the western edge of the area. Such an approach to historic places belongs firmly in an uncomfortably recent past, and should be modified in the future to bring back a more pedestrian-friendly environment which better respects the setting and coherence of the historic development and the buildings which front it.

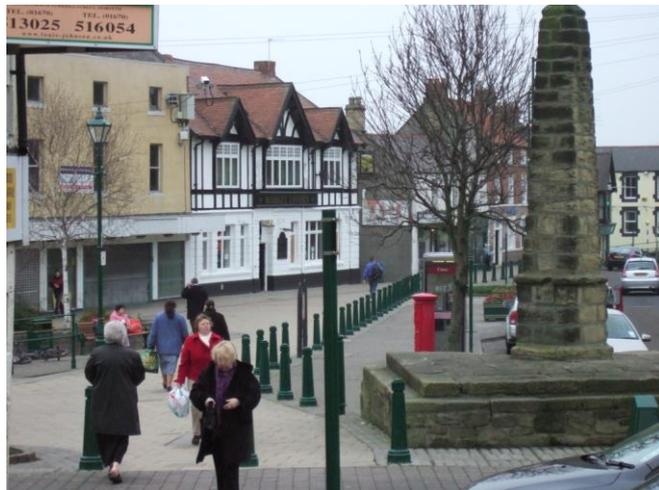
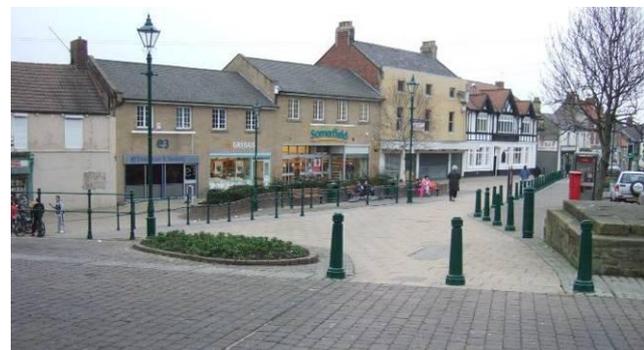
Above: the listed Market Cross, known as the 'nail', anchors the Market Place. Right: it has mixed late twentieth century layout and materials recently enhanced with new street furniture and information board

by the lack of active uses of the space for markets and the like. All of this tends to denigrate the unity and significance of Market Place as an historic space, although the presence of the Market Cross (listed Grade II) adds considerable period integrity to the space, even if it is somewhat disconnected from the current floorscape treatment.

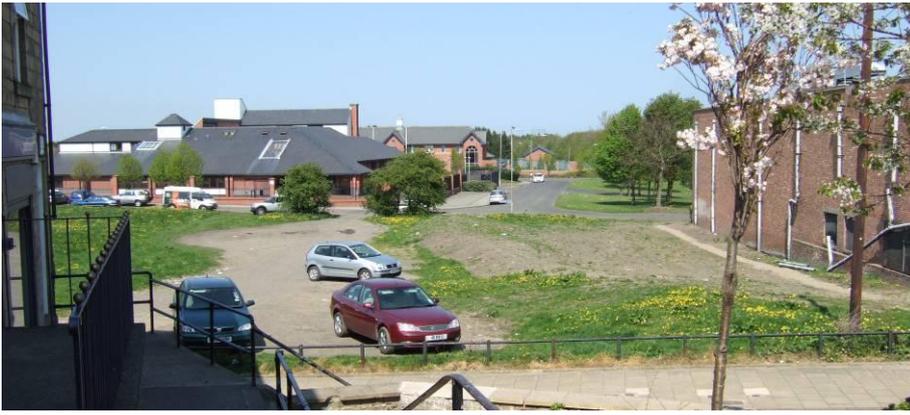
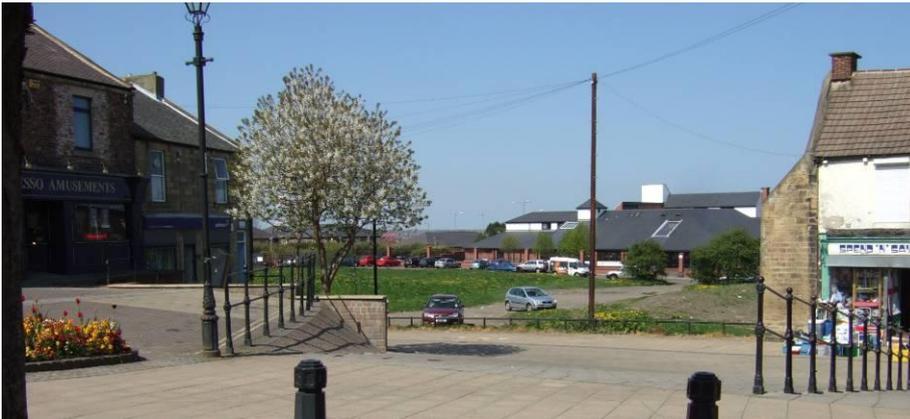
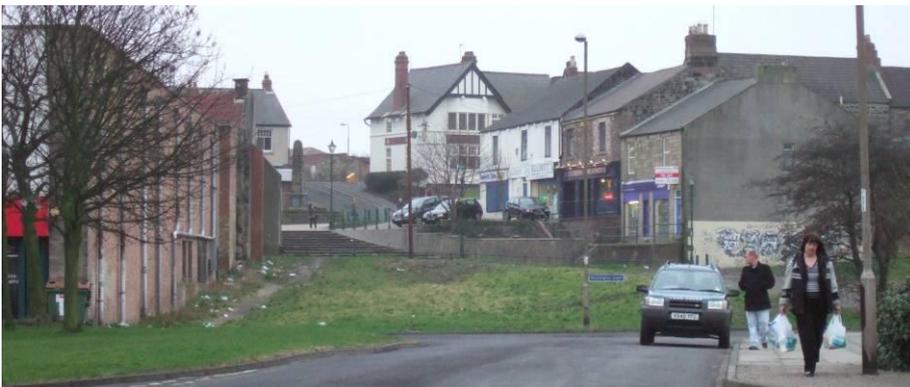
The gap site was created following mid twentieth century demolition and has left a large hole in the development pattern of the Market Place . The accidental plot has become blank scrub grass. Its redevelopment could enhance the conservation area and bring social and economic regeneration

6.58 The gap site at the back of Market Place has been an enduring problem of the late twentieth century, leaving the space ‘unfinished’ and incoherent as an urban place. Views ‘leak’ out towards the blandness of Schalksmuhle Road and, in the absence of well-designed and planned development coming forward, the meagre amenity of the blank scrub grass have unfortunately begun to find appreciation in its own right. This misguided ‘adoption’ of an accidental open space does demonstrate a desire for useable open space in the town, but must not be allowed to prevent economically or socially productive re-development of the space which, with the right conservation-led layout and design (which could

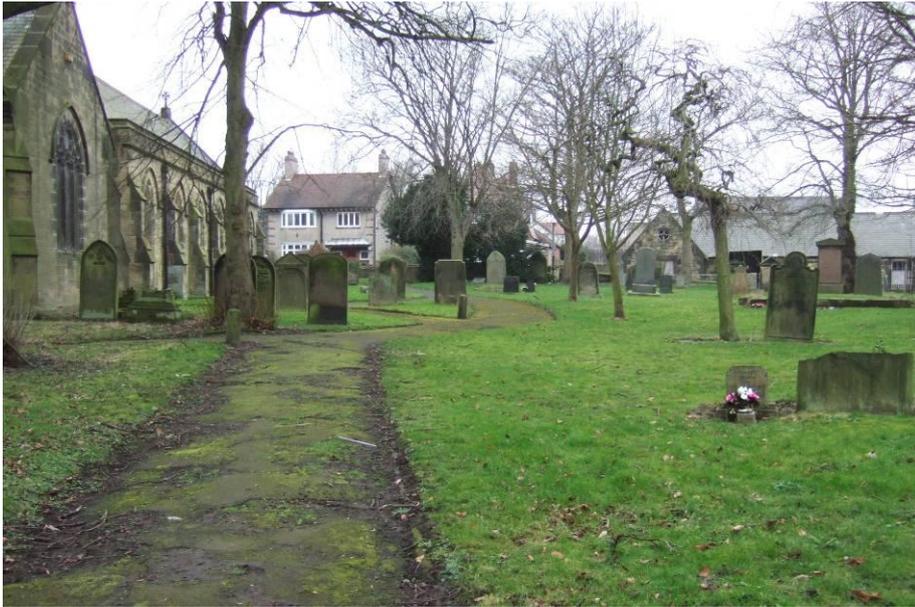
Church Lane with the church of St Cuthbert and its churchyard on the left, and the former school on the right

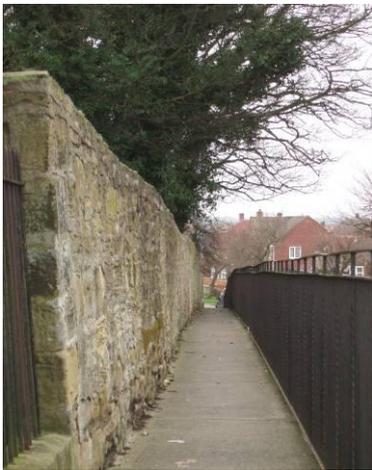
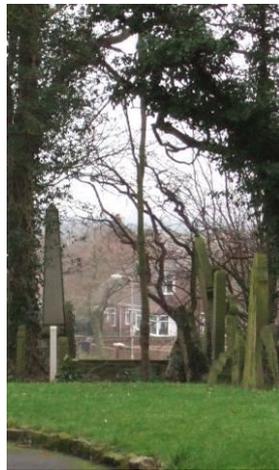
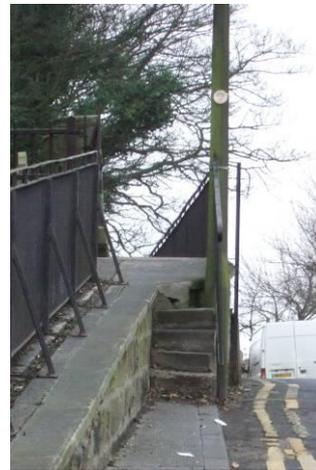
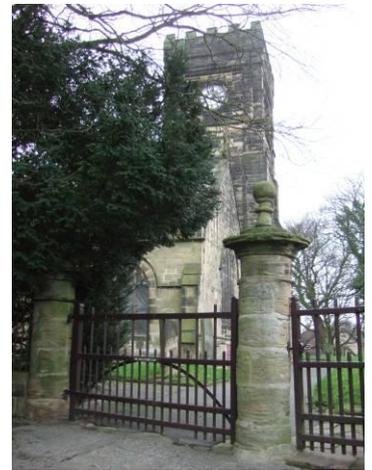
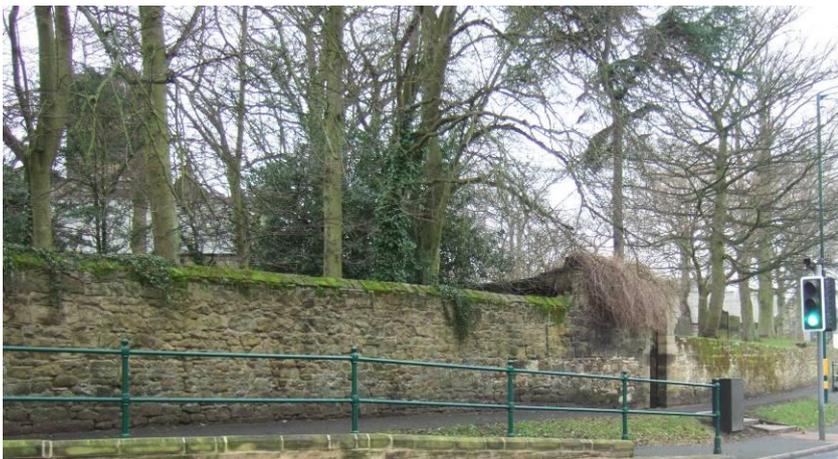
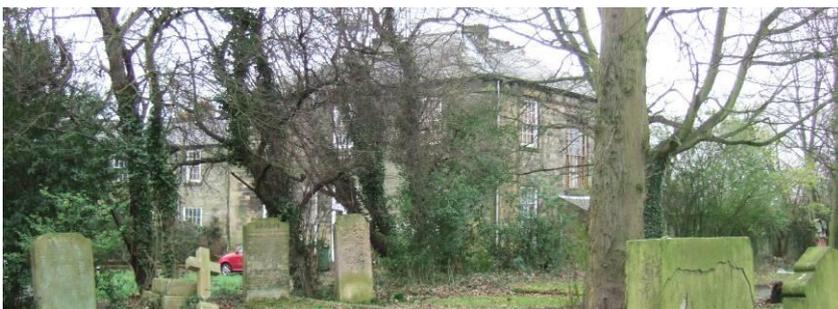
The churchyard is a rich, green, secluded space raised up from the rest of the conservation area. It is surrounded by tall sandstone boundary walls with steps and gates, and many important trees. The adjoining former vicarage (bottom left) has equally important groups of trees.

articulation to the street spaces below near the centre of the town. Its elevation creates a secluded, enclosed grassy area surrounded by rich historic boundary and retaining walls, railings and gateways in timber and stone. Its standing sandstone gravestone are copious; many are elaborate and nine are listed Grade II.

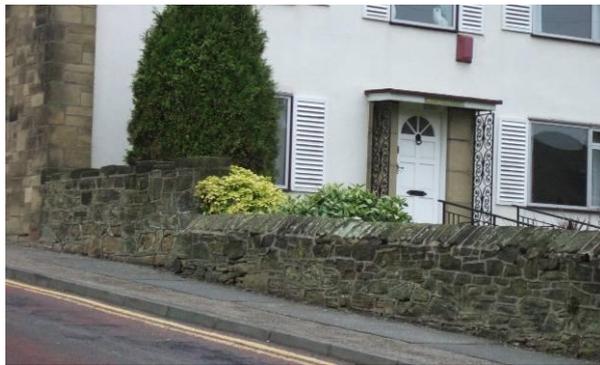
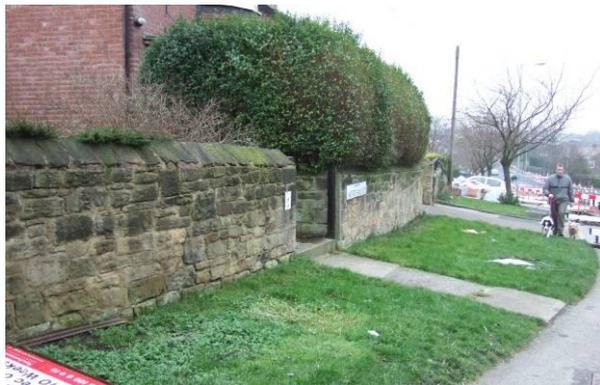
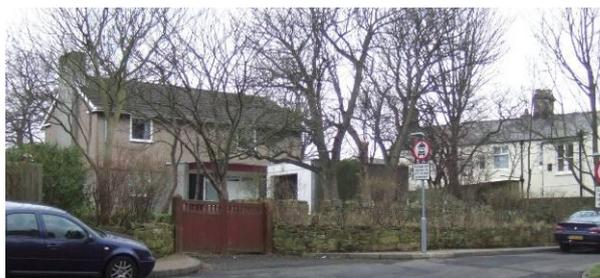
Left: historic boundary walls are important on the south side. Below: some forecourts on the south side are incoherent and cluttered

6.63 On the south side, as the layout is not to back of pavement, several private front gardens and their trees and planting add much to the character of the street, particularly around the War Memorial gardens and at the west end of Front Street. However, seen together with the various stretches of open space on the south side of Front Street West, the combined effect is somewhat incoherent, with a clutter of walls, fences and other treatments, despite the greenness of the gardens. Historic stone boundary walls, though, are important surviving features here to be protected and enhanced, including their distinctive triangular copings.

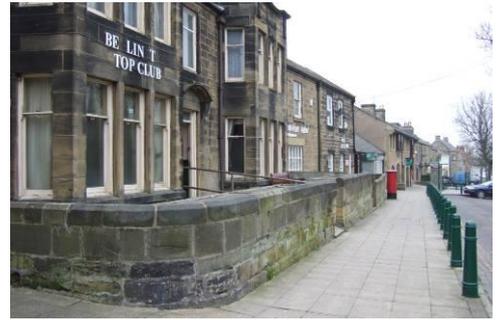
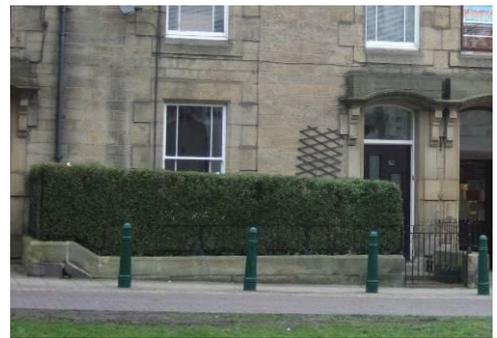
A few surviving small gardens on the north side of the street illustrate development pattern. One is still green.

6.65 By comparison with the south side, the north side of Front Street is almost entirely to the back-of-pavement, but the central stretch on Front Street West did historically comprise a series of tiny front gardens, and a few survive here to varying degrees. Outside what is now the Top Club, post office and adjoining shop are enclosed former gardens which have unfortunately lost any greenness to them but retain important historic stone boundary walls with copings. Further down is a single small garden – still green and mature – at the last surviving residential house on this part of the street, surviving in amongst the shops. This is welcome visual relief and a good historic reminder of the previous residential use of most of the properties on Front Street. Other such gardens have been lost to featureless forecourts, essentially now read as part of the pavement and eroding with them any sense of historic development pattern.

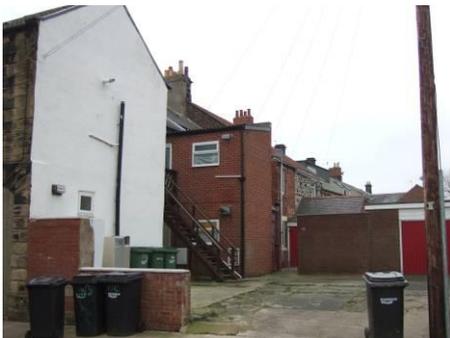
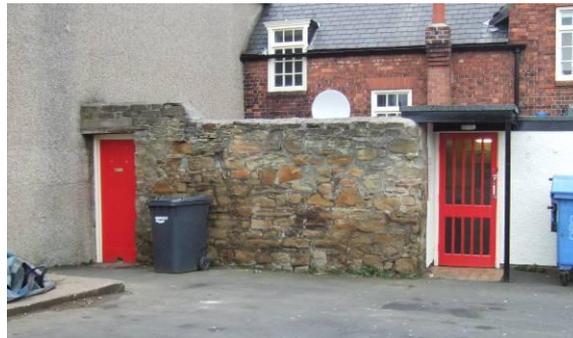
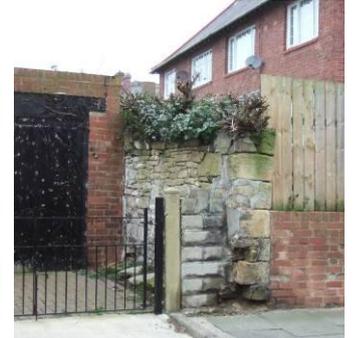
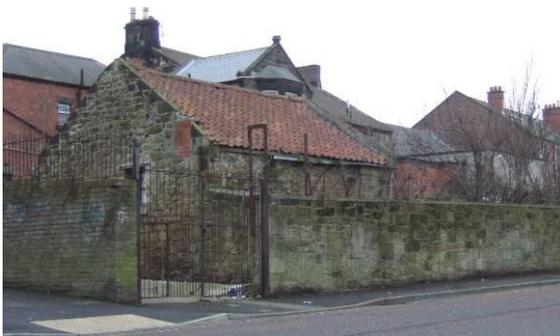
Above: important derelict outbuilding at Nos.40-40b Front Street

The significant former school on Church Lane is in a bad state of repair and is long-term vacant. Others in poor repair and/or vacant include the former gas showroom, East End Front Street, and an outhouse behind Nos.40-40b Front Street West

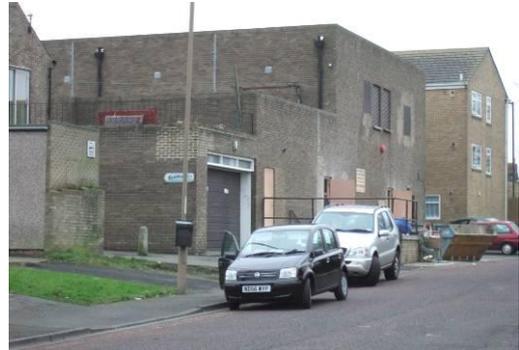
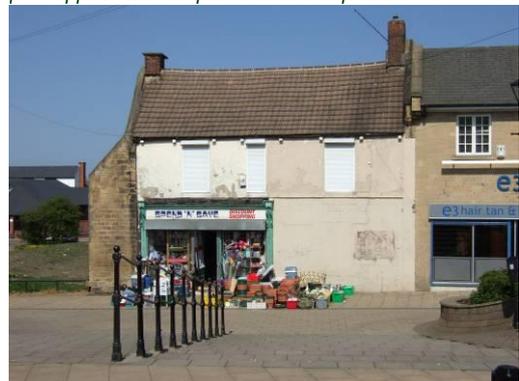
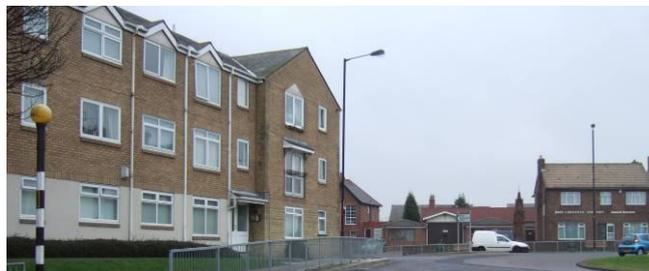
Above: Large ugly extensions blight some rears. Below: Erosion of character has left some historic buildings with a poor appearance despite their overall positive contribution

Some buildings, notably some late twentieth century housing at either end of the area, is neutral, having a balance of good and bad characteristics

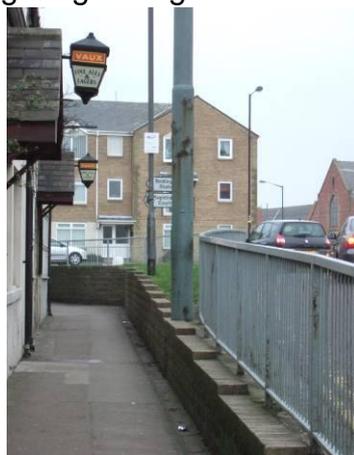
- the vast, bulky modern supermarket extensions to the rear of Market Place which have destroyed the integrity of the development pattern at the heart of the conservation area, and left out-of-scale intrusive cliff-like elevations to the north,
- the Council offices (despite its natural materials), made worse by the forest of antennae on the roof,
- the adjoining Job Centre (Longridge House), both insensitive and prominent,
- the late twentieth century appearance of the former Elliot’s Garage site, which is out-of-place through its materials and built form, though not necessarily as a result of its siting and height (there is a decent Edwardian building at its core).

Negative parts include: the Market Place gap site, huge supermarket extensions behind the Market Place frontage, the Council Offices and adjoining Longridge House, the former Elliott’s Garage site and, bottom left, the large roundabout at the west end

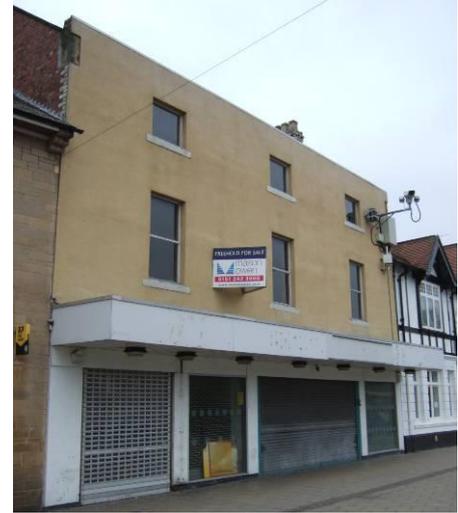
6.70 However, most harm to the conservation area has come from disfiguring change to detail and materials of the historic buildings over time. The frontage of the former Turk’s Head PH in Market Place exemplifies this. Here a once handsome late Victorian frontage of decorative brickwork surmounted by three distinctive wallhead dormers has been reduced to a bland rendered façade with heavy modern canopy, all of no architectural merit. A poorly sited public CCTV installation attached to the first floor detracts further.

No.9 Market Place, the former Turk's Head PH and most recently part of a supermarket – a significant loss of character, but almost entirely restorable

6.73 It will be important to try to curtail the most harmful damage and loss. It would also be important to find opportunities for reversing over time harmful changes to the architectural and historic qualities which give the area its distinctive character. Both would be more easily achieved with detailed guidance and incentives, such as grant aid. Monitoring these and other changes should take place to ensure accumulated change over time does not further weaken or erode the area's special local architectural and historic interest.

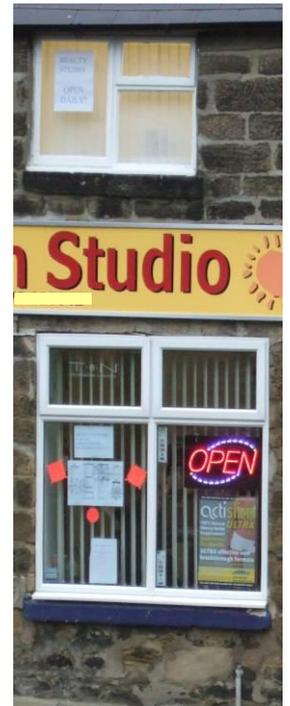
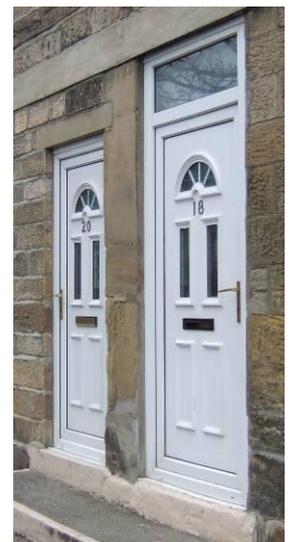
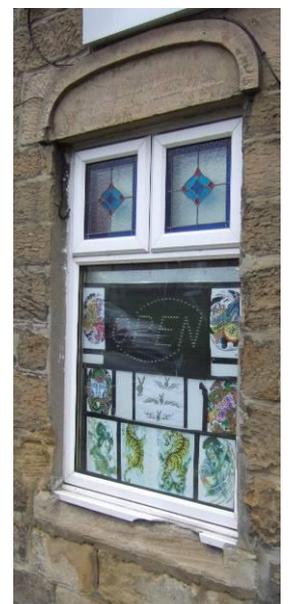
- Several enlarged or repositioned window, door and shopfront openings, which result in a loss of historic fabric, and which distort the architecture of the building, harming the basic consistency of these architectural features across the area.
- Notable loss of original front doors, which have been replaced with a variety of modern timber doors in mock reproduction or modern styles, which can have an insubstantial appearance compared to traditional solid panelled features, or replaced in PVCu (with a similar negative effect to PVCu windows, see below).

- Widespread loss of original windows, replaced with either modern timber casements or with PVCu casements. The effect which fenestration has on a building's character and appearance should not be underestimated. Even slight changes to details (such as glazing bar profile or width) can dramatically alter the character and appearance of a building. This can be true if one in a set of windows is changed or if it is repeated across a whole façade. The visual effect of modern materials and inaccurate designs is invariably jarring against a well-aged building in natural traditional materials. The success of PVCu windows which attempt to copy the design and proportions of traditional windows, depends on the width and profile of the frames. It is generally the case that PVCu frames are thicker and more angular than timber ones, and can not accurately incorporate details such as mouldings, horns, beading and stained glass. PVCu 'glazing bars' are often false strips superimposed onto glazing which have a flat, flimsy appearance. Neither does PVCu take on the patina of time like timber. The result will almost always harm character and appearance. The same is true of 'fake' sash windows (top-hung casements) which rarely reflect the particular style of the building. These and other modern window styles, including small top opening lights and those with horizontal proportions, often have clumsy, chunky proportions and are often placed flush with the face of the building, rather than being set back into an appropriate reveal, thus losing depth and shadow to the building's architecture.

Altered window openings and replacement windows and doors, some in timber, many in PVCu

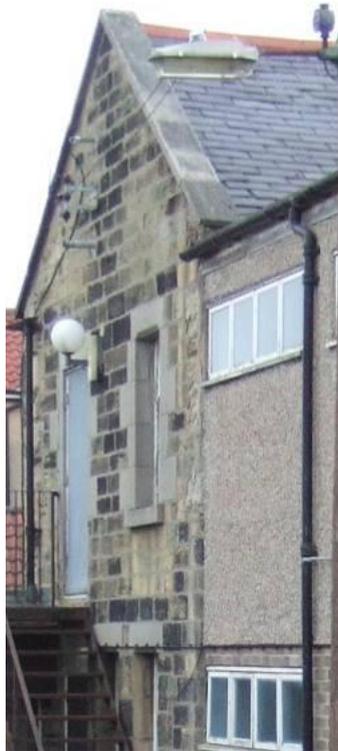
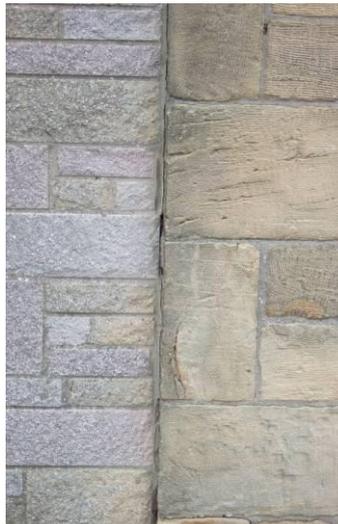
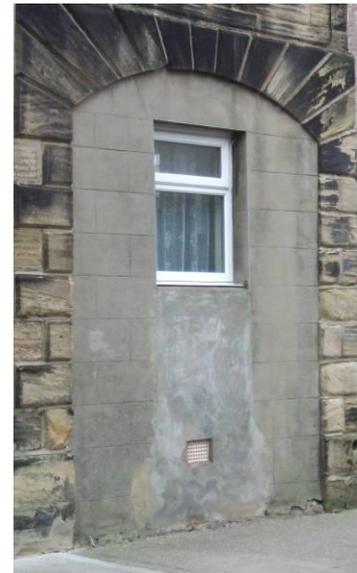
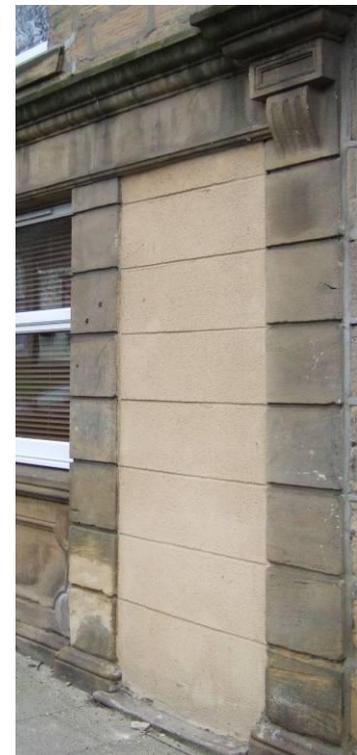
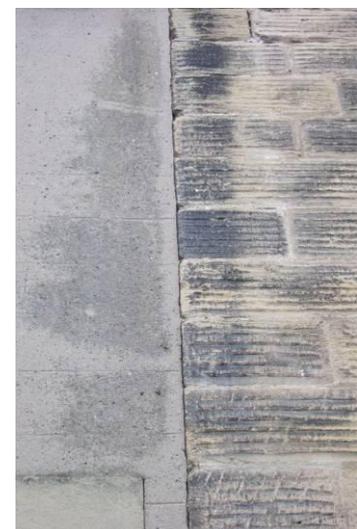
- Masonry repairs and alterations which use modern brick instead of stone or which use stone poorly matched in colour, size, texture or bond, leaving visual scarring on elevations.

- Poorly finished, badly matched or cement-heavy pointing which can significantly alter the appearance of stone buildings by making the pointing more visually prominent, as well as harming the fabric of the building in the long term.

Weak detailing, clumsy design and poor use of materials harms the character of mature historic buildings

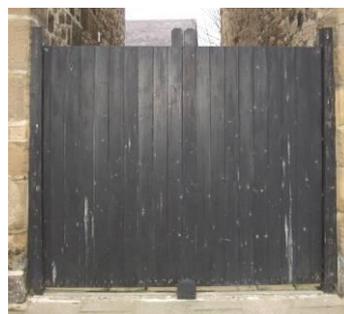
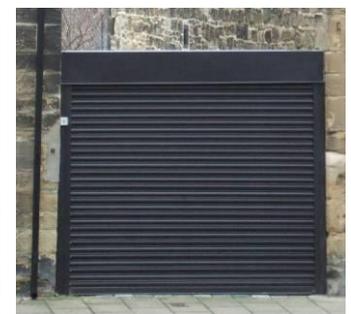
Manmade roof covering; obtrusive plastic fascia signs and altered shopfronts; loss of chimneys; masonry paint, render and pebbledash; felt-clad box dormer; use of a metal roller shutter instead of more appropriate timber gates

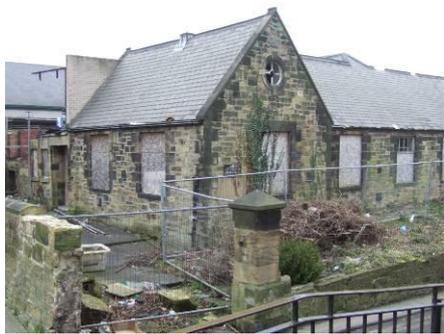
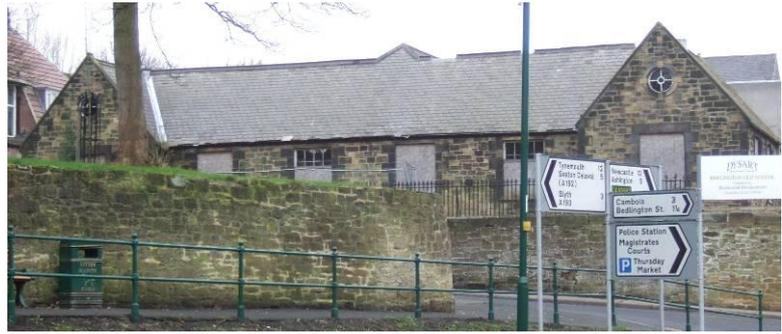
6.76 The general condition of the public realm in the conservation area is good, but the condition of many of the buildings is an on-going cause for concern, where investment and repairs have not kept pace with demand. Several buildings can be classed as being ‘at risk’, including the former Infants School of 1874 at the top of Church Lane. It is vacant, in an advanced state of decay and struggling to find an acceptable development solution. It makes a positive contribution to the conservation area through its historical connection and in its modest village architecture. Various extensions to the rear and its playground could provide some flexibility in redevelopment which would see a prominent site enhanced at the heart of the conservation area. The nearby vacant and decaying former Elliot’s garage is the subject of current redevelopment proposals. It makes a less intrinsically positive contribution, but the layout, siting, height and massing of redevelopment here would be important to protecting its impact on Market Place, and on the low density arc of open space which defines the south side of Front Street throughout the conservation area, of which the garage’s forecourt is an integral (though currently unattractive) part.

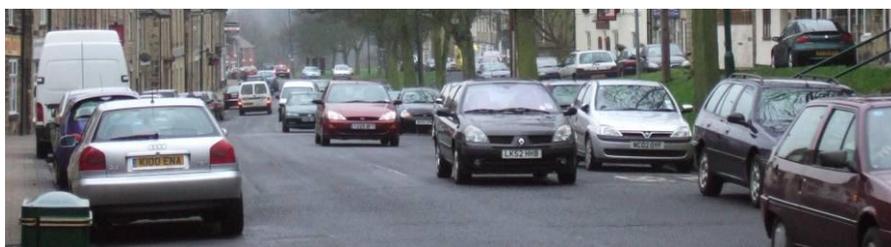
The volume of traffic on Front Street and Vulcan Place can be quite heavy

6.77 Because Front Street is both a transport route as well as a destination, quite heavy through-traffic is a perennial issue
