Current situation:-

Update 10/06/16

The road bridge still remains closed to vehicles and pedestrians while works are progressing.

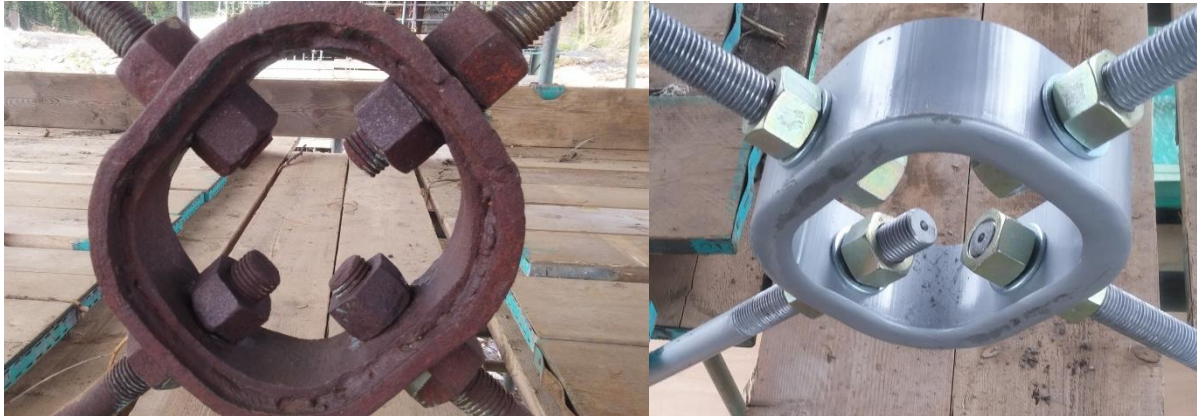
Existing & New Diagonal Tie Bracing

- **Pier Tie Bracing** – Following structural surveys of the piers in April 2016, Repairs to the damaged pier cross bracing is almost complete. This bracing was cracked and distorted during the flood event on 05/12/2015. Works have included safe removal of the damaged elements, fabrication of the new elements, localised preparation before installation, and torqueing of the new bracing to ensure it does not affect the original (unrepaired) sections of the piers. This repair has been undertaken at five locations

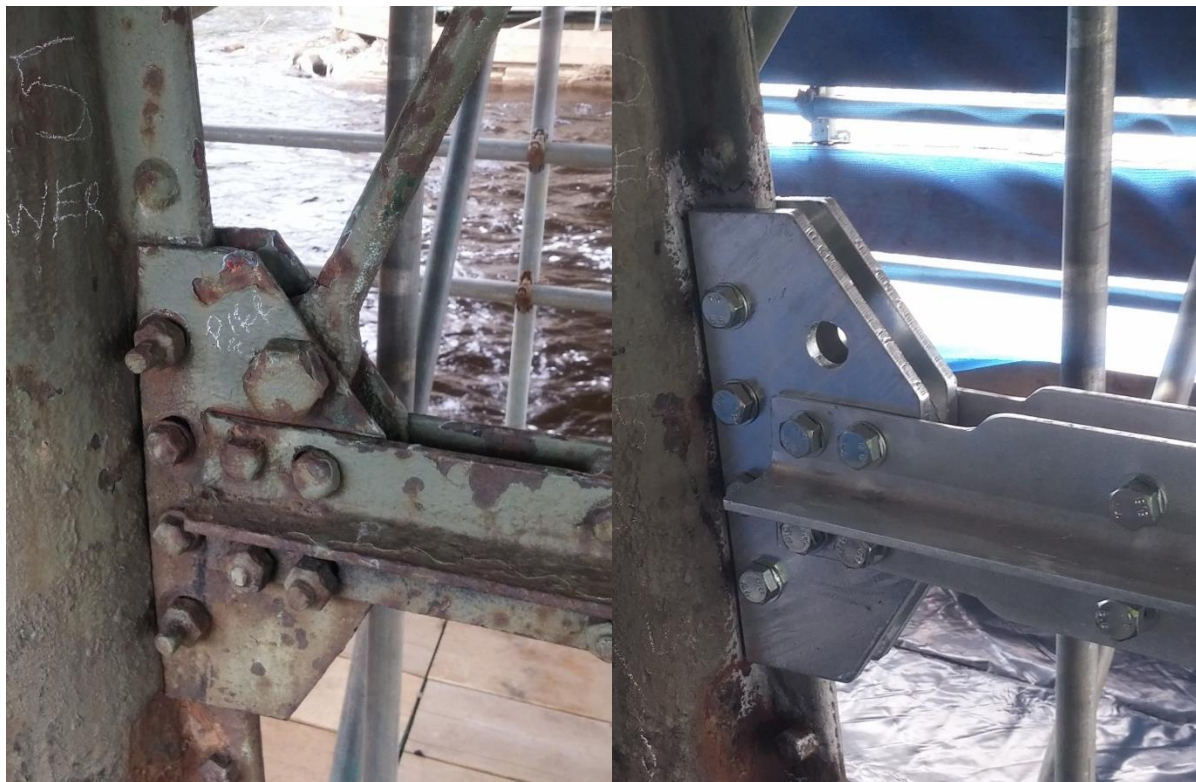
Existing & New Horizontal Cross Bracing

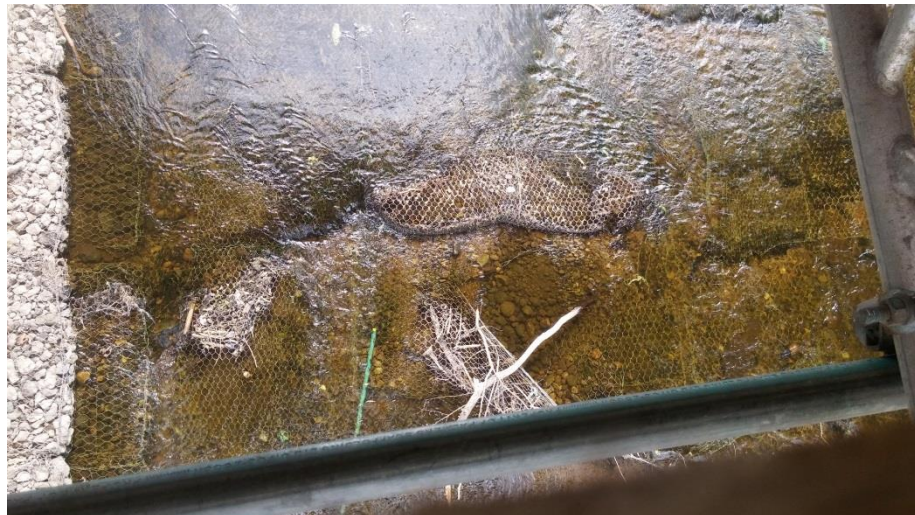
- **Reno-Mattresses** – In addition to the scour hole, a number of reno-mattresses have been damaged during the flood, the intention is to repair this mesh and replace the missing stone. Reno-mattresses reduce the risk of scour.

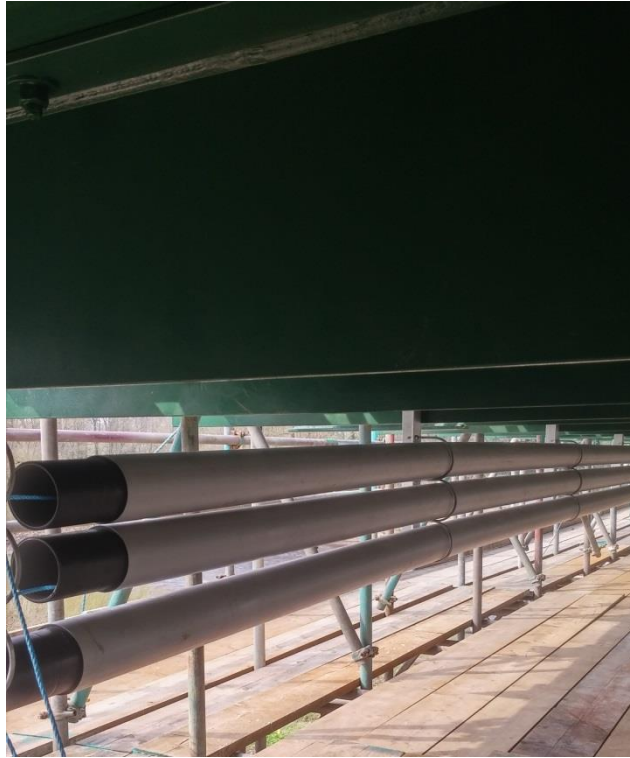
- **BT Cables** – the existing bridge supported three BT cables; they were temporarily diverted onto the scaffold during the works, with the intention of returning them back onto the bridge once the initial phase of works had been completed. The new ducts are now installed underneath the bridge, ready for BT to divert the cables.

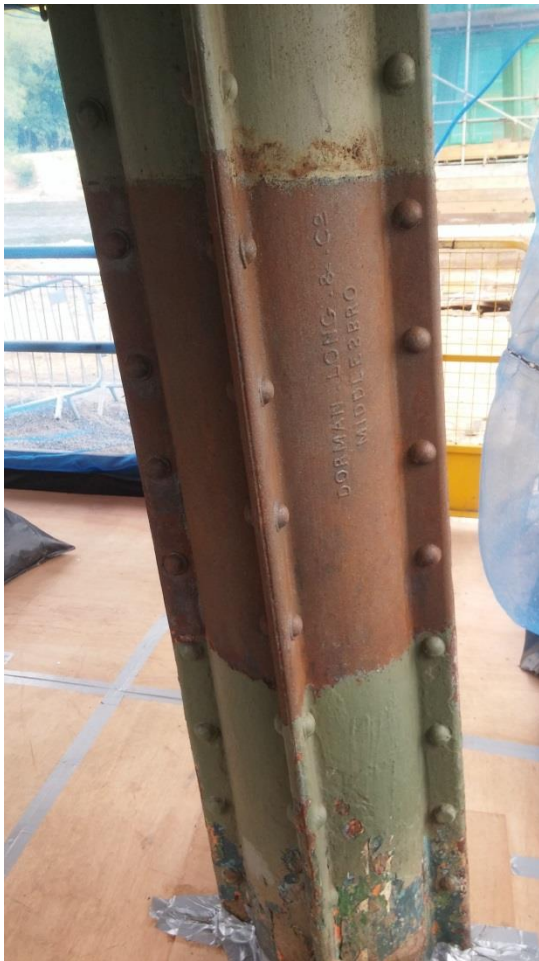
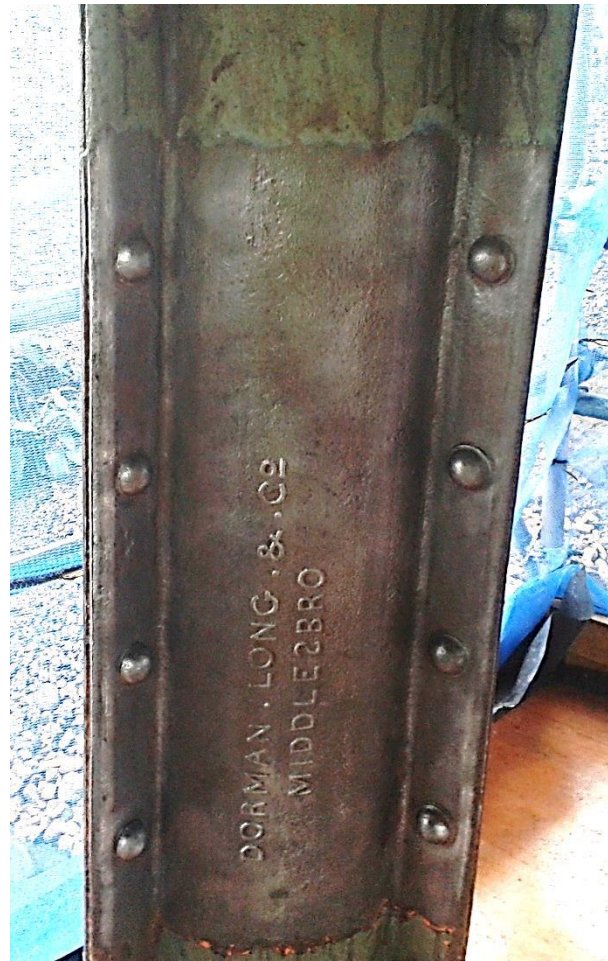
Trial of mechanical surface preparation for the application of the new paint system. picture on the left shows the surface after the existing lead based paint has been removed, the picture of the right shows the required standard for painting.

However the flood on 05/12/16 destroyed this scaffold, and damaged the pier bracing. The scaffold and bracing has been repaired and work can recommence on the painting of the piers. This section of work is anticipated to last until late summer 2016.
