# Ovingham Bridge Blog

Issue 25

## “So What’s Changed With The Truss?”

### TRUSS REFURBISHMENT

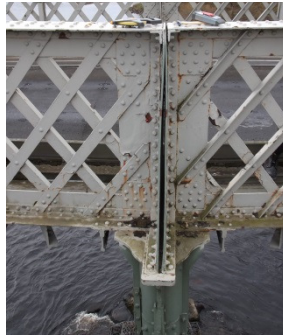
Truss after wet blasting, Wet blasting removes the lead based paint to make it safe for following trades to repair the truss

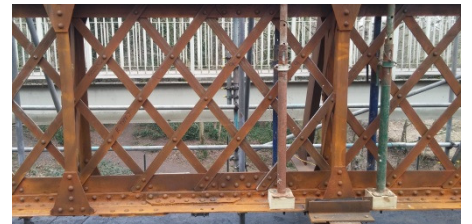
Truss being inspected and measured This determines which members are to be repaired.

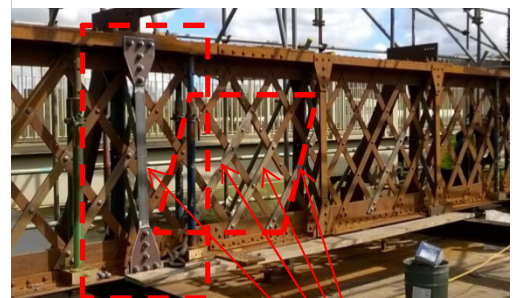
Truss sympathetically repaired The bridge is not listed, however in order to maintain its appearance the truss is repaired in keeping with its original appearance.

Repairs above as shown include, work on the U frame stiffeners and some of the lattice members.
