Ovingham Bridge Blog

Issue 27

25 June 2015

“New Bearings and Bearing Shelf”

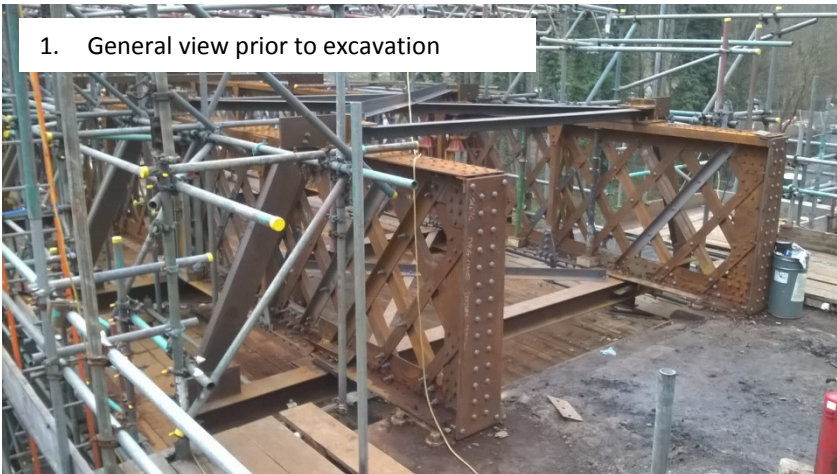
1. General view prior to excavation

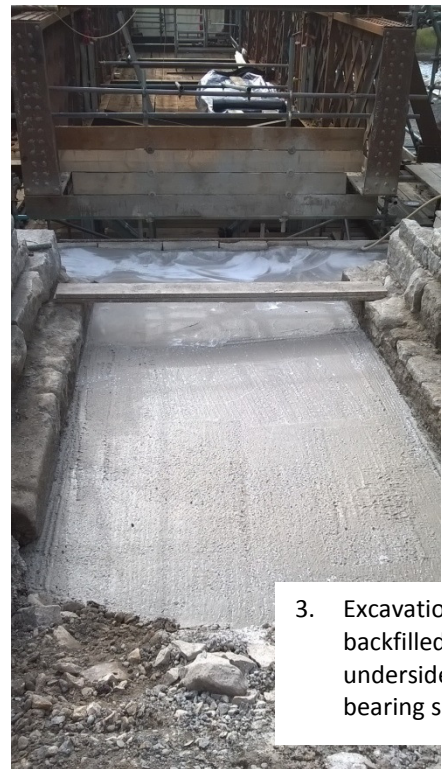
3. Excavation backfilled upto underside of bearing shelf

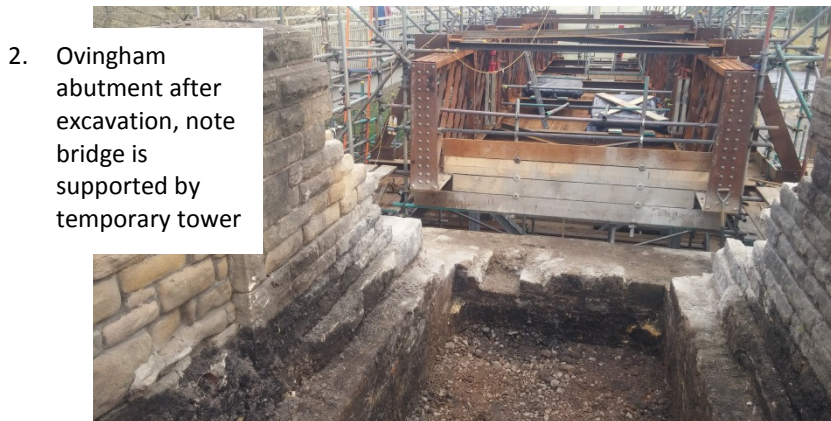
2. Ovingham abutment after excavation, note bridge is supported by temporary tower

The existing masonry abutments needed to be strengthened; this was achieved by pouring a mass concrete block dowelled into the masonry. This allowed the casting of a reinforced concrete slab which would carry the ends of the bridge.

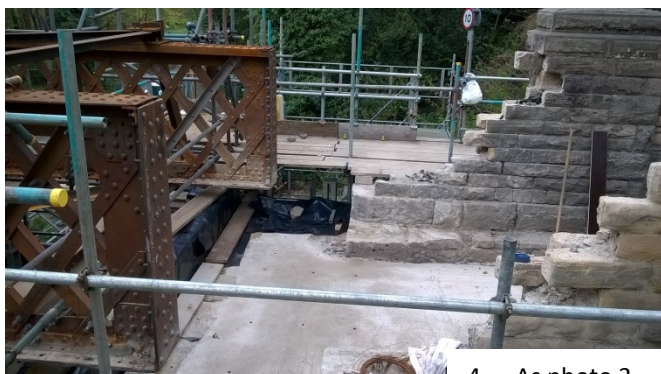
4. As photo 3

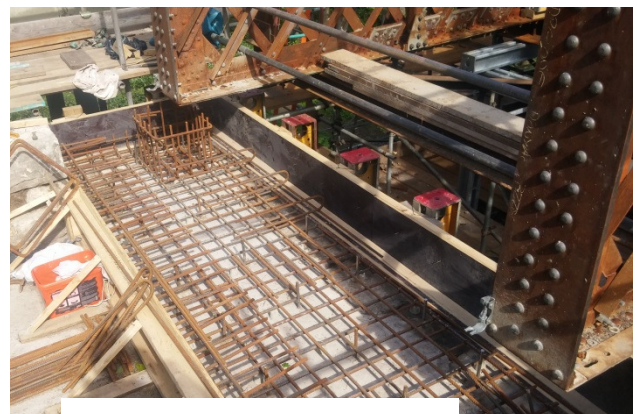
5. Bearing shelf reinforcement being installed

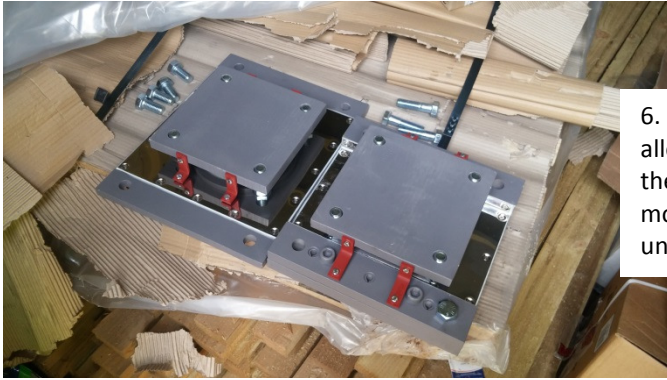
6. The new bridge bearings, one is guided allowing only longitudinal movement (along the span) and the other is free allowing movement in any direction. Photograph shows underside of bearings.

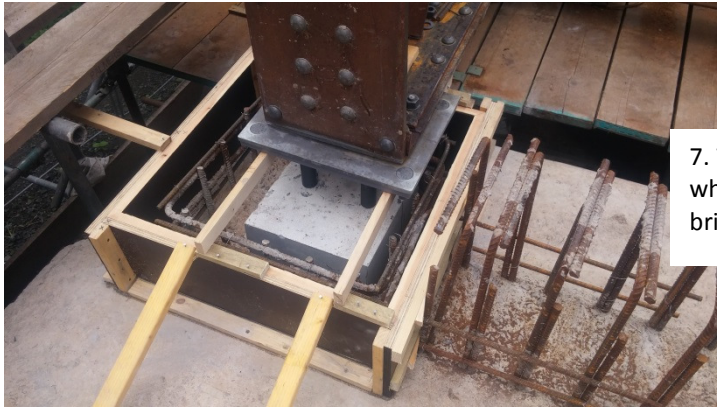
7. The new bearings are cast into pockets which are then grouted up, allowing the bridge to be jacked down.

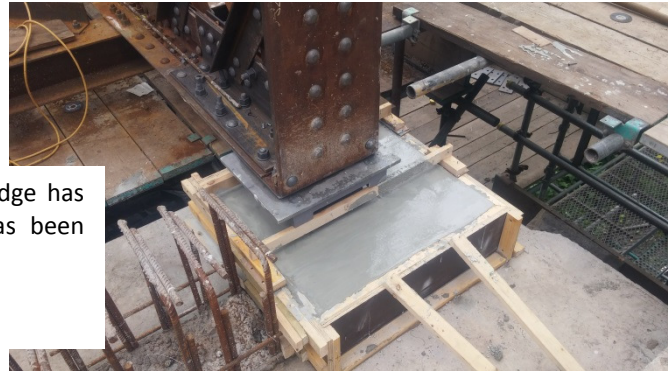
8. The new bearing after the bridge has been lowered and the grout has been cast.
