Health and Safety Bulletin

Ref: 2016/001

September 2016

Design and Technology Machinery Guarding

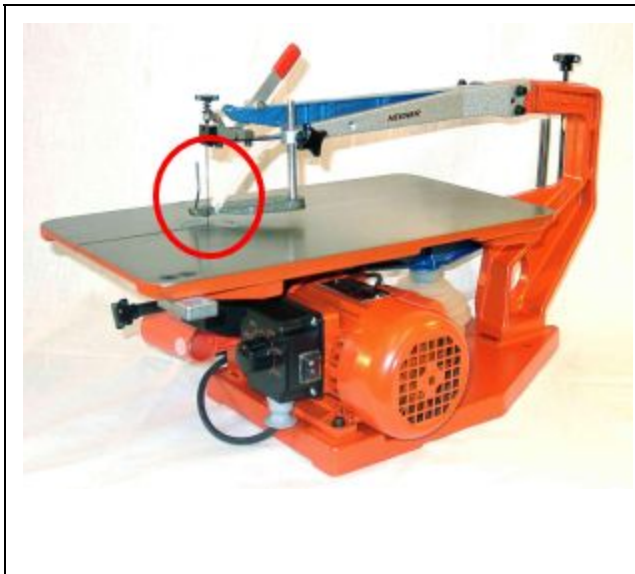
There is a replaceable teflon bung on the underside of the hold-down foot which is designed to press down on the top of the material while allowing free movement while cutting. The wire guard shown in front of the blade is sometimes replaced with a perspex guard on later models

All machines should have some form of hold-down foot, sometimes known as an anti kickback foot, above the machine table. This guard should always be raised or lowered to suit the thickness of the material being cut, thus preventing finger access to the blade. An additional perspex or wire guard may also be fitted in front of the blade. Below the table there will usually be a plastic guard surrounding the lower section of the blade. This is removable to allow blade changing but **must** be in place when the machine is operated. In all cases the guarding should be in place as recommended in the manufacturer's instructions.

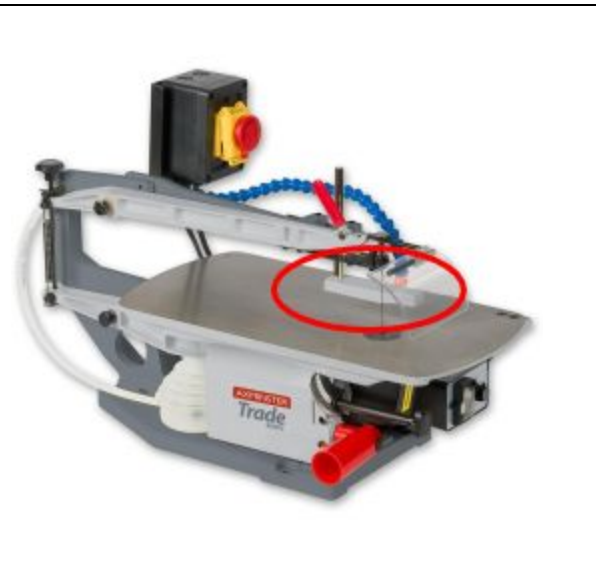
This picture shows the foot in a raised position which is beyond the thickness of any wood product which would be cut on this machine. This is the type of machine which was used at the time of the accident in question.

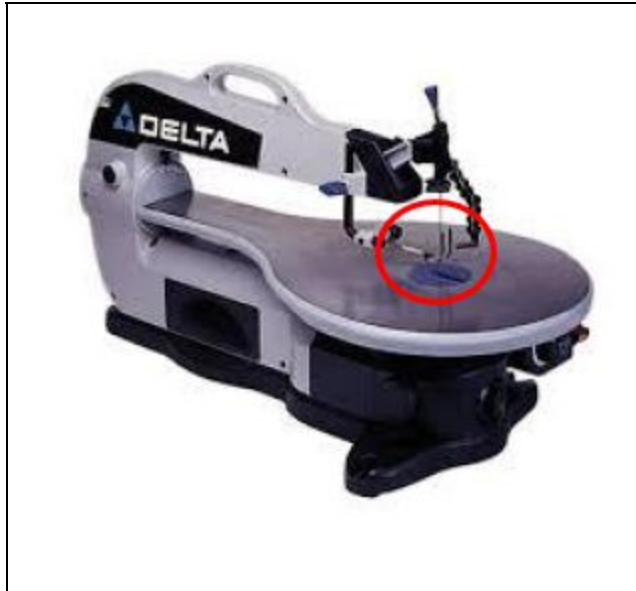
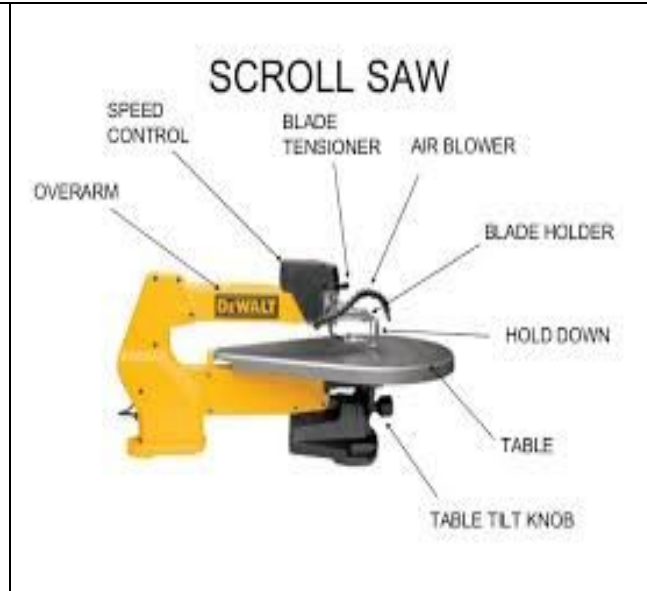
This machine has a spring steel 'sewing machine foot'. It holds down the material and also prevents finger access. The gaps between the fingers of the guard allow the operator to see the cut line.

The hold down foot should not be removed during normal cutting operations. Neither should it be set too high or turned through 180 degrees to improve visibility for complex cutting
