REPORT NO: D9148

**GEOENVIRONMENTAL APPRAISAL FOR LAND AT
QUEEN ELIZABETH HIGH SCHOOL, HEXHAM**

FAITHFUL+GOULD

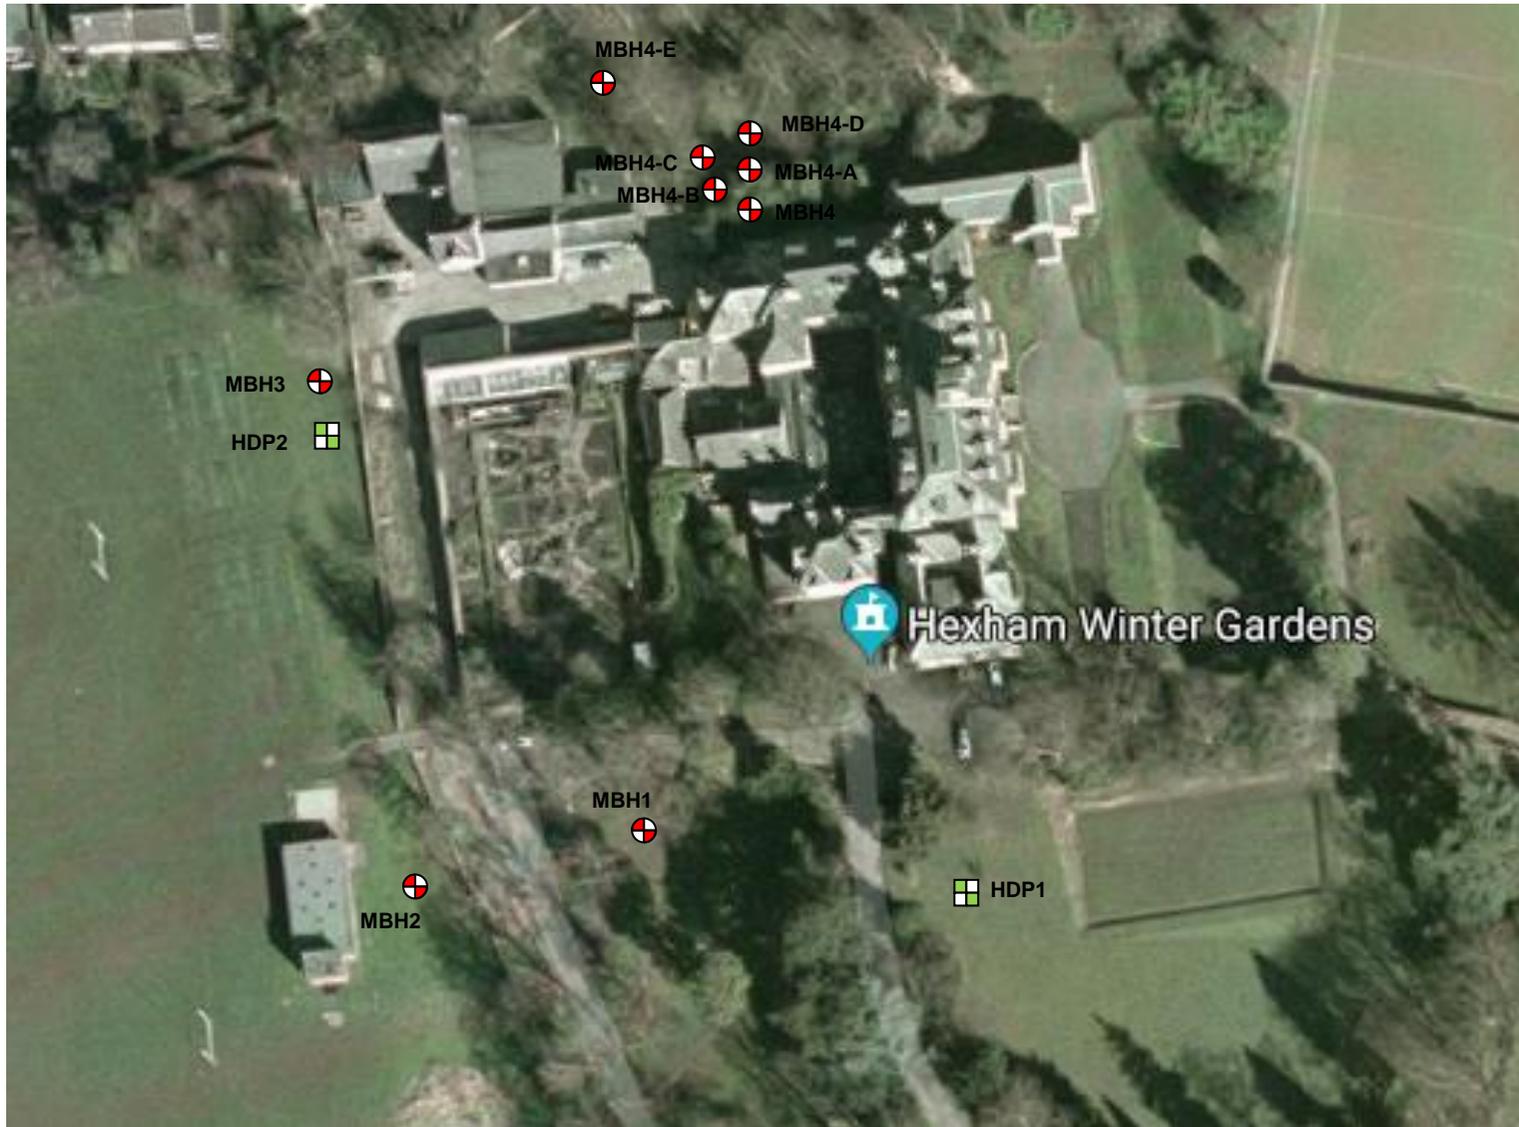
D9148/02 Exploratory Hole Location Plan

A site inspection was undertaken on 1st November 2018 and existing site features are shown on Drawing No. D9148/02 presented in Appendix A to this report.

The exploratory holes listed below, as specified by Faithful+Gould, were advanced on 1st November 2018. Records for each of the exploratory holes noted are included in Appendix B and the locations are shown on Drawing No. D9148/02 presented in Appendix A to this report.

- Hand-dug trial pits: HDPs 1 and 2.
- Soakaway tests: HDP 2 only.
- Mini percussion boreholes: WS1 to 4.

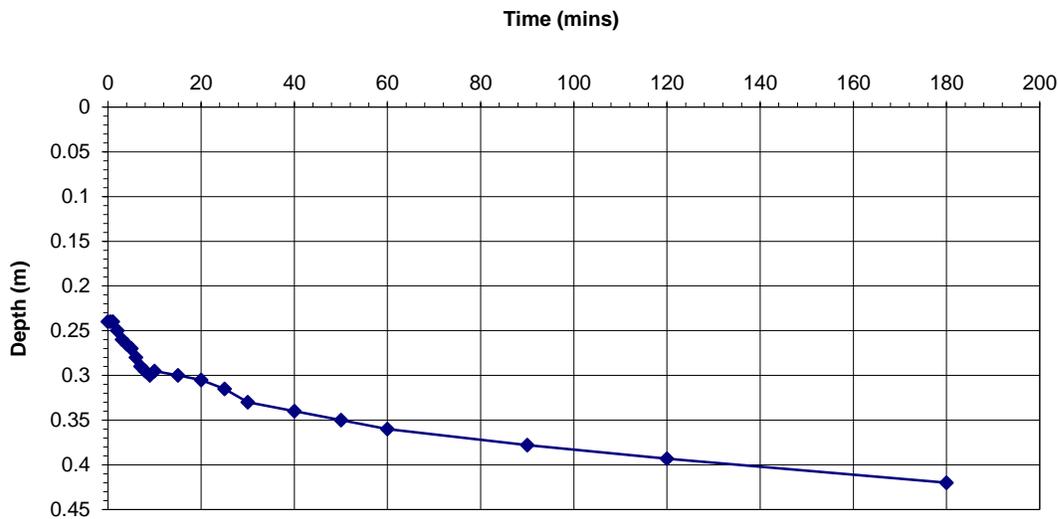
CALCULATION OF SOIL INFILTRATION RATE

Time (min)	Depth (m)	Pit Dimensions	
0	0.24	Length (m) =	0.40
0.5	0.24	Width (m) =	0.40
1	0.24	Depth (m) =	1.00
2	0.25	Depth at start of test (m) =	0.240
3	0.26	Depth at end of test (m) =	0.420
4	0.265	75% level (m) =	N/A
5	0.27	50% Effective Depth	0.67
6	0.28	25% level (m) =	N/A
7	0.29		
8	0.295	Base area of pit (m ²) =	0.160
9	0.3	V _{p75-25} (m ³) =	N/A
10	0.295	α _{p50} (m ²) =	1.232
15	0.3		
20	0.305		
25	0.315	V	0.0288
30	0.33	T	10800
40	0.34		
50	0.35	Soil infiltration rate, f, (m/s) =	2.16E-06 Inferred value
60	0.36		
90	0.378		
120	0.393	Input by:	MO Date: 07/11/2018
180	0.42	Checked by:	RS Date: 07/11/2018

A soakaway test was performed in HDP 1 in accordance with the methods outlined in BRE Digest 365. The test results are presented in Appendix D to this report. The water did not fully soakaway, and an inferred infiltration rate of 2.16E-06m/s has been calculated.
