Felton

Conservation Area Character Appraisal

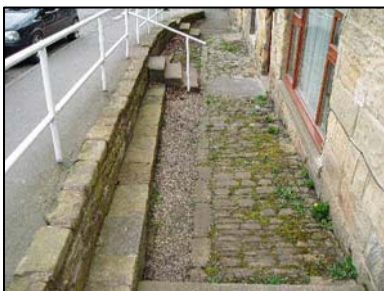
Original pavement level - Main Street

Increase in traffic required some re-grading of Main Street in 1821, resulting in areas of raised and lowered pavements which are important survivals. New buildings were constructed at the north end of Main Street as well as along the burgage plots. In the 19th century there were at least five inns (the Red Lion included a theatre) and many other businesses; most of the surviving fronts date from this time. In a few cases, buildings include datestones and inscriptions recording previous uses, giving them special interest.

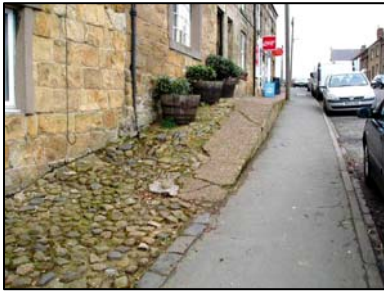
Varied pavement levels and surface treatments - Main Street

Some old pavement surfaces including cobbles, whin and sandstone setts survive, particularly where road levels have been altered, giving special interest and variety to the street. The coloured gravel dressing used on the old bridge and Coquet Vale adds to the variety of finishes, its informality a reminder of the essentially rural nature of the surroundings.

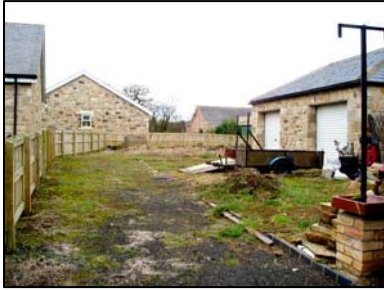
Randomly sited unsympathetically designed houses on backland - Victoria Terrace

Development on the rear of plots in Main Street has not always been sensitive in style or layout to the rest of the conservation area. Where this does not impinge on views from Main Street it can be regarded as neutral, although views over and from Back Burn should also be considered.

Most of the recent detached houses in sub-area 2 have little relationship with the road or other buildings in the conservation area. They should not be used as precedents for further development.

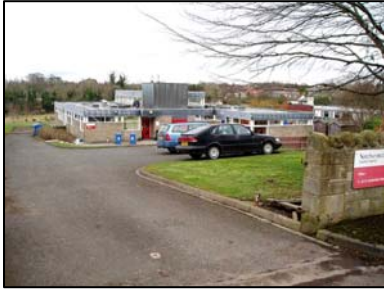
Primary School site - Moldhaugh Road

Similarly, the primary school and houses on Mouldhaugh Road tend to dilute the character of the conservation area but are hidden from Main Street and can thus be regarded as neutral.

As discussed above, the School and Moldshaugh Lane can be seen as having a neutral impact on the conservation area. The school is a modern, flat-roofed building of no architectural or historic interest with adjoining car park and hard play areas. It adds nothing to the Conservation Area and it may be difficult to argue for conservation area controls being used here. It is assumed that any original purpose of designation was to protect the setting of the Main Street section of the Conservation Area from the East but as stated with other appraisals this objective of protection is better achieved by protective policies in the Local Development Framework. The area has been de-designated.

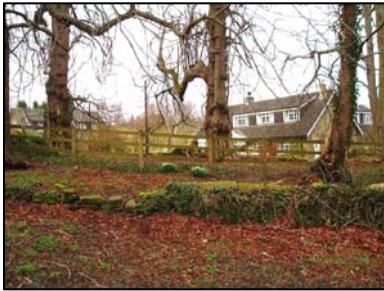
Houses not aligned with the road; wall in poor condition - Church road

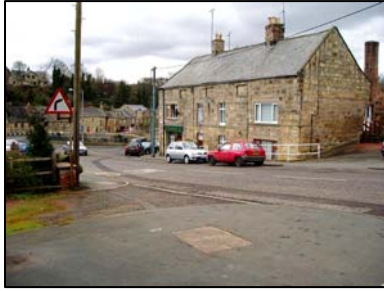
Modern street furniture and surface treatments are unsympathetic in places, particularly the wide stretches of patched blacktop in Main Street and beside the bridges. Poles and overhead lines are obtrusive, particularly in

Large areas of blacktop, poles and overhead wires - Main Street

Main Street, as is advertising on the front of the General Store. (however, these changes occurred before the conservation area was designated).

Street lighting could be improved in some parts of the conservation area, for example by replacing modern lamp standards with suitable fittings attached to the buildings, or more imaginative fittings in keeping with the historic character of the conservation area. Historic pavement features should be conserved and repaired, and could provide examples for improvements in Area 1 where varied surface treatments could also help with traffic calming. A public realm audit should be carried out to provide a baseline for such improvements.

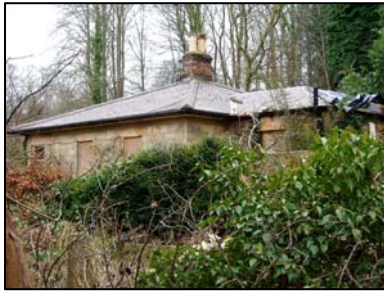
The Grade II listed Felton Park Lodge appears to be empty and in poor condition.
