Great Bavington

# Conservation Area Appraisal

April 08

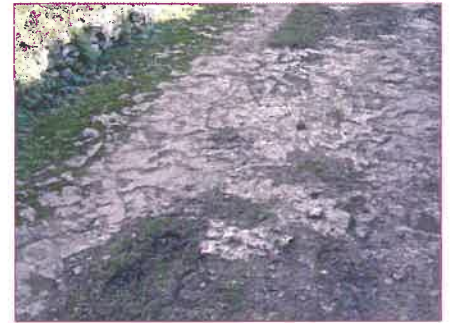
Figure 5 Whinstone bedrock surface

6.4.2 The floorscape in the public realm is of particular importance. The lane that leads through the area to the terrace is exposed whinstone (Figure 5). It provides an attractive and immediate expression of the geology of the area, and a robust and natural base to the adjacent properties. It is probable that the lane has retained this appearance for centuries, and as such is of considerable historic importance.

**9.6** Exposed whinstone bedrock should be kept as a carriageway surface and not covered or replaced with any other material.

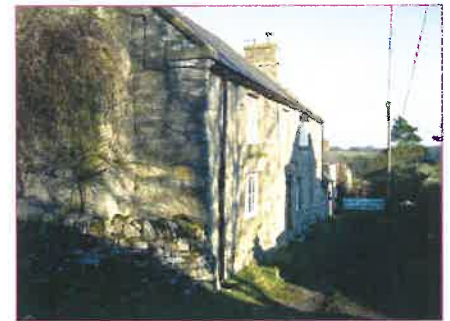
Figure 7 The south elevation of the terrace

**6.5.1** Area 4 contains the finest architectural grouping in the conservation area. This comprises the southern elevation of the terrace (Figure 7), The Manse and the United Reform Church. The lane fronting the buildings is a narrow route that retains much of its historic character, particularly the roofscape. The buildings front directly onto the lane, and consequently there has not been the opportunity to alter the running vertical plane of the terrace along this elevation. The mapping evidence indicates some limited infill, but this does not damage the overall appearance of the street.

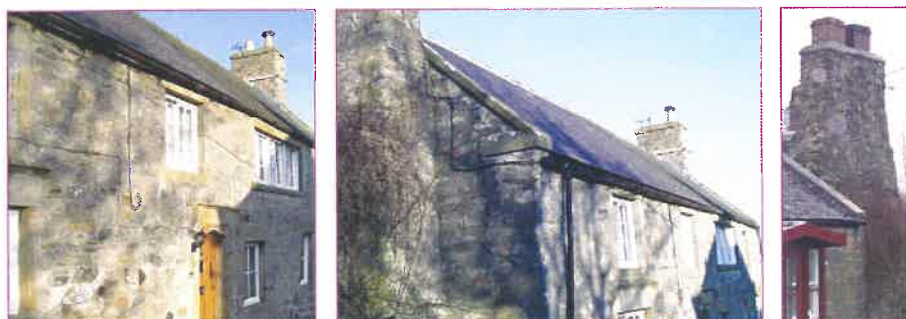
Figure 9 Easter House and Easter Cottage showing its architectural features, roof details and western chimney stack

**7.2** The earliest surviving building is the altered seventeenth century Easter House and Cottage (Figure 9), originally built as a single dwelling, and subsequently sub-divided to accommodate the Harvest Home pub, the original Manse, and the village school. Latterly, it has been divided into two dwellings. Both functionally and architecturally, it has been at the hub of the village for centuries. This property is the western stop to the central terrace, and provides a robust and attractive climax to the built spine of the village. It embraces a number of interesting details, including carved copings to the front door, and a first floor window which may have been salvaged from an earlier building. The elevations are built in random stonework, including boulders, with informal quoins. The roof is Welsh slate with stone water tabling (the stone flags that run along the edge

of the roof) springing from rectangular stone corbels. The chimney stack at the western end reinforces the visual termination of the terrace, being of a massive construction, buttressed against the side of the house.

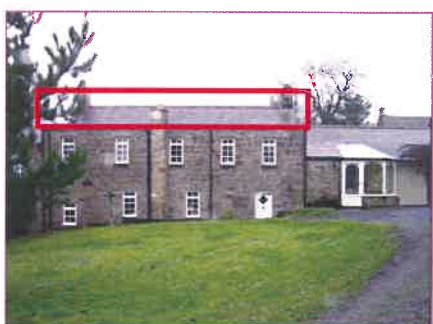
Figure 12 Parts of the northern elevation of the terrace –the red line contains unaltered pre-twentieth century roofline

7.6 The roof line (Figure 12) along this elevation is substantially unaltered, with no built insertions or roof lights other than on the northern extension to Carr Cottage. It is important that this historically intact roofscape is left unaltered and not punctuated by openings and dormers.

**9.9** The further introduction of roof lights and dormers should be resisted.

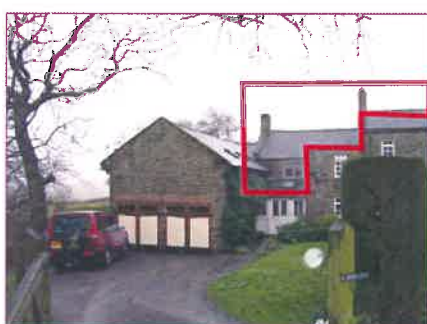
Figure 13 New windows that change the historic character of the south elevation of the terrace

7.7 The southern elevation of the terrace has not been the subject of extensions beyond the forward building line. It has, however, suffered as a consequence of the replacement of windows and the occasional regularisation of the shape and position of the fenestration (Figure 13). Windows are important because they form an integral part of the overall fabric of old buildings and add to their special character. A change to their style or appearance disrupts the overall harmony of the buildings and their historic setting. The style and colour of the new windows are not sympathetic to the age of the buildings. Some are fitted without a recess, which is an essential element of eighteenth and nineteenth century buildings.

**9.10** Whenever possible, inappropriate details and features should be removed and replaced by materials and styles that complement the eighteenth and nineteenth century origins of the surviving buildings.

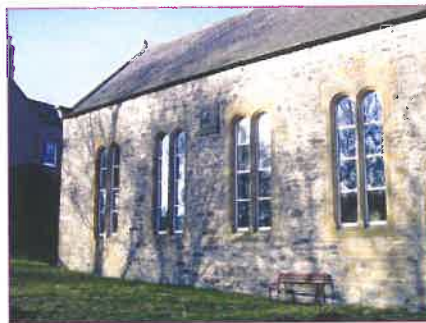
Figure 14 The south elevation of the United Reform Church

7.9 The United Reform Church and The Manse form the southern built edge of the conservation area. The church was built in 1725 and altered to a Gothic style in 1869 (Figure 14). An extension has been added to the north elevation, adding a domestic character to this façade. However, it remains an attractive building that retains much of its original charm, complementing the construction techniques used elsewhere in the village, including water tabling with stone corbelling and random stone walls with occasional coursing.

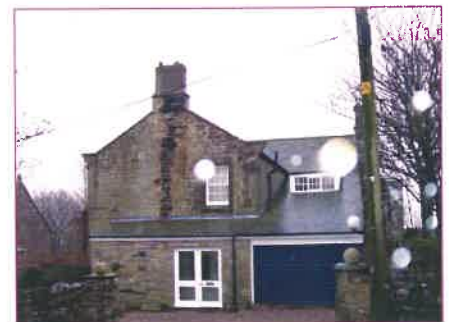
Figure 15 The north elevation of The Manse

7.10 The Manse, located to the west of the church, was built in 1854 to a solid mid-nineteenth century design. Features include irregular coursed stonework, a slate roof, water tabling springing from winged corbels, and regular fenestration. The 'L' shaped plan terminates in three gables facing north, east and west. The Manse has been extended to the west and north to produce a squared-off building. The single storey extension to the north extends across the full elevation, rising with a slate roof to blend into the original roof. The extension accommodates a double garage accessed by a single door. The modern additions diminish the historic character and appearance of The Manse.

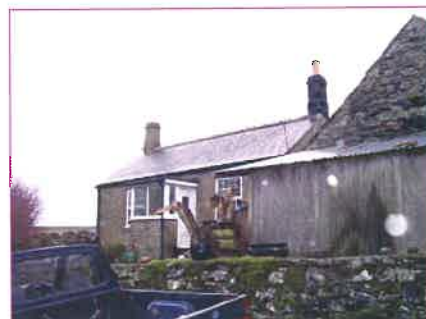
Figure 16 The west end cottage

7.11 A single storey stone cottage with a porch extension terminates views to the west from the terrace. It was built in the mid to late nineteenth century. A barn located immediately to the north of the cottage has a stone slate roof, and is the last surviving example of this type of traditional covering in the village.

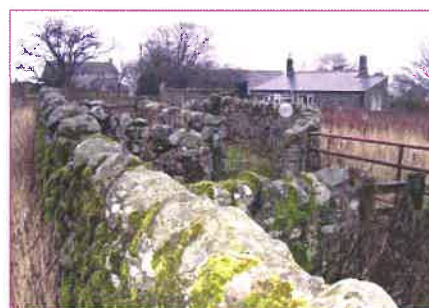
Figure 20 The sheep fold/dip

8.2 The former road to Thockrington bends past the front of the farm. The road is bounded on its eastern side by a stone wall that incorporates a sheep enclosure/dip arrangement, and an old cheese press from the farm house. The field between the boundary wall and The Manse, to the east, provides a counter balance to the field on the western edge of the conservation area, both of which protect the open setting to Great Bavington.
