*Tynedale*  
COUNCIL

# **NEWTON**

## Conservation Area Character Appraisal

**APRIL 2008**

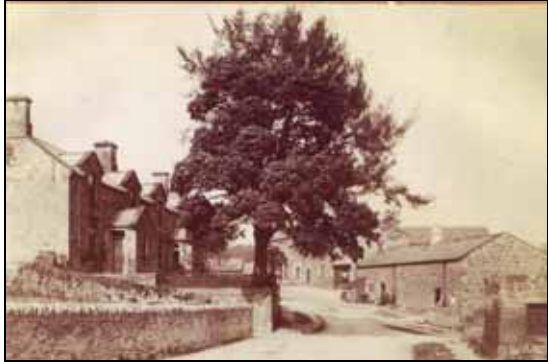
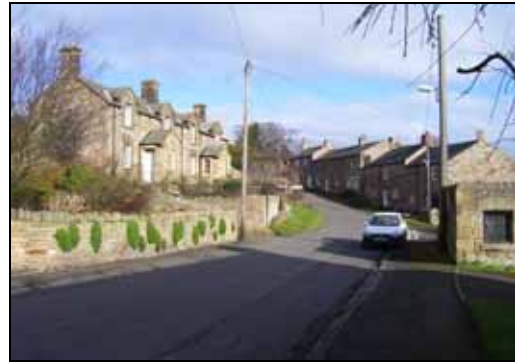
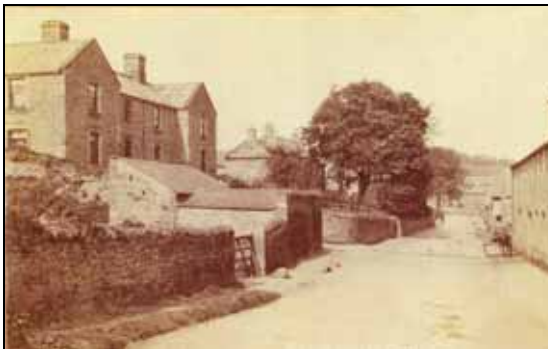
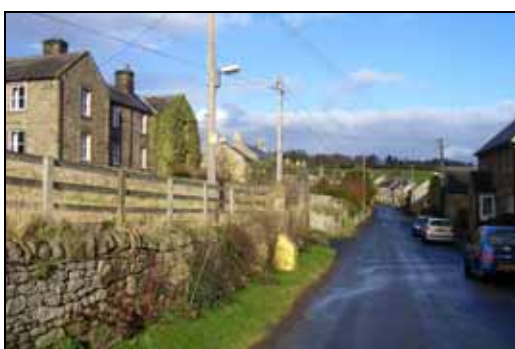
East end of village c.1900 with tree cover

East end of village 2006

West end of village c.1900 with tree cover

West end of village 2006

**Figure 3** Photographs showing the visual change to the nineteenth century character of the village following the felling of maturing hardwood trees

- 4.4.3 The village is relatively well planted with garden shrubs. However, early photographs from the late nineteenth/early twentieth century show the presence of a limited number of substantial trees in the gardens of properties on the northern side of the road, which overhung the carriageway to create a soft, green, spine to the settlement. The trees had reached maturity by 1900, that suggesting that they were planted in the early to mid-nineteenth century, about the same time as Town Farm was developed. The loss of the trees, as illustrated in Figure 3, has had a radical impact on the emerging appearance of the streetscape, in terms of colour, massing and structure. The trees filled the space between the built frontages, which, when exposed, creates a void and diminishes the skyline.

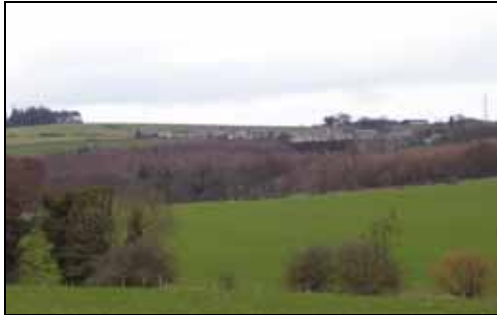
**Figure 4** Newton from south of the A69

4.6.1 Views to Newton from a southerly aspect are particularly important because of the impact that the settlement makes on the wider valley side. From the A69, the village appears to run along the edge of a valley fold, marking the crease with a single line of building mass (Figure 4). New development, together with modifications to older properties and changes of use from agricultural to residential purposes, has resulted in the presentation of a series of elevations, some with dormers, that take advantage of a south facing prospect and spectacular views across the Tyne Valley and beyond. This represents an alteration from the historic presentation of buildings that hitherto had simpler elevations with fewer windows overlooking the valley to, in parts, a suburban edge to the village (Figure 5). This is reinforced by the containment of gardens by panel fencing and conifer hedging. The loss of hedgerows has altered the traditional quilted pattern of fields that would have surrounded the village, but enough survive to trace their outline. Views to the village from other directions tend to be constrained by the channelling of roads with high banksides. This means that

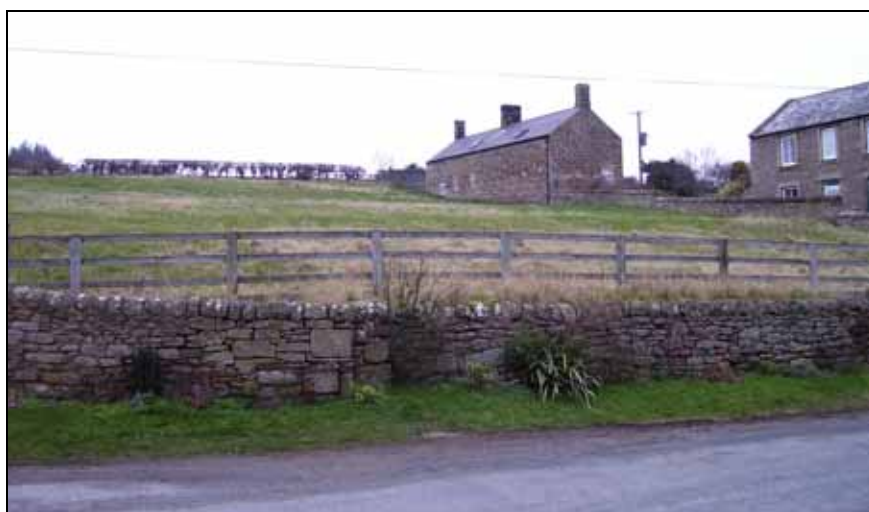
**Figure 11** Possible ancient development platform to the west of Newton House

5.2.3 Consequently, it is clear that successive developments will almost certainly overlay the village's earlier plan form and buildings. There is the possibility that the remains of earlier structures survive beneath extant buildings. There is also the possibility that parts of the lost village survive in gardens and open spaces. One area of potential interest lies within the field located between Newton House and West End Cottages where a levelled area suggests the presence of an ancient development platform (Figure 11).

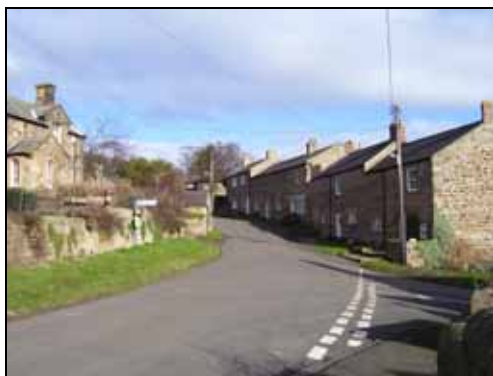
**Figure 15** View to east end Newton

The properties are built in blocks, two storeys high, that step down the street to reinforce the visual fall down the slope. There is limited fenestration overlooking the street, particularly at first floor level, giving a sense of strength to the buildings and containment to this space (Figure 15). A grassed gap halfway along the terrace provides a glimpsed view towards the landscaped containment of the village. Cartographic evidence suggests that this gap had been reduced in width and the backland developed between 1862 and 1921 with infill housing and the shop.

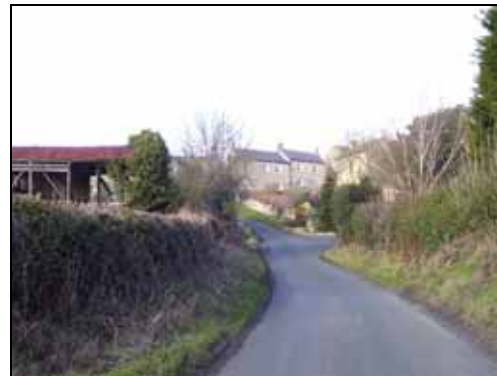
**Figure 16** View to the junction from the south

6.2.3 The junction of the main street with the approach road from the A69 (Figure 16) is visually dominated by this terrace, which is positioned on the elevated development platform that overlooks the valley. The set back gable of the terrace located to the east of the junction and a robust terrace, built between 1862 and 1921 ranged

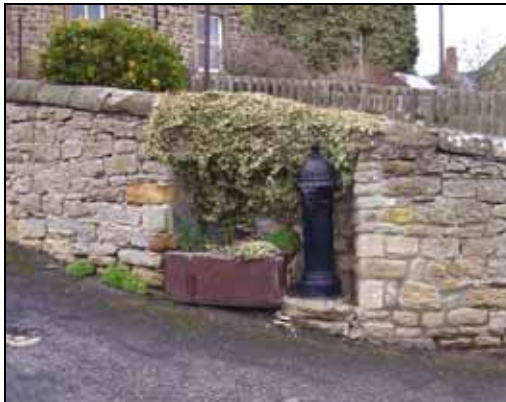
**Figure 17** The trough and hydrant

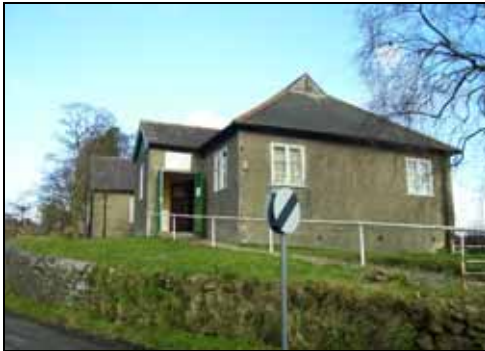
**Figure 21** The Women's Institute

- 7.2 The analysis starts at the east end of the village with the Newton and Bywell Community Hall (Figure 21). In 2006, what was the Newton Women's Institute building was demolished and replaced, on the same footprint, by the new Newton and Bywell Community Hall. The new building was architecturally designed to vastly improve the appearance of the old hall and to complement the architecture of the conservation area. The building anchors the eastern extremity of the built envelope of the village and brings visual interest and with it a statement that the social and community life of the village is thriving.

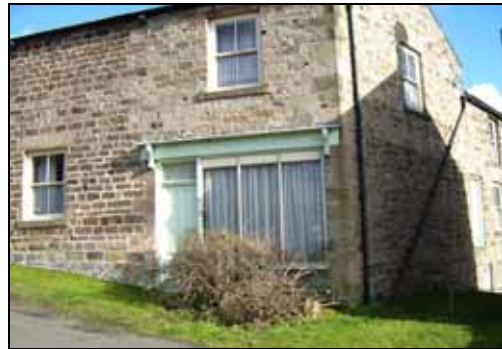
**Figure 22** The surviving shop front

that returns along the edge of the gap that bisects the terrace, are remarkable survivors from the origins of the building (Figure 22). They have been conserved and decorated in a sensitive manner that brings great quality to the architecture of the village. The retained design of the windows reflects the combination of domestic, retail and industrial uses that once occupied the building and as such add to the historic character of Newton. This building is noteworthy and its appearance should be conserved.

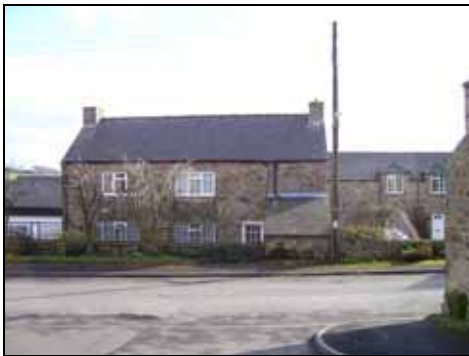
**Figure 23** The reconfigured front elevation

- 7.5 Moving to the west, the next group of buildings incorporating South Cottage and the former South Farm impact on the historic character of the village. This group made a robust, agricultural contribution to the streetscene and overall character of the village. The elevations that overlooked the road were plain and substantially without window or door openings. The buildings were converted into residential use in the 1970s. The conversions included substantial redevelopment that changed their shape, massing, height and appearance. The design of the conversion and redevelopment is typical of its period. The radical approach taken to the conversion of South Cottage and South Farm has diminished their contribution to the historic and visual character of the village. The original front building line of South Cottage was constructed along the back of the road with a single storey running through from the main two storey roof pitch. This single storey was removed and a new two storey building line, set back from the road edge, was constructed with extensions to the side and rear (Figure 23). The property has been manipulated and fenestrated in a way that makes it look as if it had been originally built as a detached house. South Farm has been treated in a similar way. The problem is exacerbated by the partial demolition of the farm to break-up a substantial 'L' shaped single building that faced the road and returned along the western boundary of the farmstead to form two detached houses. Furthermore, the partial open barn that enclosed the southern edge of the farmyard has been substantially demolished and rebuilt as a two storey detached house (Figure 24). The demolitions and introduction of domestic details, particularly the design of the fenestration, and the omission of lintels and the insertion of up and over double garage doors, has removed the agricultural origins of the complex to no more than visual hints. The eaves of some of the buildings have been penetrated by dormers. The conversion has resulted in the substantial removal

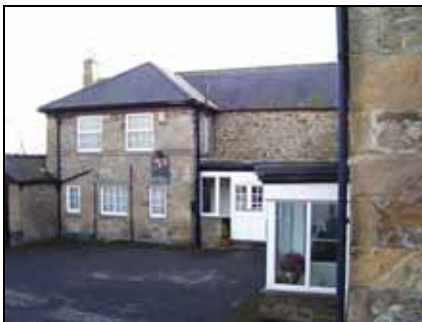
**Figure 25** Duke of Wellington

- 7.6 The Duke of Wellington public house, located to the west of South Farm, has been extended in the past, but still substantially retains most of its original fabric, except the fenestration that has been largely replaced by modern units. The original building is constructed in rough irregular coursed sandstone, the extension to the front being built in contrasting squared sandstone with an attractive first storey cill string line of slightly projecting dressed stone (Figure 25). A number of attractive details survive, including ventilated ceramic ridge tiles and metal pivoted brackets anchored to the walls from which the gates leading into Symm's Agricultural Engineering Works yard would have been hung (Figure 26). Such details are signposts to the history of the village and should be retained.

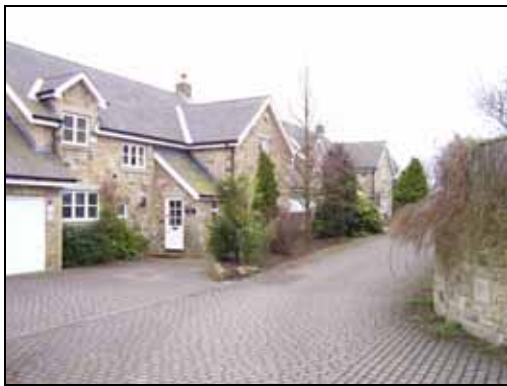
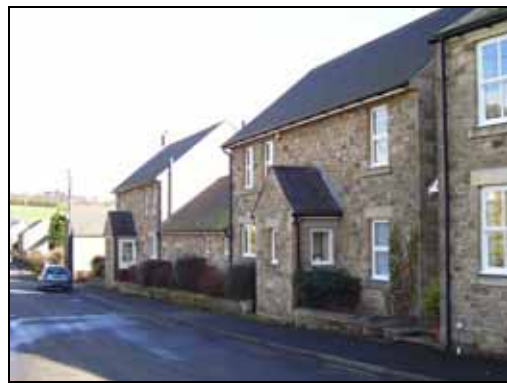
**Figure 27** Symms redevelopment

**Figure 28** New terraced frontage

- 7.7 Symm's works, to the west of the Duke of Wellington, was demolished in the mid-1980s, to be replaced by an infill housing scheme comprising two large stone faced detached houses along the southern edge of the site and a block of stone faced terraced housing fronting onto the street. The designs are clearly modern and do not attempt to confuse observers by appearing to be part of nineteenth century Newton (Figure 27). The detached houses are substantially hidden from view from the main street. Their principal visual impact is from the south, where they dominate views of the village from the wider valley. Their designs, particularly large fenestrated gables and white barge boarding, present a modern suburban appearance to the village which is reinforced by the design of the southern facades of the South Farm conversions. The terraced housing is slightly set back from the road edge to permit the construction of porches. The rhythm of the terrace is broken by the visually unnecessary insertion of a single storey link, possibly introduced to create aesthetic interest (Figure 28). This is not a common feature in Newton where terraced housing creates a substantial two storey containment of space. The stonework is random rubble with concrete lintels and sills. The steep pitch of the roofs adds weight and

height to the buildings, in contrast to the shallower, less invasive appearance of the roofs of the adjacent older properties, where the visual balance between walls and roof produces a less top heavy massing. The fenestration is modern, using non-traditional materials. The carriageway/courtyard area contained by the detached houses and the terraced housing has been laid in grey concrete blocks (Figure 27). This is an attempt to create a less formal, more traditional floorscape. The colour of the blocks is not appropriate to the village where sandstone setts would have been used to create hardstandings, as evidenced in the lane leading to Newton House where delaminating tarmac has revealed the original material. Retaining the colour of the traditional floorscape through the choice of appropriate modern materials would have reflected the historic character of the village within a contemporary development context.

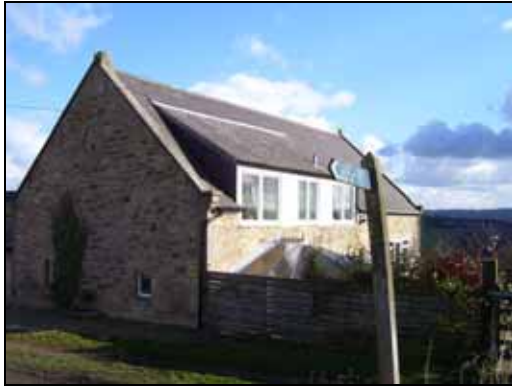
**Figure 29** Former Methodist Chapel

- 7.9 Until the end of the nineteenth century, the village terminated at this point. In 1899 the Methodist Wesleyan Chapel was built, West End Cottages being developed at about the same time. They combined to extend the boundary of the built envelope of the village further westwards. The chapel closed as a place of worship in the 1950s and was converted to residential use in the 1970s. The conversion has drastically altered the appearance of the building through the removal of lancet style windows and their replacement by rectangular openings; the insertion of a large bay window on the southern elevation and the addition of a long box dormer projecting from the west elevation with a conservatory almost reaching the base line of the dormer; and the addition of an integral garage. Architecturally, the building is now of little historic significance or aesthetic value, its principal contribution to the streetscape being a visual containment to the southern end of the village. West End Cottages are detached from the main built form of the settlement at its north west corner. The short terrace of three properties was built between 1862 and 1921. It is constructed in irregular coursed rubble with stone quoins, sills and lintels and timber vertical sliding sash windows. The Welsh slate roof is surmounted by two brick built chimney stacks. The cottages are designed without ornamentation and their simple, unaltered style and material content adds to the quality of the character of the area.

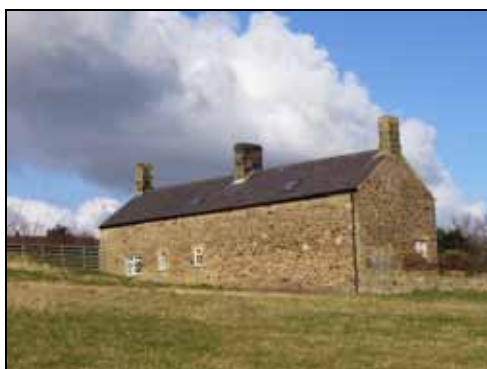
**Figure 31** Newton House

- 7.10 Moving along the northern side of the main street, Newton House is positioned some 100 metres from the road and set into the slope (Figure 31). It was built between 1862 and 1921. It comprised two properties, one of which housed the village post office until 1948. They were later converted into a single house. The house is built to a simple but attractive design in irregular coursed rubble with substantial dressed stone quoins, stone sills and stone lintels. New twelve and six light modern windows have replaced the original fenestration that would probably have been two light sliding sash units given the age of the building. Three stone chimney stacks surmount the roof. The lack of general ornamentation and minimal fenestration is typical of this building type and period in the village and as such it consolidates its overall character.

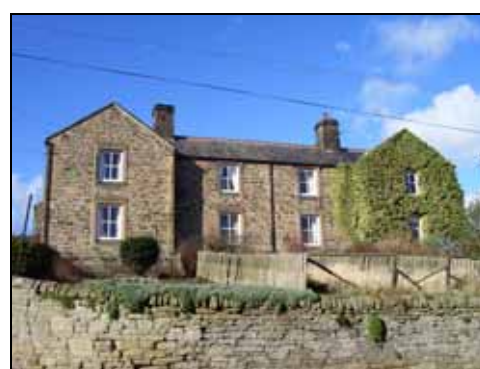
**Figure 32** Tofts Cottages

- 7.11 An impressive group of properties is ranged between Newton House and Town Farm House. Set back but fronting onto the main street, Tofts Cottages replaced an earlier building between 1862 and 1921. Tofts Cottages belies its name by being a substantial two storey group of four houses conforming to a suppressed 'H' footprint. There is a clear symmetry to the layout, and in the fenestration overlooking public space. The wings are set at right angles to the main street which is overlooked by flat gables. The building has offshoots to the rear. It is built in irregular coursed squared sandstone with substantial dressed stone quoins. The windows are set into complete dressed stone surrounds that project slightly from the main elevations. The windows are pivoted timber four light assemblies, probably replacing earlier sliding sash windows. They do not, however, detract from the general appearance and historic interest of the building which makes a considerable contribution to the character of the village (Figure 32).

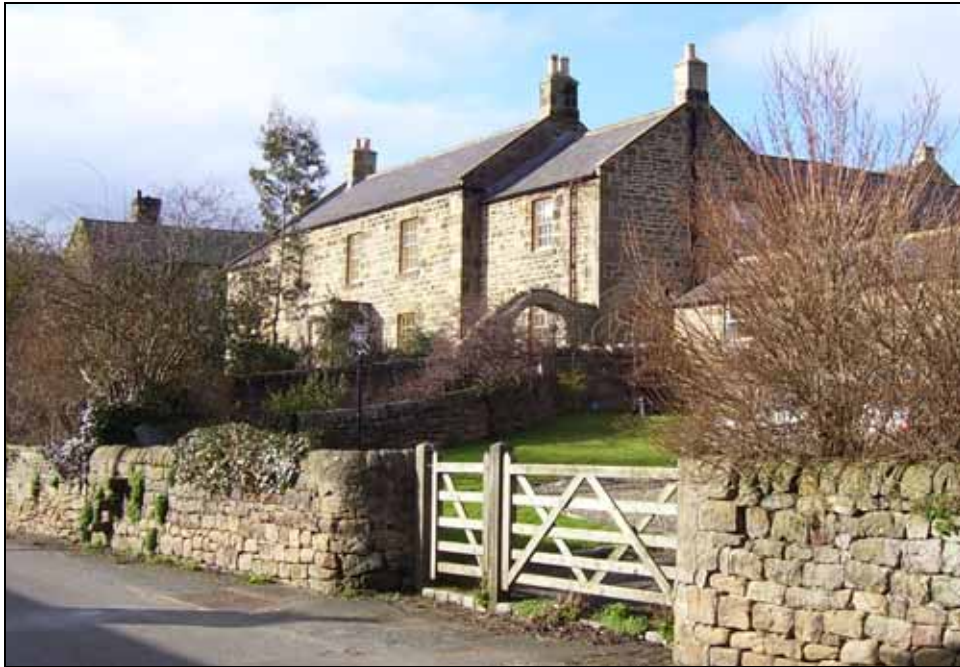
**Figure 33** Town Farm House

- 7.12 Town Farmhouse, to the east of Tofts Cottages, is of outstanding quality, retaining its original features and fenestration. Built in about 1830, it was the principal building of the adjacent planned farmstead. It has a central projecting portion with two

wings, one of which returns to form part of the planned range of farm buildings. The house is built in squared stone except for the west end bay which is coursed rubble. The windows are original sixteen light timber sliding sash units painted light tan that adds to their authenticity. The coped gables with corbelled stops, the fine chimney stacks and clay pots, and boarded doors complete the attractiveness of the house (Figure 33)

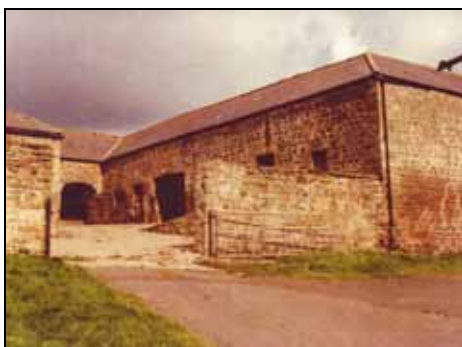
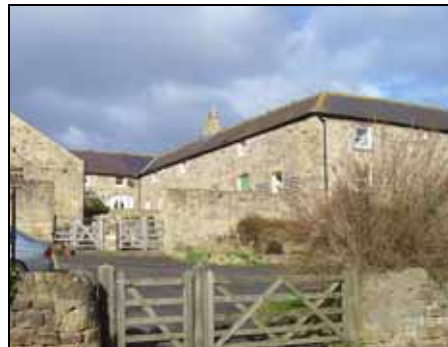
**Figure 34** Town Farm 1980 before conversion

**Figure 35** Town Farm post conversion

7.13 The adjacent 'U' shaped range of farm buildings has been converted to residential use. The conversion has retained the early twentieth century footprint of the agricultural holding and to a large part the arrangement of openings. Eaves line has not been interrupted by the insertion of dormers, but chimney stacks and vents have been added that break the hitherto flat roofline. This has resulted in a scheme that keeps much of the general visual integrity of the farmstead, including the impressive brick chimney stack that served the mechanically driven threshing/milling machines which replaced the need to house the horse drawn equipment in the gingan. The introduction of domestic fenestration in the openings impairs the quality of the conversion. For example, the use of windows designed to echo the pattern of the timber slatted units that once occupied the openings would have respected and related to the agricultural origins of the buildings. This is retrievable in the future if and when the existing units are replaced. The farmyard is subdivided into individual gardens/yards, but this fragmentation is substantially obscured from public view by the substantial, original yard boundary wall.

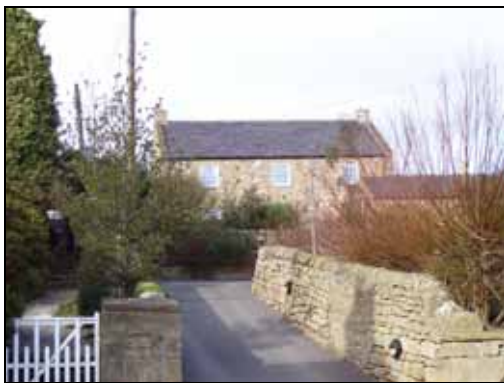
**Figure 36** New Town Farm development

- 7.14 Two new houses were built about the same time as the farm conversion, one to the north of Town Farm House (Figure 36) and the other to the east of the farm complex (Figure 37). Both are large detached properties built in stone with Welsh slate roofs. They have been designed to reflect the grandeur and period of Town Farm House, including the use of sixteen light windows. Although clearly modern, their style leans towards a suggestion that they form part of a group of early nineteenth century buildings, focussed on Town Farm House. Town Farm House is historically unique to the village and its contribution should not be diminished by copies. It would have been more appropriate to design the new houses in a way that they could make their own sympathetic contribution to the evolution of the development of the village.

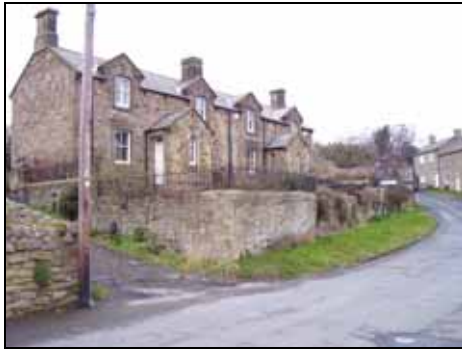
**Figure 38** Town Croft

- 7.15 Opposite the junction of the main street with the A69 approach road is another high quality group of late nineteenth /early twentieth century properties (Figure 38). This group acts as a visual counterweight to Tofts Cottages at the western end of the main street. Constructed between 1862 and 1921 and replacing an earlier building, Town Croft is attractively designed with a level of detailing that is uncommon throughout the rest of the village. It is built in irregular coursed squared sandstone with stone quoins. There are four pitched dormers over first and second floor windows. The dormers have water tabling with substantial stone corbelling. The windows have continuous dressed stone surrounds with carved details. The four light sliding sash fenestration is original. Two stone built pitched roof porches project beyond the front building line. They are decorated by tall six light arched windows overlooking the main street. The fenestration is original. This group is of outstanding quality and its unaltered appearance and design interest makes a substantial contribution to the character of the village.

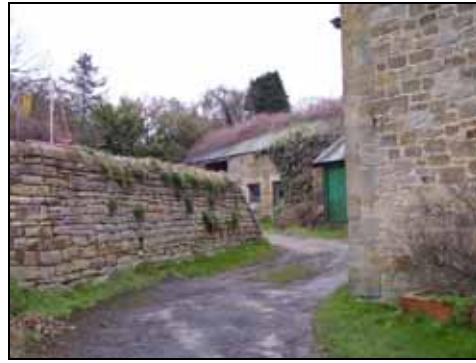
**Figure 39** Buildings behind Town Croft

- 7.16 A number of dilapidated stone buildings are located behind Town Croft (Figure 39). Their appearance suggests that they have agricultural origins and cartographical evidence indicate that they were built at the end of the nineteenth century. They are of historic interest and should be retained.

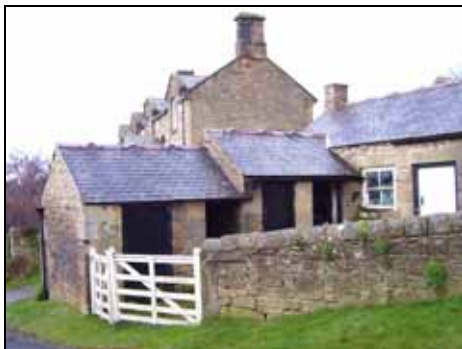
**Figure 40** Agricultural workshops

- 7.17 The north side of the village is terminated by a small group of single storey buildings that is ranged at right angles to the main street (Figure 40). The back unit with a chimney stack might have been used as a cottage. The group is an attractive stone built collection with an original four light sliding sash window. It is substantially built with stone quoins, sills and lintels with ceramic ventilated ridge tiles that match the appearance of those found on the Duke of Wellington. This group is visually attractive, unaltered and of historic importance.

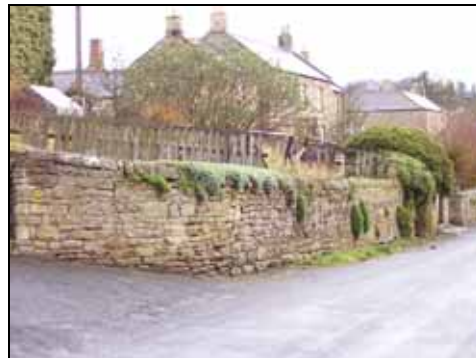
**Figure 41** North side retaining wall

- 7.18 A stone wall runs along the length of the northern side of the main street between Tofts Cottages and the east end (Figure 41). It is substantial, but in a state of disrepair in places, particularly where it returns along the lane approaches to Tofts Cottages and Town Croft, and is showing signs of salt erosion along its base. It has been patch repaired in the past using cements that occasionally obliterate part of the stonework. The wall contains a stone stile to the front of Town Farm and two water troughs with ornamental cast iron hydrants. The wall is a significant structure and makes an extremely important contribution to the attractive appearance and character of the village.
