OVINGTON

Conservation Area Character Appraisal

April 2008

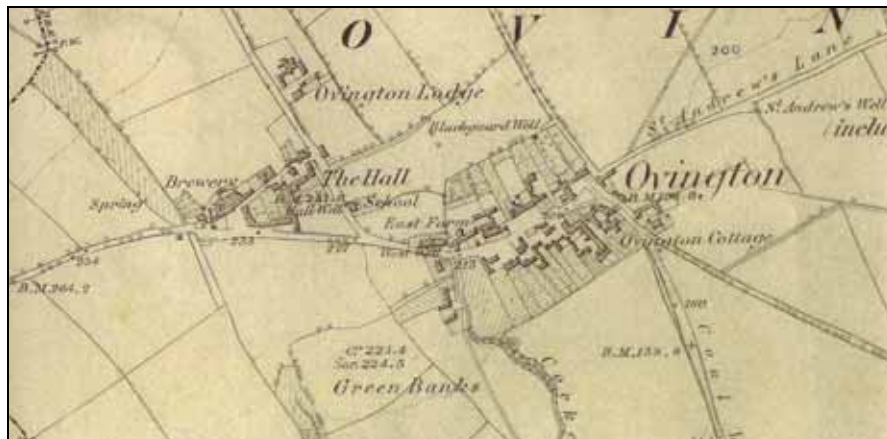
Figure 8 Ovington 1862 Ordnance Survey

- 5.1.8 The changes from 1862 onwards can be identified through an appraisal of Ordnance Survey plans. Figures 8, 9, 10 and 11 show how the shape of the village has changed and Figure 12 summarises the extent of change over the last 100 years.

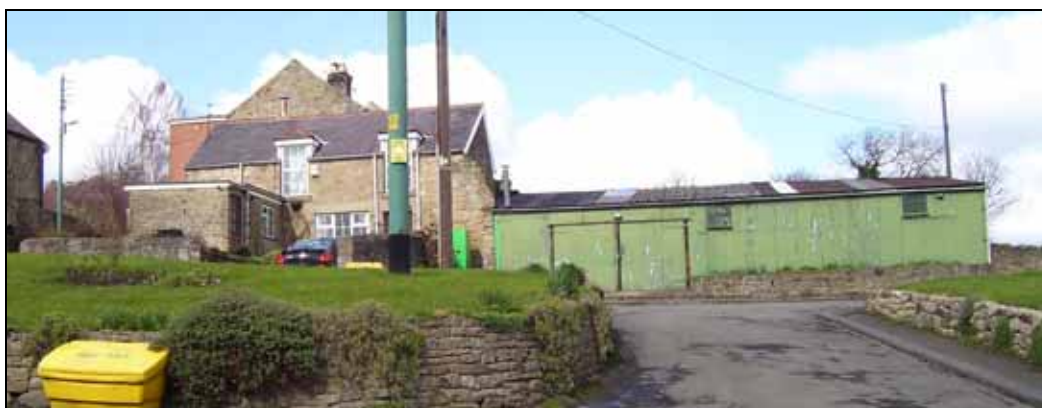
- 7.2.9 Dene View Cottage is a single storey mid-nineteenth century house that was altered in the 1950s by the addition of a flat roof extension to the south (front) elevation. The east elevation, where it joined the lost buildings, is built in random rubble, and the south elevation is built in a random pattern with regular shaped stones. Two dormers that break through the eaves have been inserted to form two storey accommodation. The cottage has been altered in such a way that its original form and appearance have been largely lost.

Figure 32 Dene View Cottage with remains of lost properties against the eastern gable and metal workshops

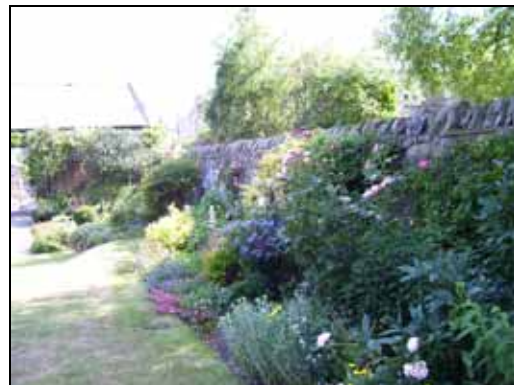
Figure 38 Holly House boundary wall

- 7.3.1 The northern side of Area 2 runs from Holly House to Leazes Cottage. Holly House is an attractive late seventeenth century detached property with a range of buildings to the north that have been converted into ancillary residential use. Holly House is constructed in coursed random rubble sandstone with a Welsh slate roof, raised gables and stone chimney stacks. A flat roofed extension has been built onto the rear elevation. New windows have been inserted into original openings. A window has replaced the former front door. A fine stone boundary wall that makes a significant contribution to the street scene returns along the side of the garden between Holly House and East Farm (Figures 37 and 38).

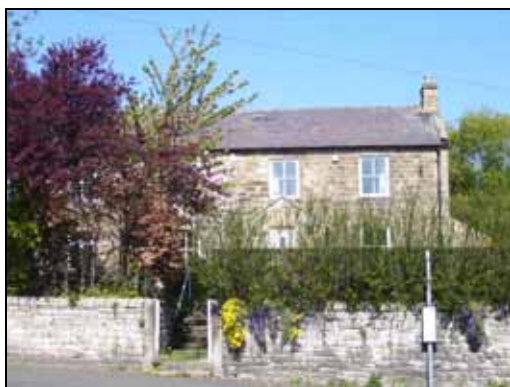
Figure 39 East Farm

- 7.3.2 East Farm is located immediately to the west of Holly House. The building is of a fine late seventeenth century/early eighteenth century appearance. The 1862 Ordnance Survey shows that a large range of outbuildings were linked to the northern side of the farmhouse. These have been lost to accommodate the Springfield development. It is probable that the house was extended in the past, with the west half being constructed in coursed rubble stone, and the remainder in regular coursed sandstone. A modern porch that fits comfortably with the character of the original building has been added to the front. The roof is Welsh slate with raised gables supported at eaves level by projecting stone corbels. The window openings are original with modern replacement timber window (Figure 39). Access to the lost agricultural buildings and land was via a drive between Holly House and East Farm. This survives as a green drovers path accessed from the main street by a five bar gate supported on the western side by an ancient timber post (Figure 40). The front of the property is contained by a fine stone wall that returns along the western boundary to contain the remains of the garden. The wall along this edge probably incorporates the remains of the former farm outbuildings. It has been punctured by a large and ungainly garage door. The combined impact of Holly House, East Farm, the gated link to the former agricultural buildings and the stone boundary walls is of high group value and establishes an historic anchor point for this part of the village.

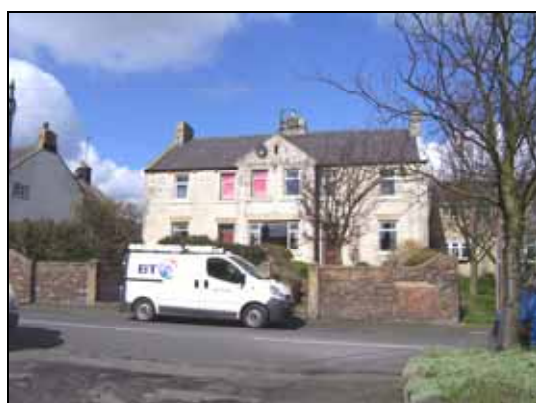
Figure 41 Laburnum House and Poplar House

- 7.3.4 Laburnum House and Poplar House, located to the west of the access road, were linked to the lost properties. They were built in the late nineteenth century as a single property with a central bay. The building is of brick construction with a mixed random rubble and rubble coursed west gable, and a rendered wall where it joined the lost properties. The central bay has been altered by the introduction of a large single picture window on the ground floor. The other window openings are original with modern top hung casement replacement frames. The roof is of Welsh slate with raised gables and brick chimney stacks (Figure 41). The front brick boundary wall has stone copings and gateposts. It is of particularly high value in the streetscape as it terminates the historic building line to the west of the access road which leads to the Springfield estate. (Figure 42). The back garden survives, although sub-divided, together with some outbuildings.

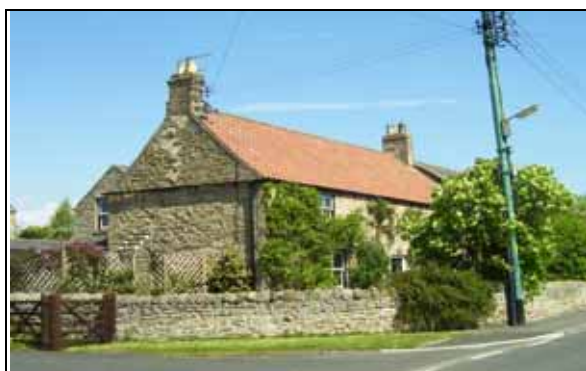
Figure 43 West Farm

- 7.3.5 Moving to the west, the next group of buildings are the remnants of West farm and adjoining buildings. The 1862 Ordnance Survey shows that the farm had an extensive range of outbuildings as did the adjoining properties. The early-nineteenth century Storehouse and Greystones that are built onto the eastern gable of West Farm have been altered. They were both extended in the twentieth century to provide shop premises and a post office. The post office to the front of the Storehouse has been removed and the property restored back to a house with altered window openings. The pitched roof shop to the front of Greystones has been converted into a two storey house through the addition of a box dormer to the front

elevation. Originally, the two buildings formed a modest but attractive terrace (Figure 20). They have radically changed in appearance and their main contribution to the historic character of Ovington is as a roofscape where the principal, original, roofs are uninterrupted by modern dormers or rooflights (Figure 21). Parts of the outbuildings of Greystones survive in the subdivided back garden. West Farm, a grade II listed building, is the remnants of a substantial complex of agricultural buildings. The surviving farmhouse is thought to be seventeenth century in origin, the profile of the roof suggesting that it was originally thatched. It is constructed in coursed sandstone with nineteenth century sash windows in earlier original openings. The front roof span is new clay pantiles and the rear span is welsh slate. The building survives to make a substantial contribution to the historic character of the village (Figure 42). The adjacent farm buildings have been demolished and the site has been redeveloped. Three detached houses have been built, none of which add to the historic character of Ovington. Two, The Granary and the Willows are located outside the conservation area. However, the Granary impacts on the conservation area by virtue of its size and high visibility through the gap on the main street created by the construction of its access drive. The third modern building, Barn House, fronts onto the main street and generally complies with the footprint of a former agricultural building. It is a modern stone built bungalow that neither complements the appearance of the historic core of the village nor reflects, through its design, the agricultural character of what was probably the largest farmstead in the village.

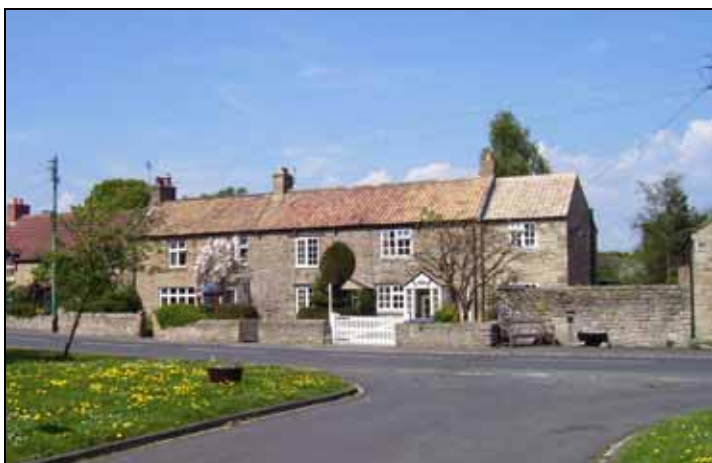
- 7.3.7 A high stone wall is located between Evenwood Cottage and Barn House. It is set back from the road and is built over the culverted Cockermere Burn. The remains of a pump and trough are positioned on and by the wall (Figure 44).

Figure 44 Evenwood Cottage, Evenwood, Jasmine House and Leazes Cottage and the high link wall over Cockermere Burn

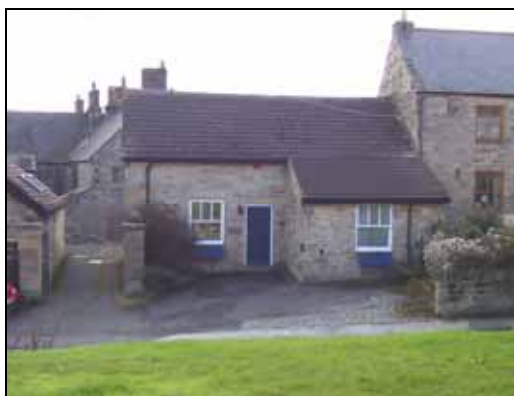
Figure 46 Post House

- 7.3.8 Moving to the south side of Area 2, the analysis starts at the eastern end with Post House and terminates with Hunters Cottage.
- 7.3.9 Post House is located to the west of Gardener's Cottage. It was formerly a post office and shop, and was converted to residential use in 1994. It is single storey, with a first floor added into the storage area through the insertion of a dormer window on the south roof span. The elevation overlooking the main street is constructed in regular coursed sandstone, the exposed east elevation being irregular coursed rubble sandstone (Figure 45). A catslide roof extension has been added to eastern end of the front elevation. It has a concrete pantiled roof. The Post House has an open frontage to the pavement. Ivy Cottage is joined to the western gable of the Post House. Ivy Cottage is a two storey house probably dating from the late eighteenth century. The main elevation is constructed in squared coursed sandstone with a coursed random rubble finish to the exposed eastern gable. The windows are regular in shape with modern timber inserts. An extension has been added to the western end of the building to accommodate a garage on the ground floor. The roof is modern Welsh slate. The building has been modernised in a manner that does not impair its general contribution to the streetscape (Figure 46). The property is contained at the front by a modern/repared stone boundary wall that reflects the traditional containment of front gardens in the conservation area.

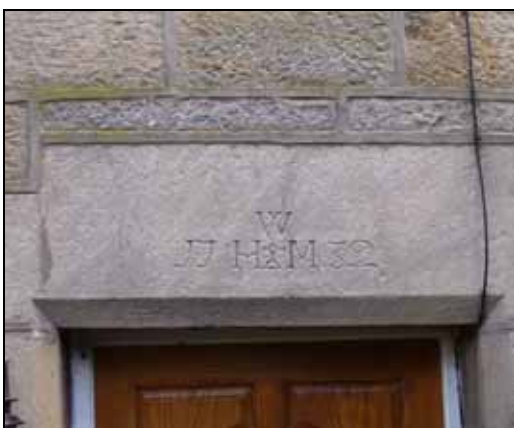
Figure 48 Elrigg House datestone

- 7.3.10 Elrigg House and Peartree Cottage form a single building but with two contrasting halves. Elrigg House, to the east, is constructed in squared coursed rubble, whereas Peartree Cottage, to the west, is heavily pointed random sandstone. The two overlap and blend together in the middle. Elrigg House incorporates a carved stone dated 1732 (Figure 47). This is probably an original feature. A window above the datestone has been blocked-up. Modern windows have been inserted into altered openings. The blend of stonework suggests that Peartree Cottage replaced the western half of the original building. The roof is hipped at both ends and covered in Welsh slate. Early photographs show that at the end of the nineteenth century the roof terminated in straight gables. The 1862 and 1898 Ordnance Surveys illustrate a long range of buildings extending to the south of Elrigg House. This, together with anecdotal evidence, suggests that the buildings formed a substantial agricultural complex. The range of farm buildings has been substantially lost, and that which remains has been altered to provide residential accommodation. Elrigg House and Peartree Cottage, although altered, are of historic and architectural interest (Figure 48).

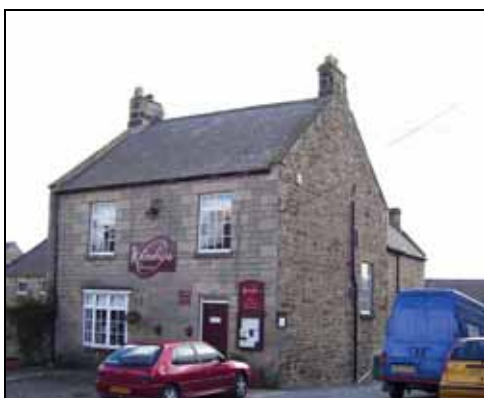
Figure 50 Winships

7.3.11 Winships, joined to Peartree Cottage, was formerly the Ship public house. It was built in the mid to late eighteenth century with nineteenth century alterations. The principal elevation overlooking the main street is constructed in ashlar coursed stone with fine stepped stone surrounds to the window openings. The window on the ground floor has been altered to accommodate a modern bay window. Raised gables and stone chimney stacks contain a Welsh slate roof (Figure 49). The exposed west gable is coursed random rubble. The rear wing, which 'squares-off' the mass of the building with Peartree Cottage, may pre-date the front part of the building. The extension includes a first floor projecting bay window that rests on a stepped stone plinth. Although reglazed, the bay window remains largely unaltered (Figure 50). Winships is a fine building that is of architectural and historic significance.

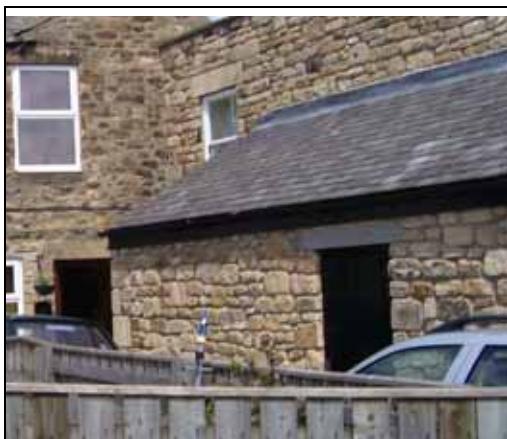
Figure 51 The Malthouse

7.3.12 The land behind Winships has changed over time. The range of outbuildings linked to Peartree Cottage has been partly demolished and partly converted into a house,

the Malthouse (Figure 51). Three new houses, Mash Tun, The Sheiling and The Maltings have been built in the area behind Winships and Peartree Cottage/Elrigg House. The three detached properties are separate and of different designs. The Maltings incorporates stone details from the cottage that it replaces, giving some context to the rebuild. However, its southern elevation overlooking the valley is crowned by three large dormer windows with white infill panels and frames, which together with the neighbouring Sheiling, dominates views of the southern edge of Ovington to give it a contemporary appearance that belies its historic character (Figure 52).

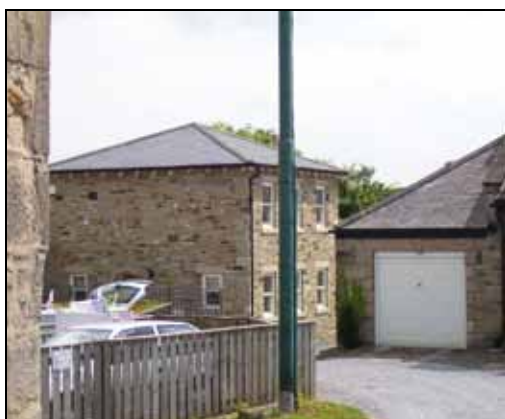
Figure 53 South of Winships

7.3.13 The original nineteenth century linked layout of farm buildings has been lost, to be replaced by a disparate arrangement of late twentieth century properties that belie the original historic built pattern, and, as such, diminish the historic character of the area (Figure 53). A fine stone boundary wall some twelve feet high contains the western edge of this area, and is of considerable importance in defining the historic plan form of the settlement (Figure 54).

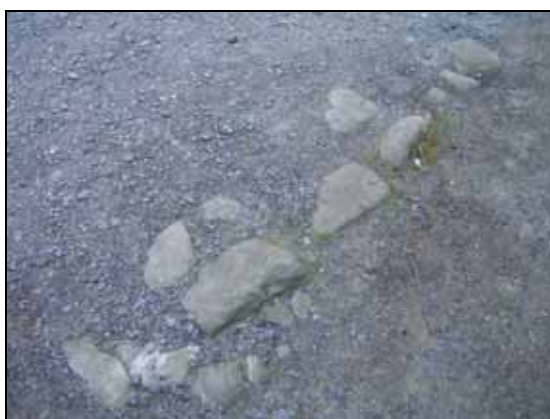
Figure 55 Surviving cobbled surface

7.3.15 Little Buildings is set back from Front Street to create an informal village square that is now occupied by a raised planting bed, but historically was an area of hard surfacing. There are small areas of exposed rough cobbling in this central area that illustrate the type of metalled surfacing that was probably typical in Ovington during the nineteenth century (Figure 55). The 1898 Ordnance Survey shows that a smithy,

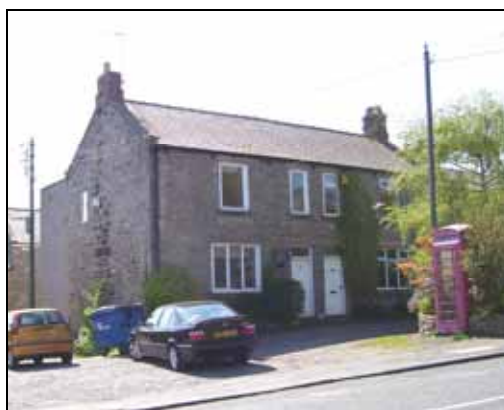
Figure 56 Little Buildings

now lost, was located between Little Buildings and the main street. Little Buildings probably dates from the early to mid-nineteenth century, with the west end being added in the late nineteenth century. The length of terrace of Little Buildings that fronts onto the main street is built in coursed random rubble with substantial stone quoins. The window openings conform to a symmetrical pattern. They have substantial stone cills and lintols, and appear to be original, with modern inserts. The roofs are Welsh slate with raised gables. The front elevations make a pleasing and robust contribution to the appearance of the historic core of the village. The uncluttered and unaltered roofscape is of particular value (Figure 56). Unfortunately, extensions to the rear elevations are of a poor quality. They are generally flat roofed two storey boxes that cramp the space between Little Buildings and South View, and introduce bland modern elements that have no design resonance with the remainder of the area (Figure 18).

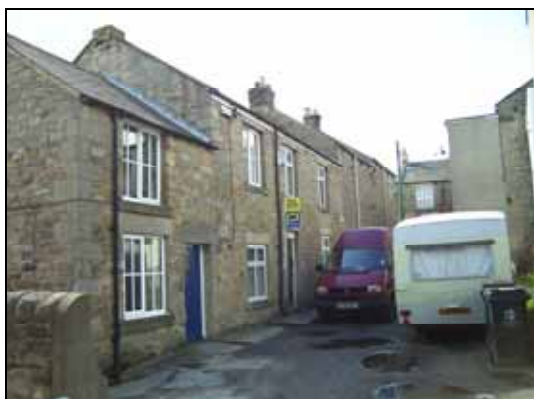
Figure 57 South View

7.3.16 South View runs parallel to the main street to the north of Little Buildings. It is a terrace of houses dating from the early to mid nineteenth century that steps down the slope from west to east (Figure 57). An external brick block of outbuildings was added in the late nineteenth century (Figure 58). The terrace, which shows signs of phased development through gutter support and quoin work, is built in random coursed stonework, with brick chimney stacks and Welsh slate roofs. Original window openings survive with modern infills. The terrace is attractive, but overshadowed by the flat roofed extensions to Little Buildings. The floorscape is pitted asphalt leading to a grassed area where the external toilets are located.

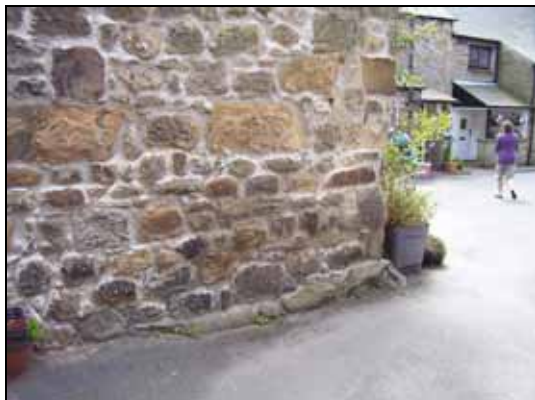
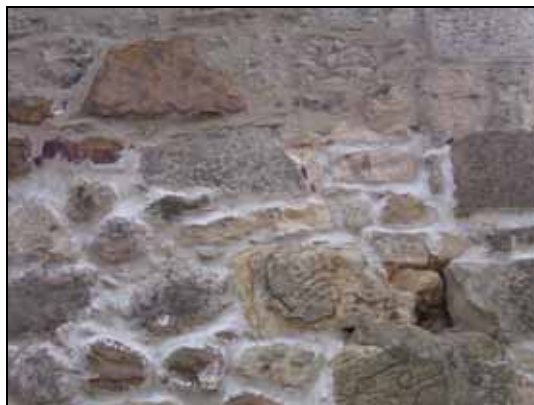
salvaged from an earlier building. There is evidence of the original pitched roof gable line at the interface of first and second floor levels. (Figure 60). The first floor was added in the first half of the nineteenth century. The house was built as two dwellings and converted into a single house. It is of good quality, with a Welsh slate roof and raised gables. The earlier phase of development adds historic value to the property, and the contribution that it makes to the conservation area (Figure 61).

Figure 59 Steward's House ground floor **Figure 60** Steward's House – pitch line of earlier single storey cottage

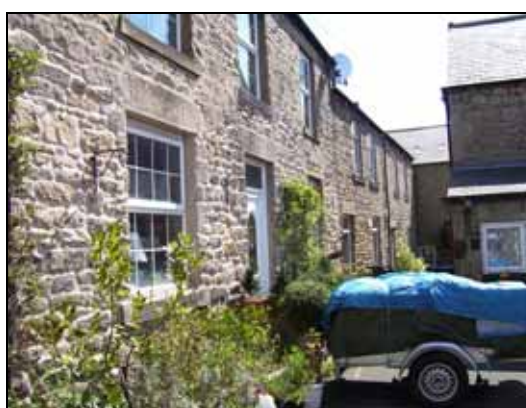
Figure 62 Little Buildings to the south of Steward's House

7.3.18 The remainder of the terrace might also incorporate fragments of earlier buildings, the rubble stonework at ground floor level being composed of much smaller units, compared to the larger, squared stones at first floor level. This length of terrace is of a more modest design, but links with Steward's House to complete a fine range of buildings (Figure 62).

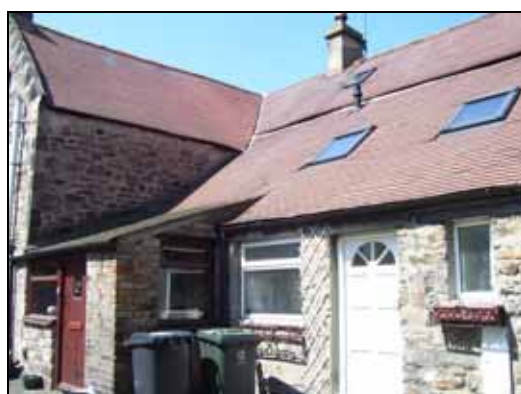
Figure 65 Back of Lynn House and White Cottage

7.3.19 Thompson's Buildings, at the southern end of Little Buildings, is an attractive pair of dwellings that probably dates from the early to mid-nineteenth century (Figure 63). It is a two storey stone built property with a Welsh slate roof. Cosy Neuk and its neighbour, to the west of Little Buildings, form the third side of a small courtyard contained to the north by White Cottage and Lynn House, and to the west by the former Highlander Inn. Cosy Neuk was probably built first and added to by its neighbour to form a short terrace. Both properties have been extended in a way that does not greatly diminish the contribution that they make to the general form and character of the space (Figure 64). The backs of White Cottage and Lynn House have also been extended by the construction of a catslide roof addition at ground floor level. It is possible that the extensions are early, and have been re-roofed

(Figure 65). White Cottage has a pitched roof return with an attractive crow-stepped stone gable. Brick Cottage was added to the eastern gable of White Cottage in the twentieth century. The west side of the courtyard is formed by the east hipped roof gable of the former Highlander Inn. It is of a simple, coursed random rubble construction, and provides a robust counterpoint to Steward's House (Figure 66). The courtyard is an attractively enclosed space that adds variety and visual interest to the historic character of the area.

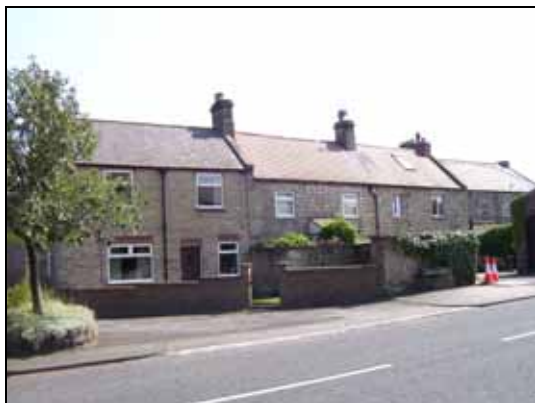
Figure 67 Brick Cottage, White Cottage and Lynn House

7.3.20 Lynn House, White Cottage and Brick Cottage front onto the Main Street where they make a strong contribution to the street scene (Figure 67). The replacement of ground floor windows to White Cottage with larger units supported by concrete sills and lintols is the only strikingly discordant note, but one which does not adversely impact on the general contribution that the terrace makes to the visual character of the historic core of the village. Further erosion of the integrity of the appearance of the terrace should be avoided. Lynn House and White Cottage are probably eighteenth century, and are constructed in squared coursed rubble, Lynn House predating White Cottage. Photographs show that Lynn House, formerly the Mason's Arms, had a stone flag roof in the nineteenth century, to be replaced by a red tile roof. Brick Cottage is an attractive and sympathetic later extension of the terrace. It is constructed in white colliery brick with contrasting red brick cills and lintols, and a Welsh slate roof.

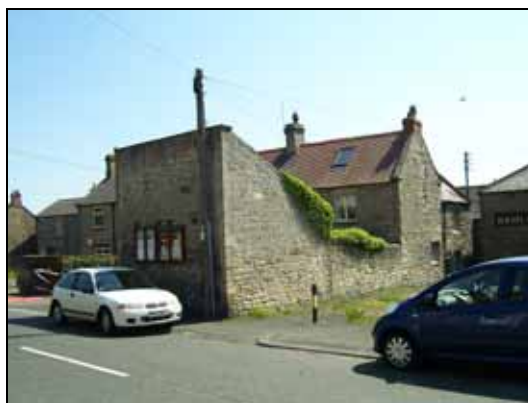
Figure 68 Mono-pitched building

7.3.21 A monopitched stone building is located between Lynn House and the main street. Its origins are uncertain, but it appears to have been built in the early twentieth century. It presents a blank stone gable to the main street. There are similarities between the quoin work on the early photograph and the surviving gable return to suggest that this is the case. The building, although much changed and fragmented, is an important part of the history of the village (Figure 68).

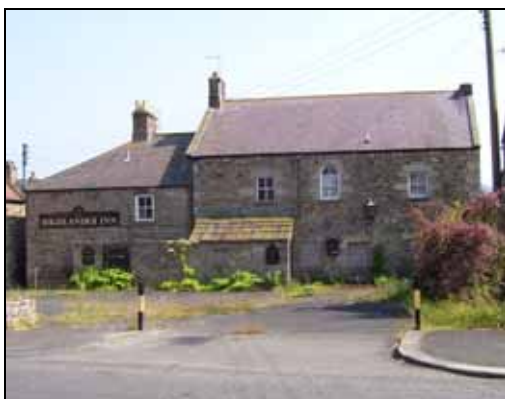
Figure 69 Former Highlander Inn

7.3.22 The former Highlander Inn was probably built as a house in the eighteenth century. It was sympathetically extended to the east in the early nineteenth century, possibly to provide four back-to-back dwellings. A terrace of houses, now lost, was built in the forecourt in the latter half of the same century. Both the main building and the extension are built in coursed random rubble. A lean-to porch to the front has a stone flag roof, the remainder of the building being roofed in Welsh slate, with raised gables and stone corbelled gutter supports. It is probable that the Welsh slate replaced stone flags to reflect the finish of the porch and the neighbouring Lynn House. The principal elevation to the north has a fine arched window at first floor level. The window openings, supported by substantial stone lintols and cills, appear to be original with late nineteenth century four light sliding sash window inserts. The forecourt is an abandoned car park. Cartographic evidence indicates that it was unenclosed in the mid-nineteenth century. The Highlander is a high quality building that makes a substantial contribution to the character of the conservation area (Figure 69).

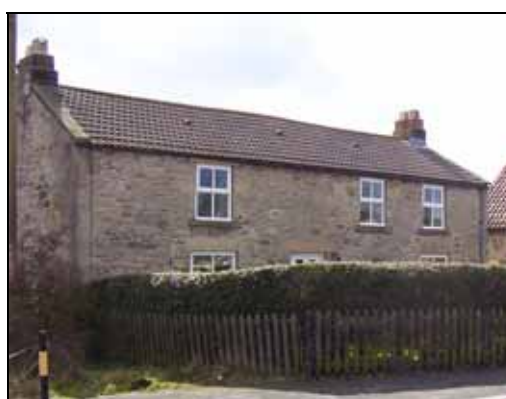
Figure 70 Hunters Lodge

7.3.23 Hunters Lodge, to the west of the Highlander, is another fine coursed random rubble building, possibly dating from the eighteenth century. It could have been built as two dwellings – the 1898 Edition Ordnance Survey shows this arrangement. Although altered, with modern window inserts, the building continues to make a good contribution to the historic core, with the exception of the concrete tiled roof that adds an element of modernity, detracting from the historic integrity of the structure (Figure 70). Hunters Cottages are built to the west of Hunters Lodge. The cottages are Grade II listed buildings that date from the seventeenth or early eighteenth century. They are a single storey terrace, built in random rubble, with crow-stepped gables and a clay pantiled roof. It is probable, given the pitch of roof and its age, that the building was originally thatched. They are listed because they are a rare

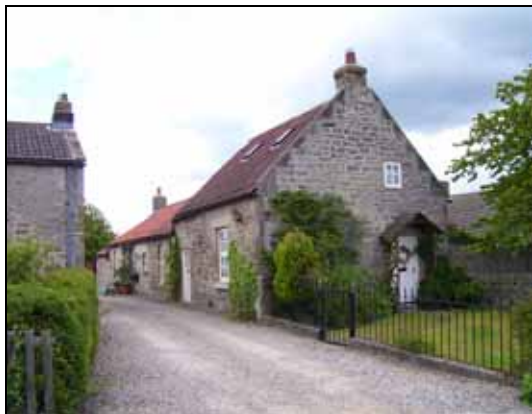
Figure 71 Hunters Cottages

example of a linear farm, with a cottage linked to a stable and byre. The buildings have been sympathetically converted to dwelling houses in a manner that generally retains that visual character of the former farm (Figure 71).

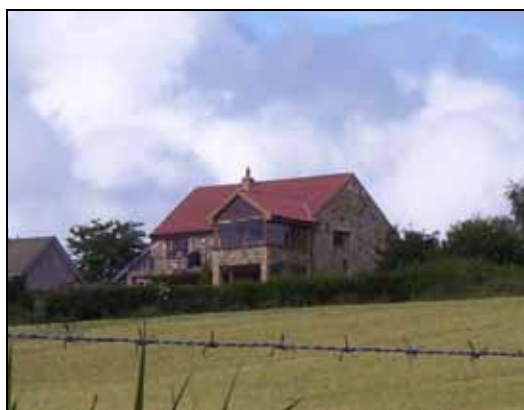
Figure 72 Hunters Croft from the south

- 7.3.24 Two new houses, Hunters Croft and Jubilee Cottage, have been built on land to the north of Hunters Lodge and Hunters Cottages. They introduce large modern elements into the conservation area that have a particular impact on views of the southern edge of the village (Figure 72).

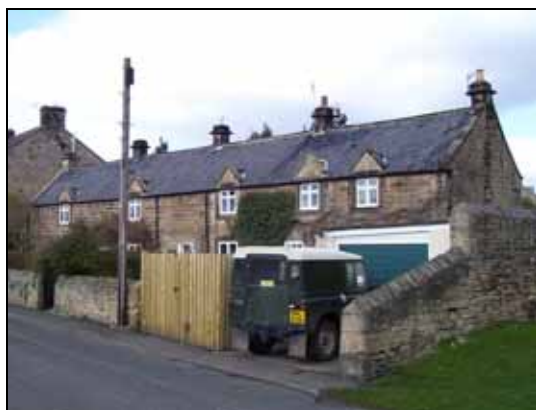
Figure 73 Jubilee Terrace

- 7.5.1 Area 4 focuses on the Old Brewery complex and Ovington Hall Farm. The former brewery is approached from the east by Jubilee Road, which moves past the playing fields to a terrace of houses built in the mid to late-nineteenth century (Figure 73). They are a fine group of buildings that might have been built to accommodate brewery or farm workers. They are two storey cottages with pitched dormers at eaves level. They are constructed in squared, coursed rubble with stone chimney stacks and a Welsh slate roof. There are raised gables at each end of the terrace, supported by projecting stone corbels. The windows are set in stone surrounds with new insertions. The front gardens are generally contained by the original stone boundary wall. A modern garage has been built in the front garden of 1 Jubilee Road, where the boundary wall has been replaced by a high timber fence. This introduces a discordant element into an otherwise extremely attractive group of buildings. Jubilee Road is terminated by Stonecroft, an early twentieth century detached house. Stonecroft is an excellent example of a building of its type and period. It is built in coursed random rubble, with a Welsh slate roof and raised gables supported by projecting stone corbels. Stone chimney stacks surmount the raised gables. A projecting stone string course and a stone weather board supported by stone brackets over the front door decorate the principal elevation. A garage has been added (Figure 74).

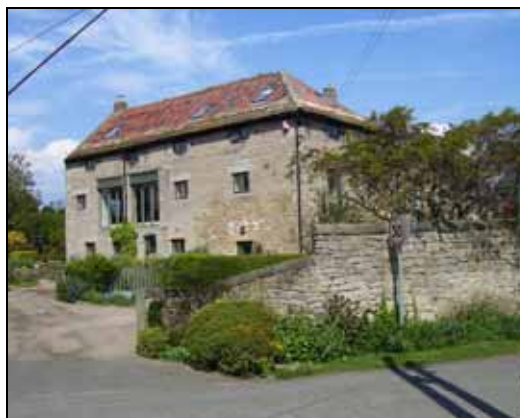
Figure 76 The Old Brewery

7.5.3 The building to the west end of the site, The Old Brewery, has been sensitively restored to keep the principle design features and, through the application of appropriate techniques, has retained its character. It dates from the eighteenth century, possibly including the remnants of earlier buildings. It is constructed in random rubble with a mixed slate and pantile hipped roof. The building incorporates Yorkshire sash and shuttered windows with a granary door and ventilation slits. It is a Grade II listed building (Figure 76). West End Cottage, which neighbours The Old Brewery, marks the western extremity of the conservation area. The Cottage has been extended to the west with the addition of a dormer window and porch to the front elevation.

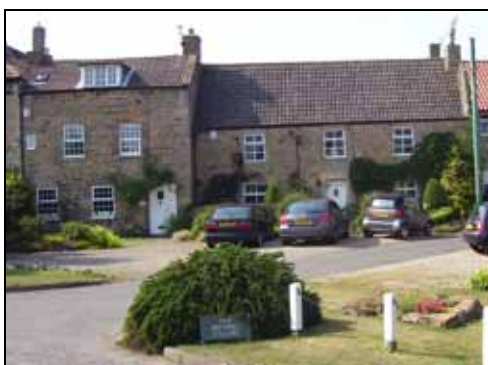
Figure 77 Old Tunnery & Brewery House **Figure 78** Westgarth & Brewery Cottage

7.5.4 The Old Tunnery and Brewery House to the east of The Old Brewery have been retained and upgraded to provide contemporary residential accommodation. Their general appearance, in terms of massing and window and door openings, has remained unchanged from at least the end of the nineteenth century (Figures 26 and 77). The early photographs show that Brewery House had a stone flagged roof which is now concrete pantiles. The only other major changes are the insertion of a dormer window to the front roof pitch of The Old Tunnery, and the replacement of windows. Together with the adjacent Old Brewery, they have considerable group value, in addition to their good individual quality.

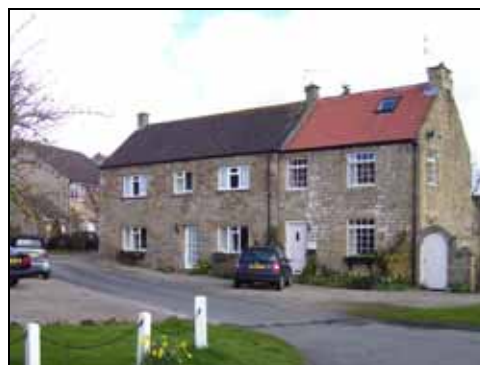
- 7.5.5 The east side of Brewery Square is formed by Westgarth and Brewery Cottage. The 1862 Ordnance Survey shows that this side of the Square continued as a terrace of properties that wrapped around the corner to link onto the cottages on Jubilee Road. By 1898, the terrace had been reduced to Westgarth and Brewery Cottage, and in the early years of the twentieth century much of the site had been developed with the construction of Stonecroft. The south gable of Brewery Cottage contains an area of tumbled rubble that is probably the consequence of the demolition of the terrace. Westgarth has been heightened and the roof pitch eased to match that of Brewery Cottage. Although changed, the two buildings combine to provide a reasonable containment of the Square. Changes to the shape of window openings from vertical to horizontal to the front elevation of Westgarth have had a deleterious effect. The other major change has been the removal of rendered lime wash to expose stonework (Figures 26 and 78).

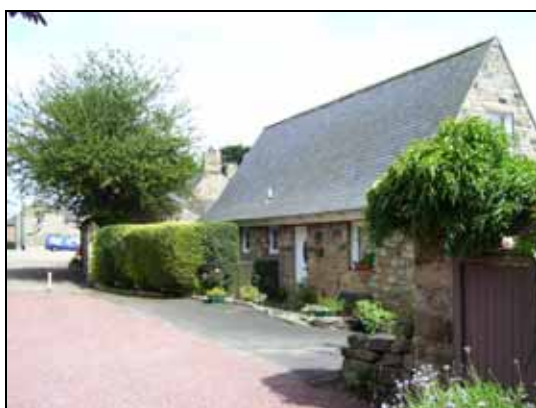
Figure 80 Stockholm

- 7.5.6 New houses have been built between Brewery Square and Ovington Hall. Stockholm was originally intended as a building for an agricultural worker but does not have any occupancy restrictions. It is single storey with a steeply pitched slate roof (Figure 80). The remaining three properties, Bellfield, Fairfield and Meadowfield, are detached two storey houses (Figure 81). They are clearly contemporary and do not have a sense of place or local distinctiveness in the context of their visually sensitive location. Their design diminishes the historic character of this part of the conservation area.

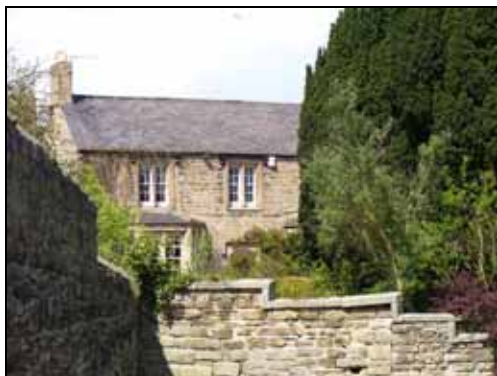
Figure 82 Ovington Hall

- 7.5.7 Ovington Hall and its attached stables are of great merit. They are Grade II listed. The building has a probable medieval core with sixteenth or seventeenth century phases culminating with the development of mid-nineteenth century frontage (Figure 82). The three bay front has an original door in the centre, with an attractive Tudor style arch and hoodmould. The bays either side include two light, eight pane sash windows. The attached two storey stable has a granary on the first floor. It was probably substantially rebuilt in the nineteenth century, but incorporates an early

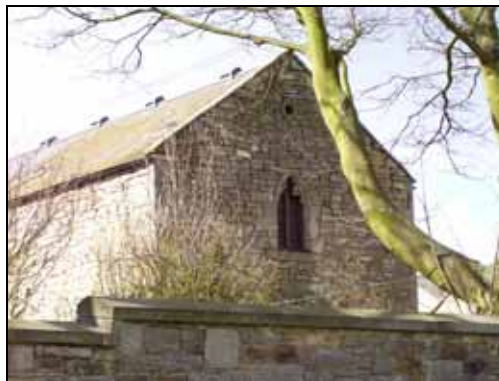
fourteenth century window in the east elevation as a decorative detail (Figure 83). A garden to the front of the Hall is contained by a stone boundary wall and a collection of maturing holly, yew and ash trees. Associated farm buildings to the north east of the Hall have been converted or refurbished to provide residential accommodation.

Figure 83 Ovington Hall stable, the early fourteenth century window

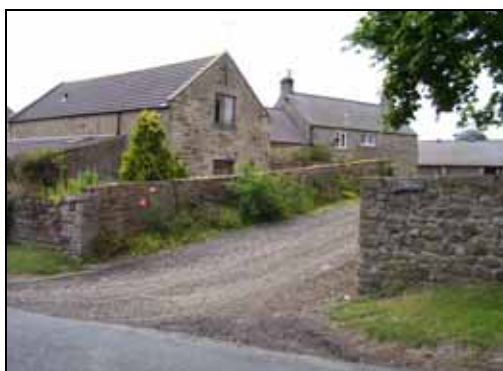
Figure 84 The Old Barn, East Cottage and West Cottage

- 7.5.8 The linked West Cottage and East Cottage retain much of their original character with some alterations, including the insertion of pitched dormers on the south elevation (Figure 84). The Old Barn incorporates some original features, but the quality of its conversion gives it the appearance of being a new building styled to look older. South Cottage is clearly residential, with domestic architecture substantially obscuring its agricultural forebear. Pitched roof dormers and a large, visually dominant, chimney stack reinforce this perception (Figure 85).

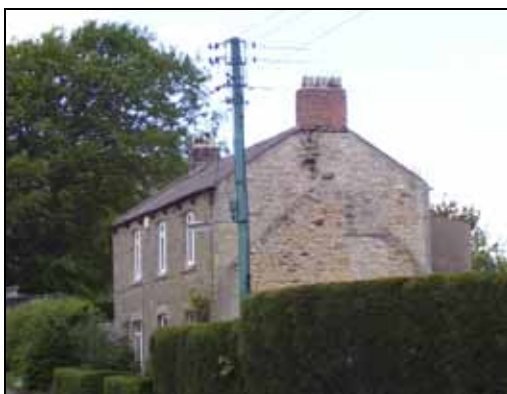
Figure 86 Lodge Farm Cottage

- 7.5.9 Two properties, Lodge Farm Cottage and The Band Hall/Old School House on the east side of the main street complete the conservation area. They are separated from one another by 7 to 12 The Green, built in the 1930s, which lie outside the conservation area boundary. Lodge Farm Cottage (Figure 86) is an attractive nineteenth century detached house that remains substantially unaltered, the principal change being the insertion of new windows into original openings. The house is constructed in squared, random rubble with a Welsh slate roof and brick chimney stacks. The south elevation incorporates the remains of a previous single storey building. The former school was built in 1832 and enlarged in 1859 and 1880. The school closed in 1961, and was subsequently used as a bandhall until 1993. It was then converted into two houses. It still maintains its general appearance and retains some original details, making a valuable contribution to the social and architectural history of the village (Figure 87).

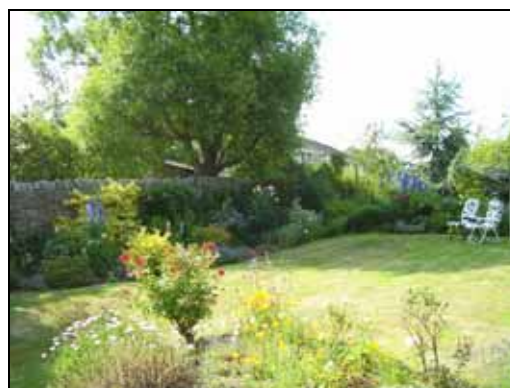
8.1.2 To include the surviving gardens to the north of Holly House and the north of East Farm. The adjacent gardens and fine surviving stone boundary walls, although truncated, are important extant remnants of the traditional ribbon gardens that were a dominant feature of nineteenth century Ovington. They also provide attractive settings to the two buildings, and a buffer between the late twentieth century Springfield estate and the historic core. It is important to ensure that these spaces are not developed, but retained as open curtilage space (Figure 90)

Figure 90 Surviving garden and boundary wall, Holly House
