Flood Investigation Report

Location: **Burnstones (Knarsdale)**

Incident Date: **28/06/12**

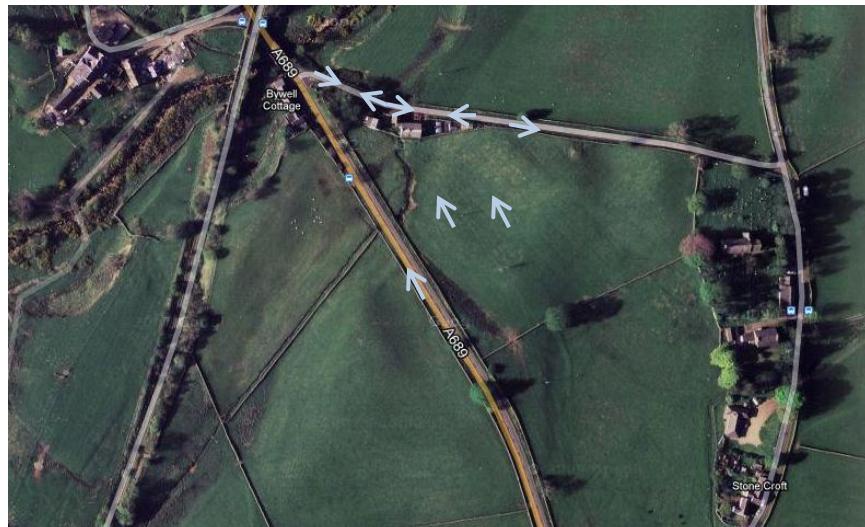
Plate 1: Flow routes in Burnstones

In Burnstones surface water from the A689 contributed to the flooding of one property. In other rainfall events, the drainage system along this stretch of road has been adequate, with no reported previous problems. However, the rainfall on the 28th June was excessive and the drainage system could not cope. The standing water on the road was not at a depth to flood the adjacent properties but speeding vehicles on the road caused waves in the flood water which resulted in the subsequent flooding.

The properties off the A689 within Burnstones south of the masonry arch bridge were affected by flooding. There is an ordinary watercourse that flows from south to north, at the back of these properties. The watercourse enters a culvert adjacent to one of these properties before exiting south of the road. Reports were that water levels in this watercourse rose and became out of bank, here water flowed around to the front of the properties and water entered via the front doors. Surface water from the highway would have also contributed. However, the contours of the road mean that there is not a large contributing area.

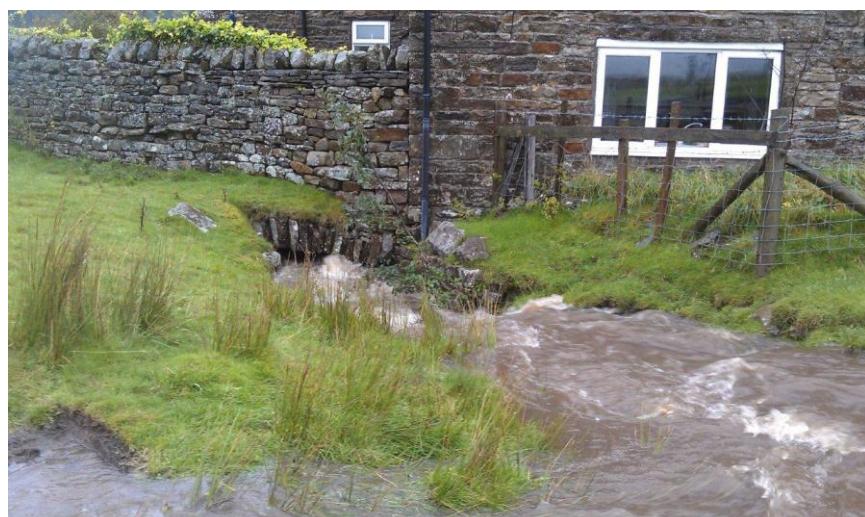
Plate 2: The entrance to the culvert in bank full conditions at Merit Hall, Burnstones
