## **Flood Investigation Report**

## 4.6

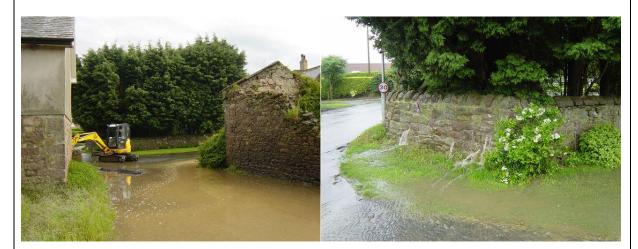
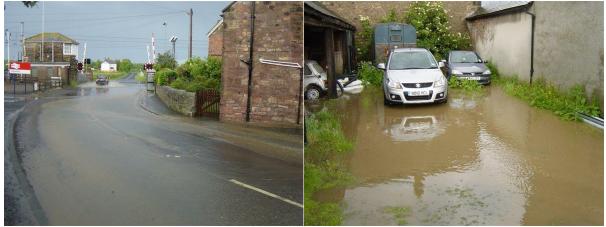
High-intensity rainfall on 28 June 1012 resulted in flooding to the highway and properties to the west of the railway line. Surface water from the highway and land to the south and east of the village was conveyed through the village. Due to the flashy nature of the event the drainage system was overwhelmed. Four properties are reported to have experienced internal flooding, with access problems and 'near misses' reported to at least a further two properties.

Photos of flooding in Chathill on 28 June 2012

RMA Actions:					
	Exercised:	Flood Investigation carried out			
NCC	Proposed:	Investigate opportunities for funding to support further study and alleviation of the issues.			
EA	Exercised:				
	Proposed:				
NWL	Exercised:				
	Proposed:				
Other	Exercised:				
	Proposed:				
Additional supporting information
