Lynemouth Coastal Landfill

Site Characterisation and
Interim Generic Quantitative Risk Assessment

Client: Northumberland County Council

Reference: PB9153-RHD-ZZ-XX-RP-Z-0001

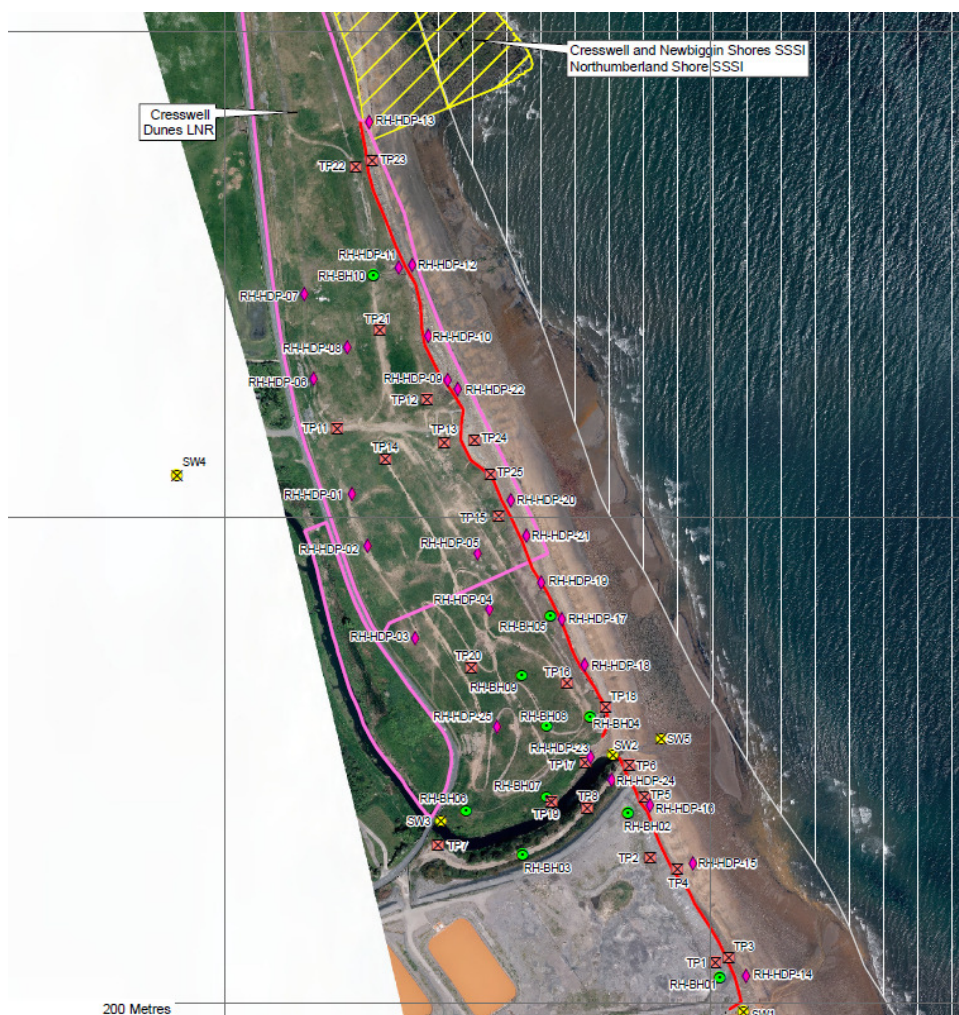
Figure 1: Sampling Location Plan

The Lynemouth Coastal Landfill 2019 ground investigation was designed by RHDHV and carried out by Dunelm Geotechnical and Environmental (Dunelm). Two site supervision visits were conducted during the works with regular phone calls between RHDHV and Dunelm to discuss installation details and any queries that arose during the works. Following a review of the available information the site was designated as a red site, as such appropriate working practices were implemented in order to protect those working on site.
