## **Flood Investigation Report**

#### 4.7

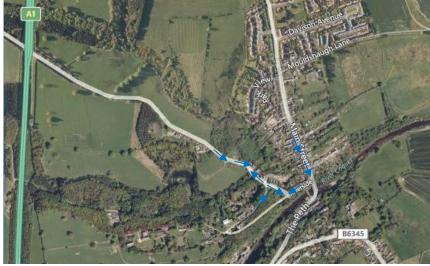
Figure 1: Surface water flow paths around Felton

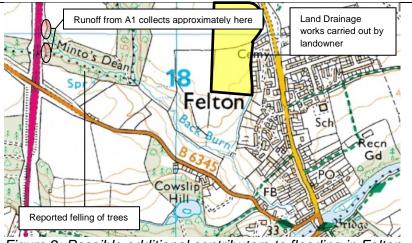
Figure 2: Possible additional contributors to flooding in Felton

The Highways Agency have been contacted to obtain drainage plans from the A1. In addition we have asked for any features to be investigated and cleared if necessary. It may be possible that any surface water features were not working to their capacity and hence this could be increasing the risk of flooding on the Back Burn.
