Flood Investigation Report

Location: Halton Lea Gate	Incident Date: 28/06/12 & 04/08/12
----------------------------------	---

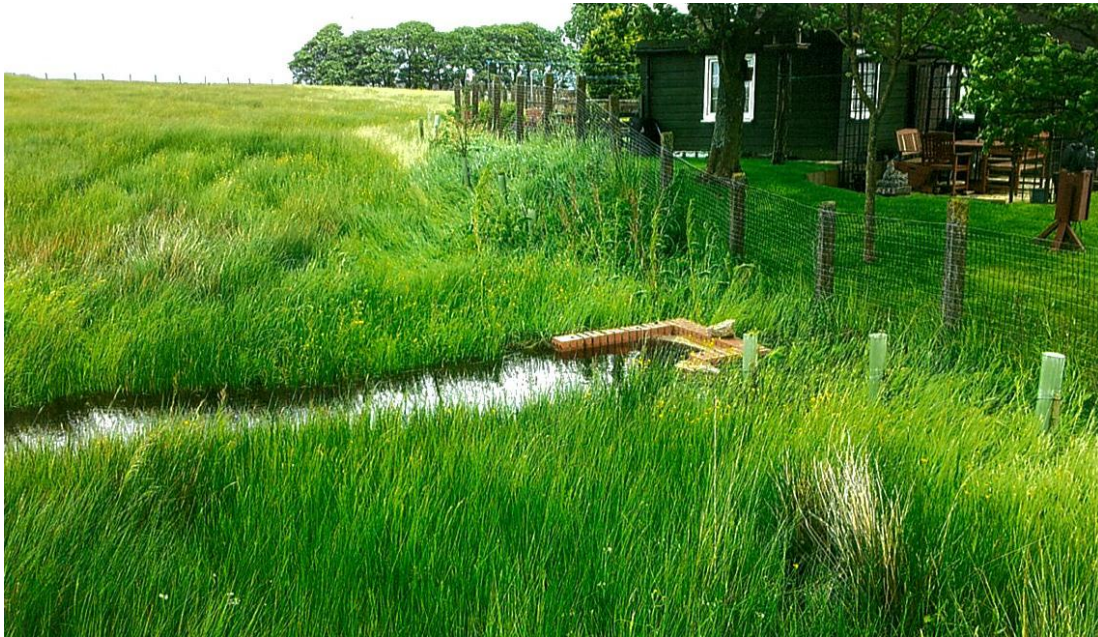
On the 28th June flooding in Halton Lea Gate occurred in two main areas of the village. The first was within the Leaside area. An ordinary watercourse that takes rainfall from the hills south of the village, runs northerly under the A689 and then west of Leaside. Here a culvert runs under the road before outfalling into the watercourse about 160 metres east. The inlet to this culvert became blocked which caused flood waters to rise and eventually come out of bank. Once out of bank the flood waters went through some of the gardens in Leaside and onto the road. Surface water runoff from the fields at the rear of the northern properties of Leaside led to the flooding of gardens and contributed to the flooding within the roads. There is also a green area within Leaside, which according to reports is quite often very wet. The wet area is caused by groundwater flooding and could be a result of historical mining activity in the local vicinity.

Figure 1: The blocked inlet west of Leaside, Halton Lea Gate

NCC	<i>Exercised:</i>	Carried out Flood Investigation Report.
	<i>Proposed:</i>	Look to seek funding for any potential flood alleviation works in the MTP.
EA	<i>Exercised:</i>	
	<i>Proposed:</i>	
NWL	<i>Exercised:</i>	
	<i>Proposed:</i>	
Other	<i>Exercised:</i>	
	<i>Proposed:</i>

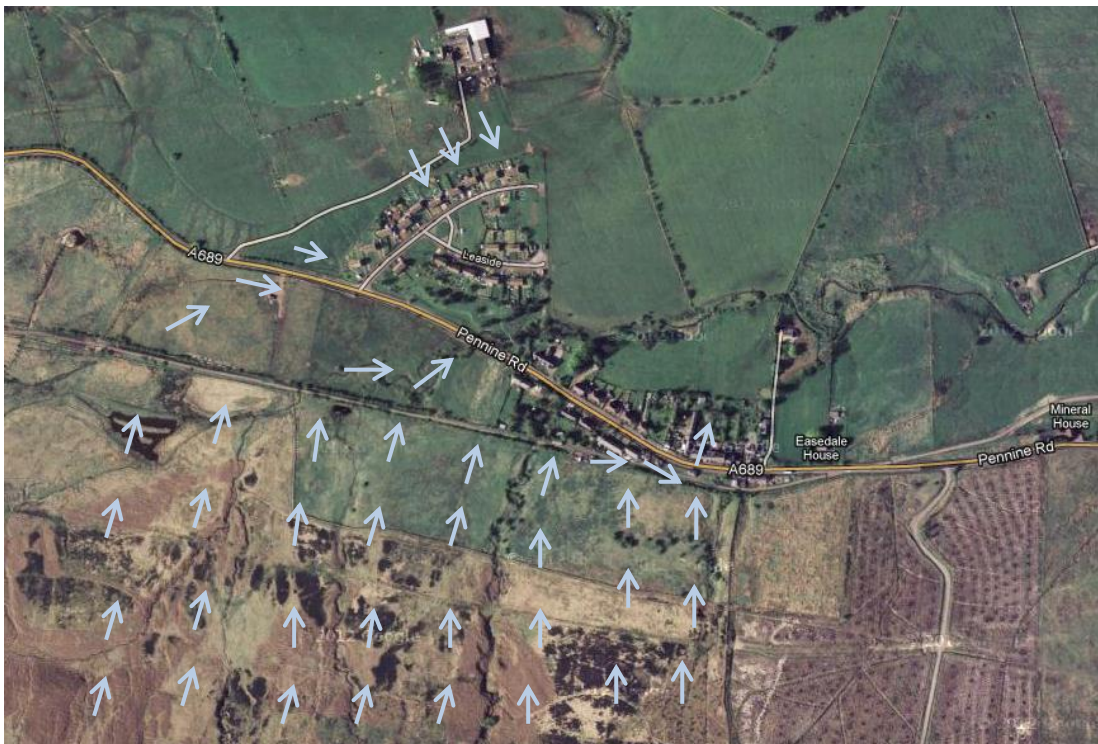
The second area that was affected was the eastern end of Pennine Road (A689). Here 5 properties were flooded. The old railway line to the south of Pennine Way now forms a cycle path that is maintained by Sustrans. There is a ditch that runs west to east, south of the cycle path. The fall of the cycle path is such that it falls from north to south. This fall means that surface water will run into Pennine Road and not the adjacent ditch. Water was funnelled down the access road to the cycle path and into the gardens and properties of Pennine Road.

Figure 2: Surface water flows around Halton Lea Gate

Post flooding edit – During a site visit on 14 March 2013, clearance works on the ditch adjacent to the cycle path had been undertaken.
