Flood Investigation Report

2.2.2

Location: **Ovingham**

Incident Date: **12th August 2019**

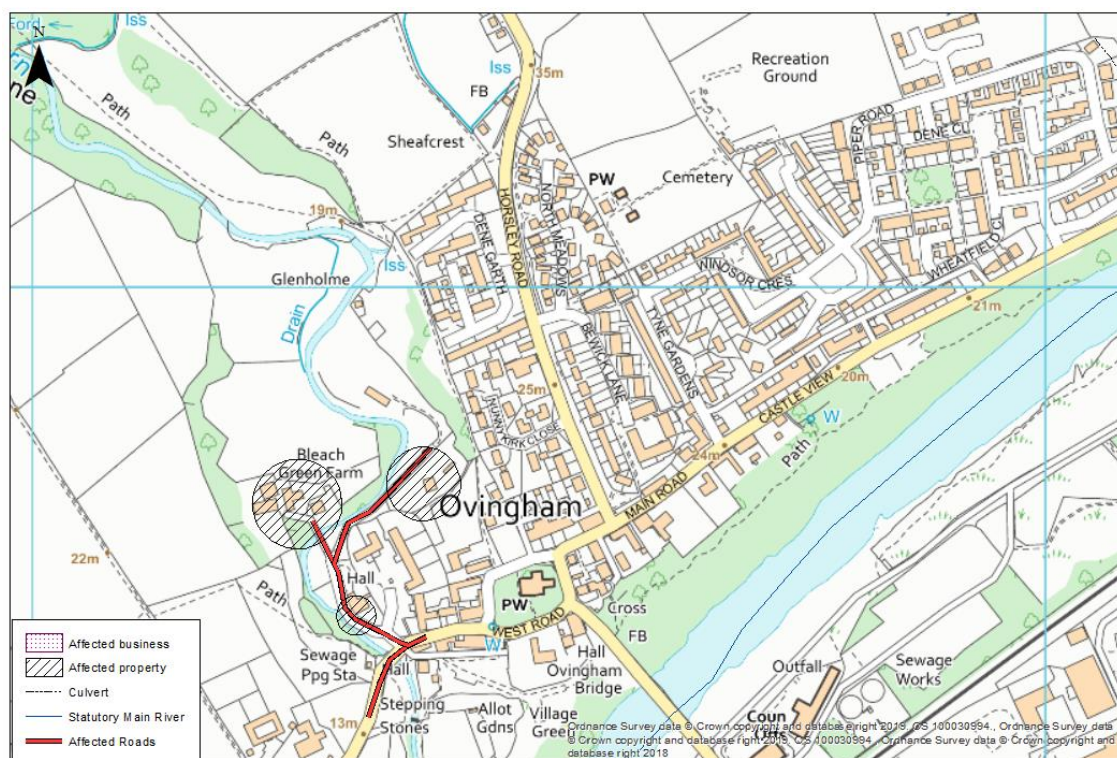
Whittle Burn – high flows and debris caught on the Whittle Burn Bridge (West Road) caused the burn to back up and breach its banks causing flooding to the highway and driveways. 2 properties suffered internal flooding, one of which had property level protection (PLP) in

High river levels in the Whittle Burn, debris caught on road bridge, 13th August 2019
