Flood Investigation Report

4.17

cation: Ponteland					25/09/2012
Source(s) of flood		0 (
Ordinary Vatercourse	Main River	Surface	Groundwater	Sewer	Coo	Tidal
watercourse	River	Water	Groundwater	Sewer	Sea	Lock
		\boxtimes				
	sidential	Business	Other Buildings	Roads	Critical In	frastructure
number)	9	0	0	4		0
West Houses For Reference Punot To BE REP		Cartle Parties And Andrews And	Pol Standard Bridge Standard S	CH Clicke	ckemin viot ew	Metres N
Northumberland County Co		FCERM	Ponteland - flooded areas 25/09/2012		250 500 L I I I J	Surface water flow direction
Northumberland County Council County Hall Morpeth Northumberland NE61 2EF Tel: 01870 533000	This map is reproduce Cristiance Survey on Crown Copyright. Un may lead to prosecut	sed from Ordnance Survey material with the permit behalf of the Controller of Her Majesty's Stationar authorised reproduction infringes Crown Copyright tion or civil proceedings. License no. 100049048 (;	ossin of Office and and and (2009). Drn: Date: Scale: 10/12/2013	— Ord	ids_affected inaryWatercourses n_rivers_10k	- now direction

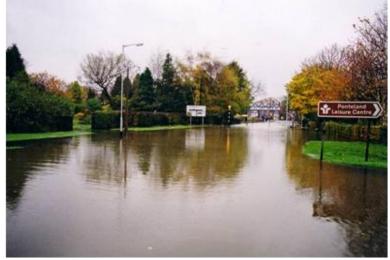
Plate 1: Flooding of Callerton Lane near Mayfair Gardens

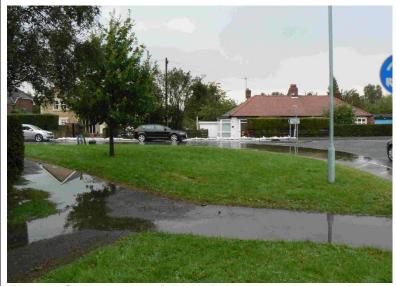
Plate 2: Callerton Lane/Middle Drive roundabout and impromptu sandbag barrier at driveway
