# Ovingham Bridge Blog – June-August 2014

27 August 2014

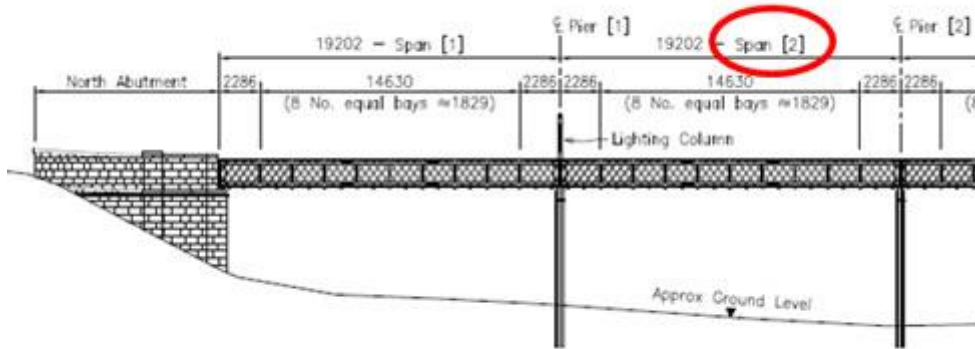
Upstream elevation at Ovingham end of bridge, showing spans 1 and 2 and piers 1 and 2

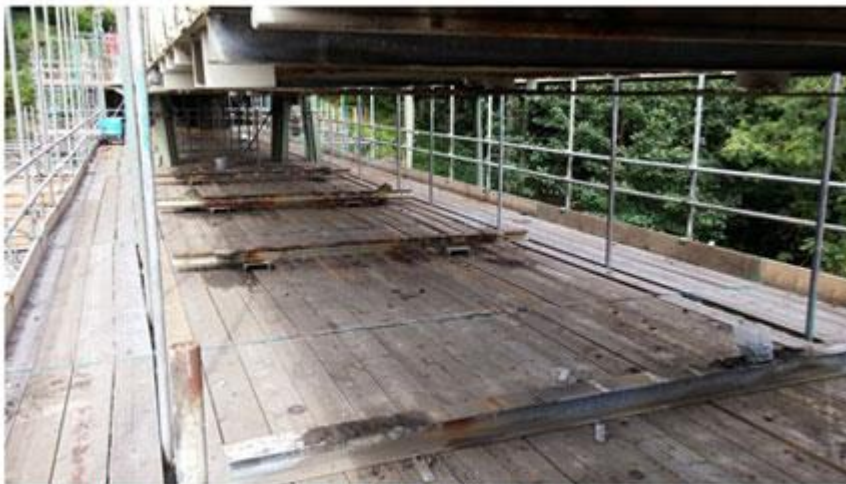
Photograph taken 22 August 2014 looking towards Ovingham  
Cross girders removed from span 2

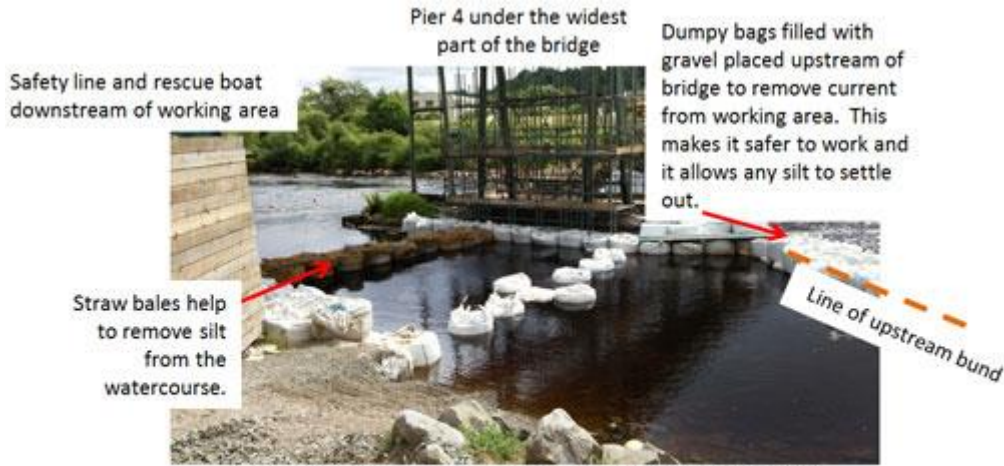
Photograph taken 30 July showing temporary works in the river, in order to build scaffold supports around bridge legs. River levels were low, typically around 0.4m, as measured at Bywell gauging station. River levels are available from the Environment Agency's website.

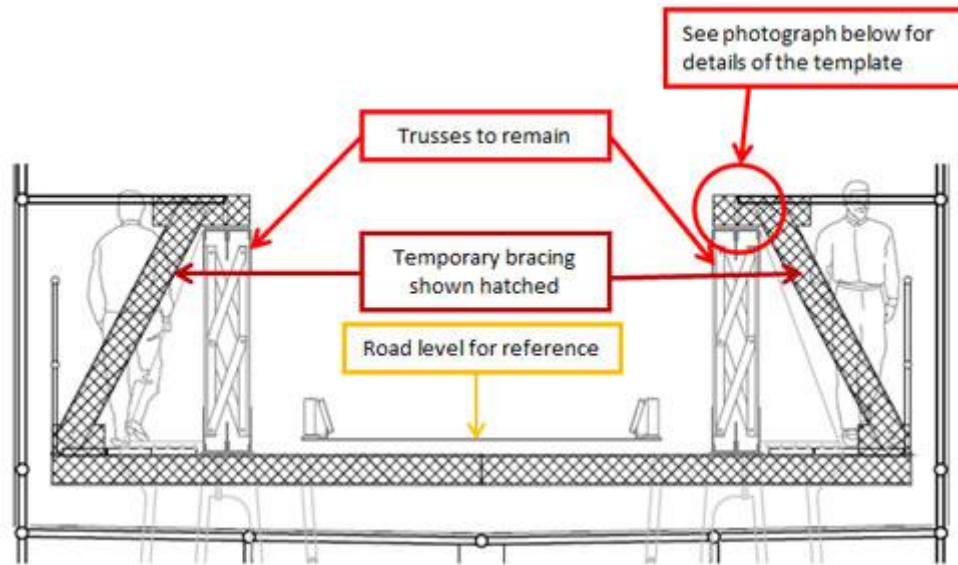
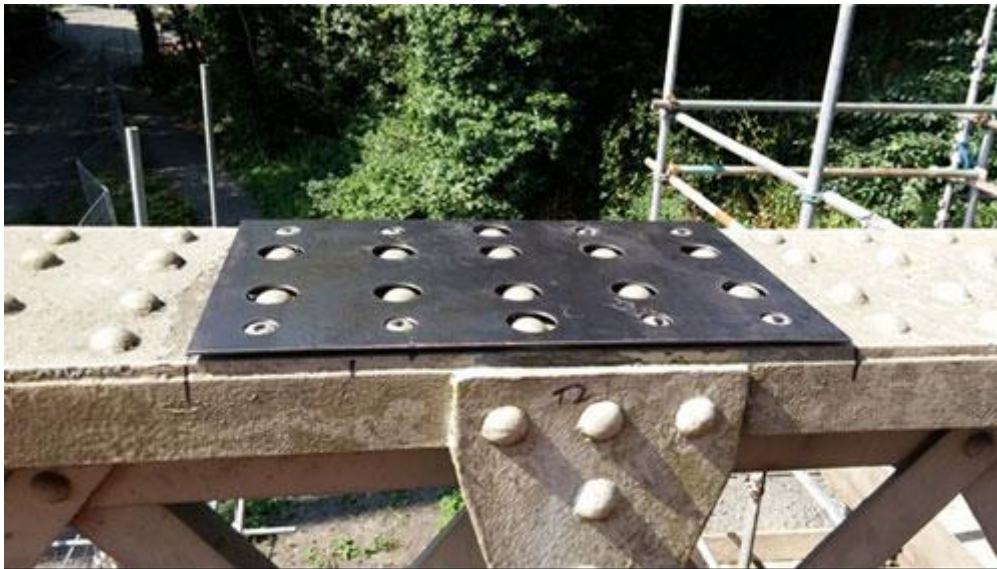
The steelwork fabricator is making a template of the rivet layout to the top of the truss. This is to ensure the connection between the top of the truss and the temporary bracing will fit. See the diagram above for the temporary bracing layout. There are ninety six of these plates to be made. With specials required at the passing place (because of the change in angle) and where the rivet layout is different to that shown above, as the photograph below demonstrates.

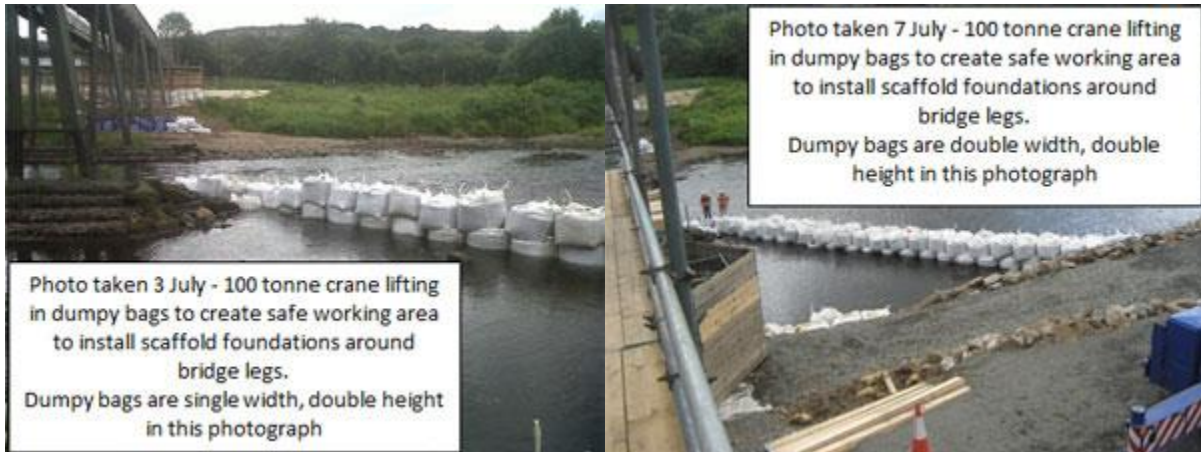
The section of bridge which is missing its scaffold requires foundations in the river.

The crane on site is placing dumpy bags within the watercourse to provide a safe working area to construct the scaffold foundations.

The scaffold above water level will be 2m (6') away from all faces of the pier. The foundations will be the same distance out from the visible scaffold.

It is expected this work will be halted today due to the weather. Depending how much damage is done to the dumpy bags in the lower photograph. This will dictate how much time is spent putting them right, before the planned work can continue.

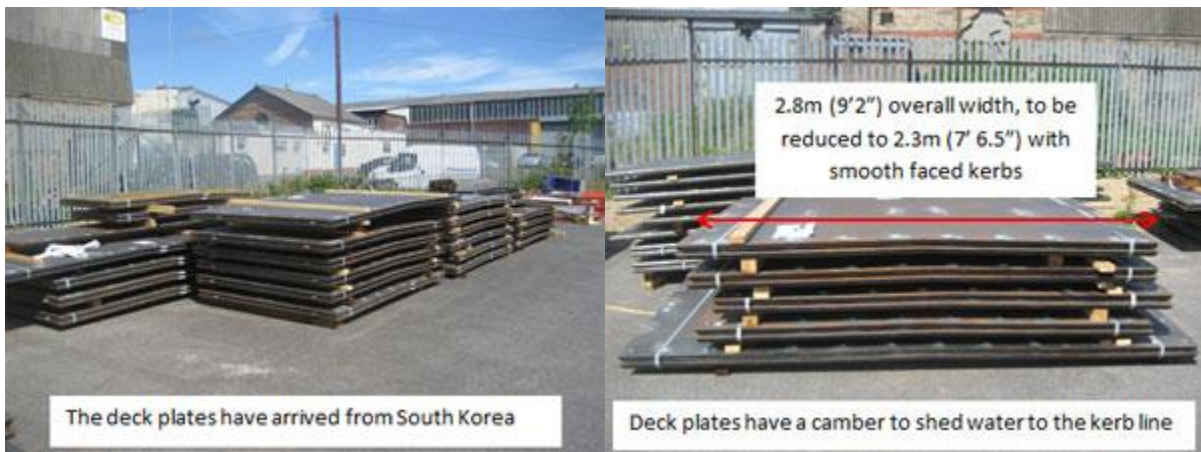
The deck plates are 41mm (1.6" thick), they are comprised of 8mm thick steel plates 25mm (1") apart. The 25mm (1") gap is injected with polyurethane filler.

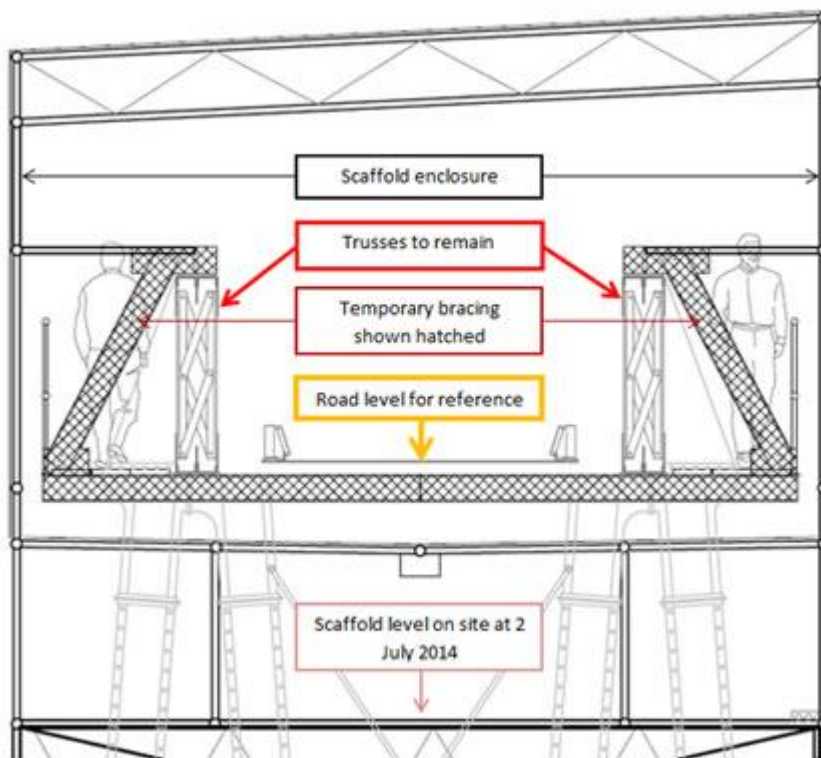
Scaffold enclosure, showing temporary bracing
