Ovingham Bridge Blog – September-December 2014

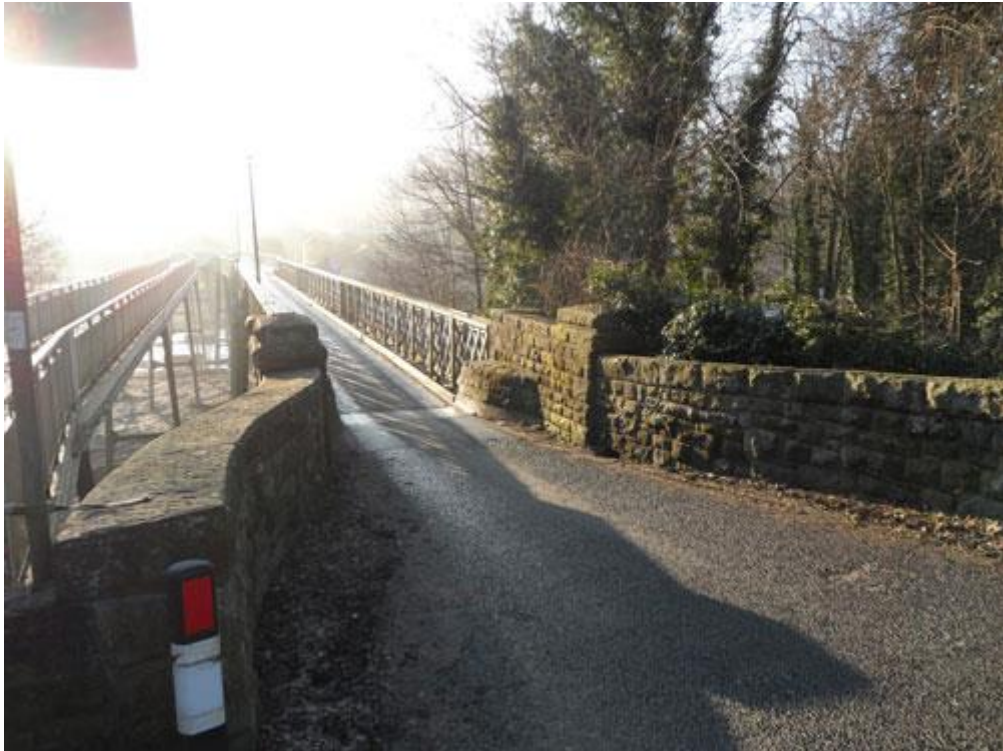
Photograph taken 19 February 2013

General view of approach walls at Ovingham end

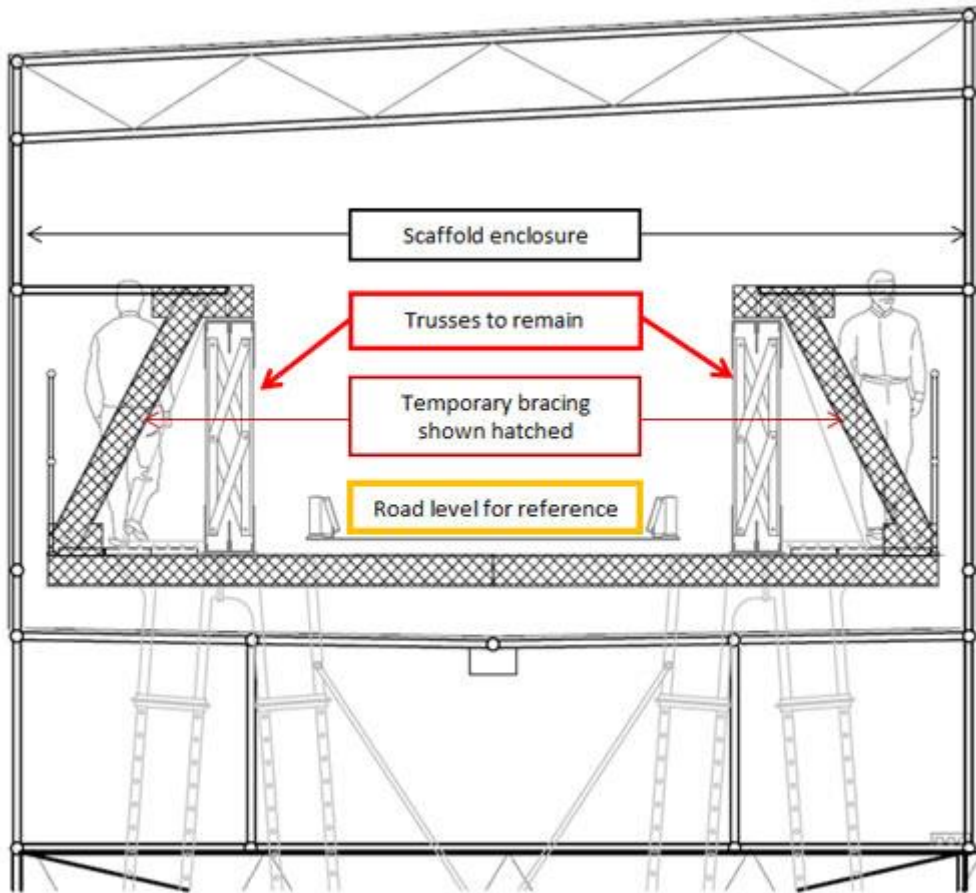
Scaffold enclosure, showing temporary bracing

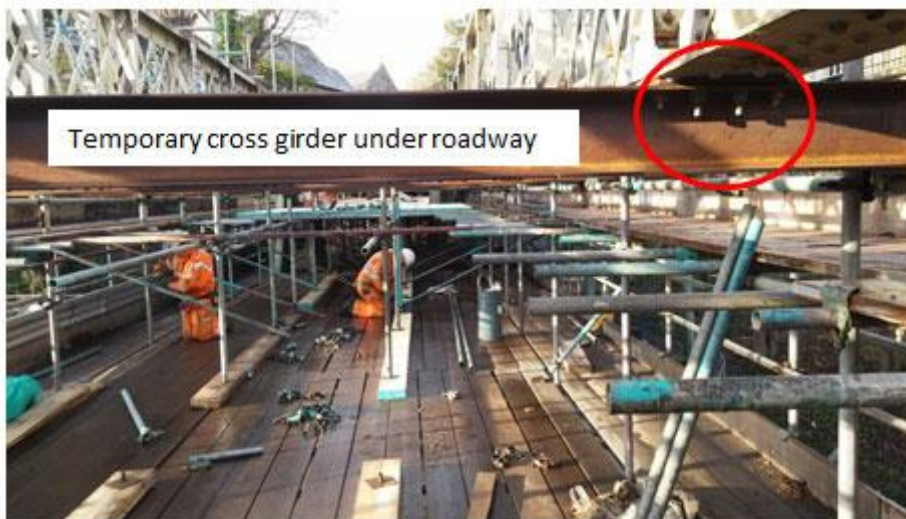
Photograph taken 12 November 2014 Scaffold beneath the road is being constructed. For connection detail (within red circle) see photograph below.

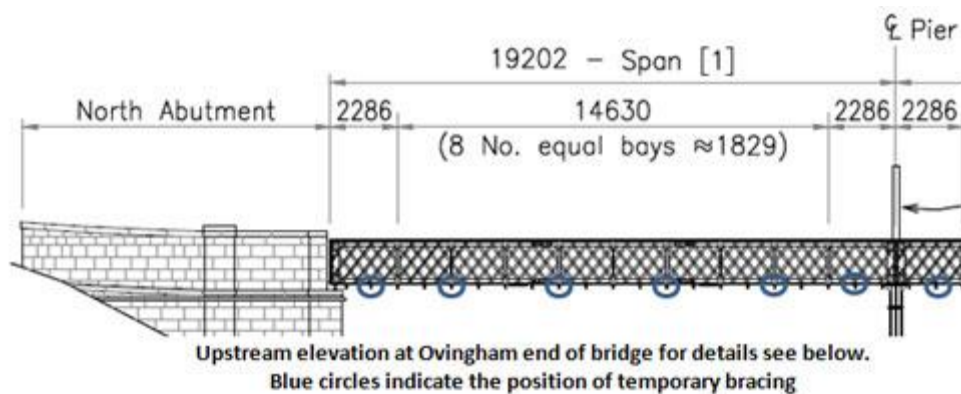
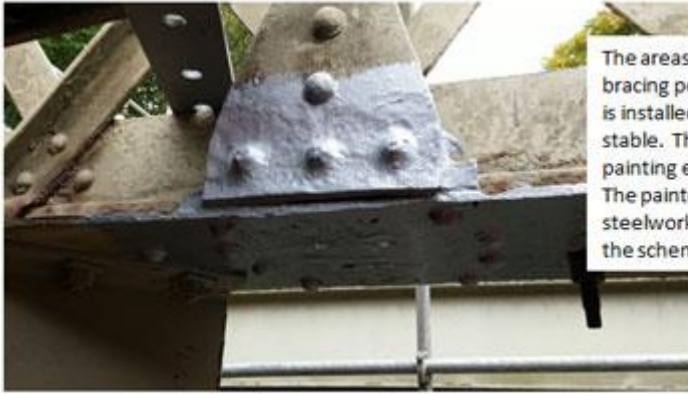
The areas being painted are at temporary bracing positions. The temporary bracing is installed to ensure the trusses remain stable. The critical load case is when the painting enclosure is loaded by wind. The painted areas will be covered by steelwork elements for the remainder of the scheme.

Refer to the blog dated 15 October, which gives the extent of the area to be prepared, repaired and painted.

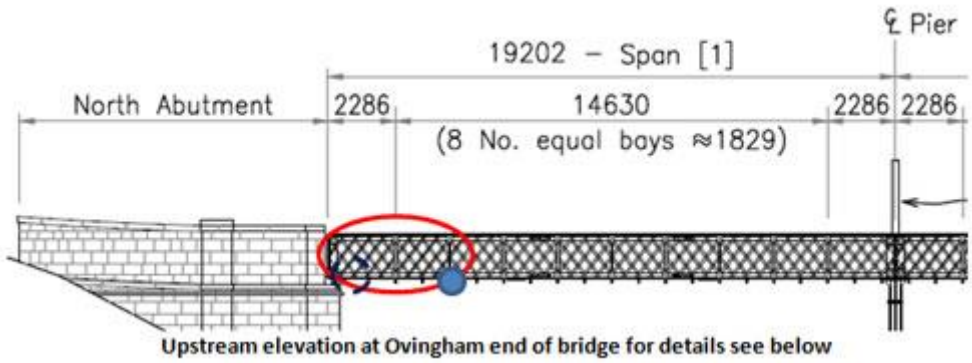
Detail to upstream elevation at Ovingham end of bridge showing extent of repairs
 Members called off as B and C are flats, members called off as D and E are angles
 10mm thk overplates (red lines) and web plate repair (dark blue oval)

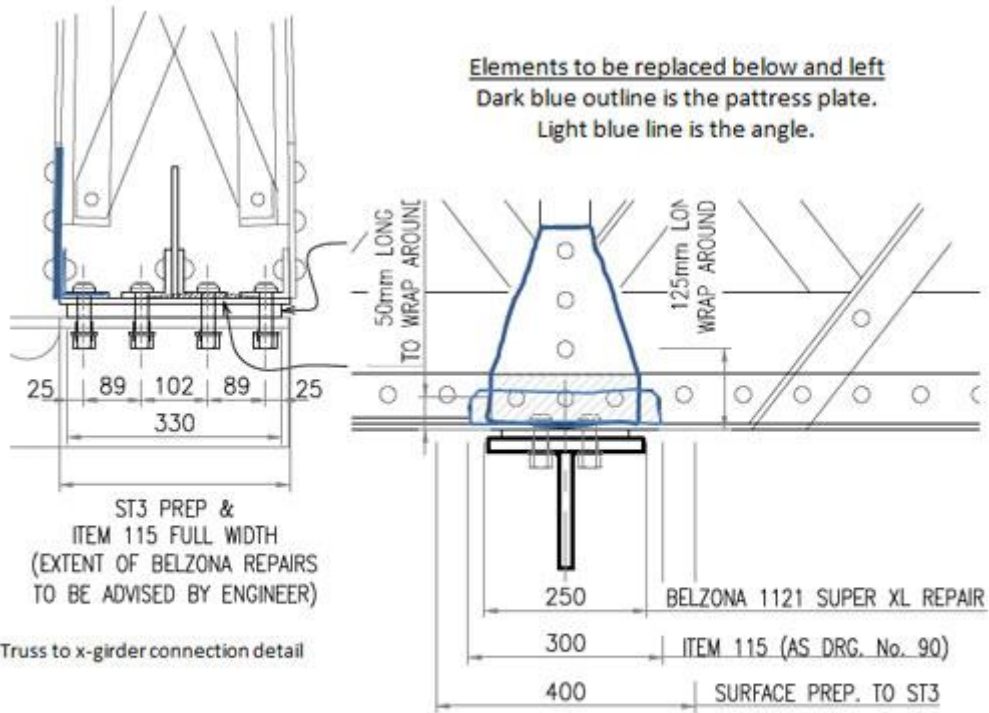
Truss to x-girder connection detail, showing permanent x-girder.
See photo dated 29 August for the marked up surface preparation

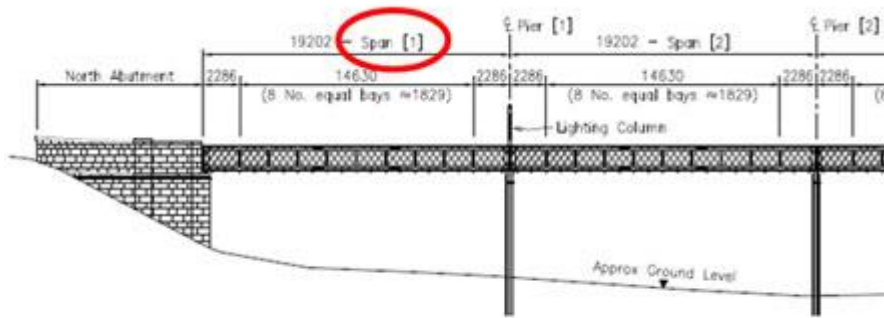
Upstream elevation at Ovingham end of bridge

Photographs below were taken on the underside of the truss in span 1
