# VERIFICATION REQUIREMENTS FOR COVER SYSTEMS

Technical Guidance for  
Developers,  
Landowners and  
Consultants

**Yorkshire and Lincolnshire  
Pollution Advisory Group**

Version 4.1 – June 2021

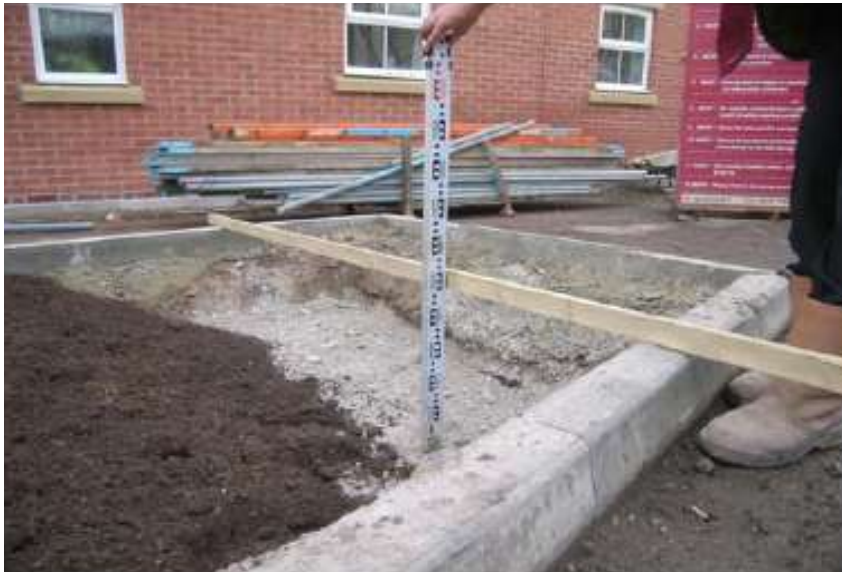
Photograph 1:  
Depth check of inert  
cover within area of  
public open space.  
Physical break layer  
and topsoil visible.

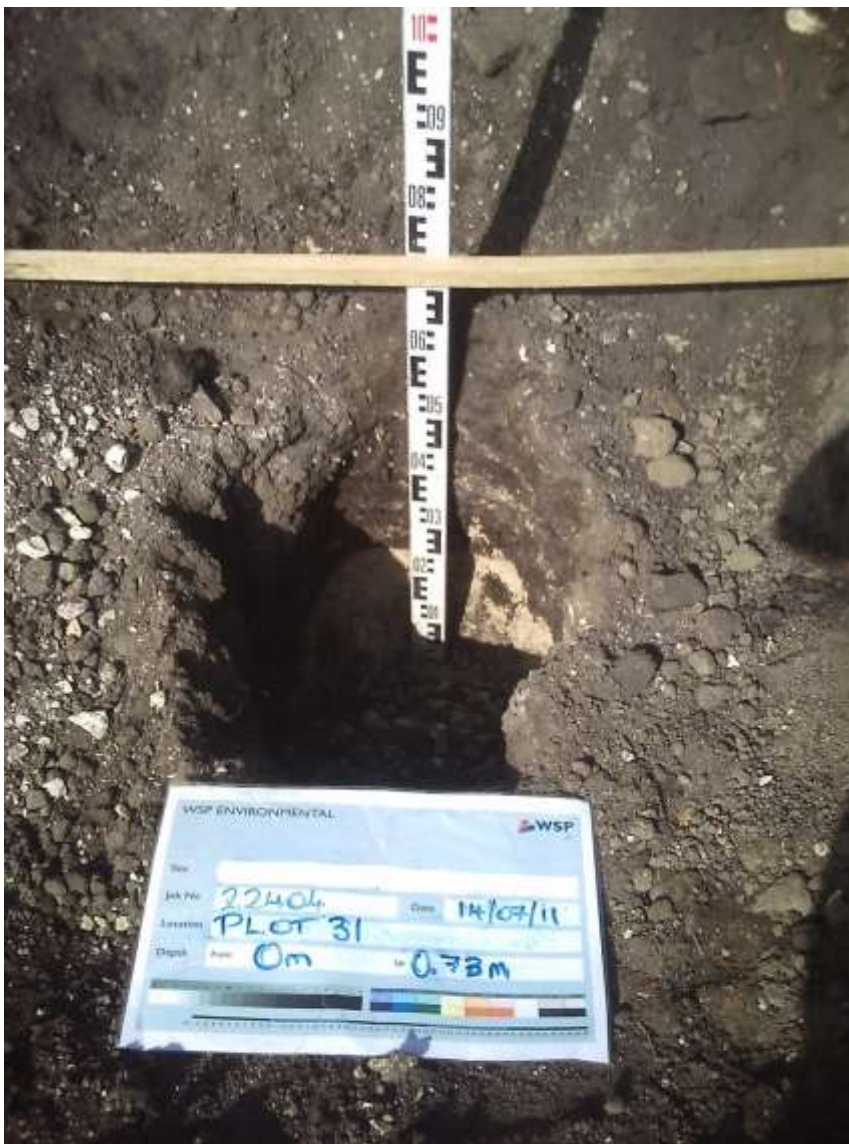
Photograph 2:  
Depth check of inert  
cover with Site &  
Location Information  
Board.

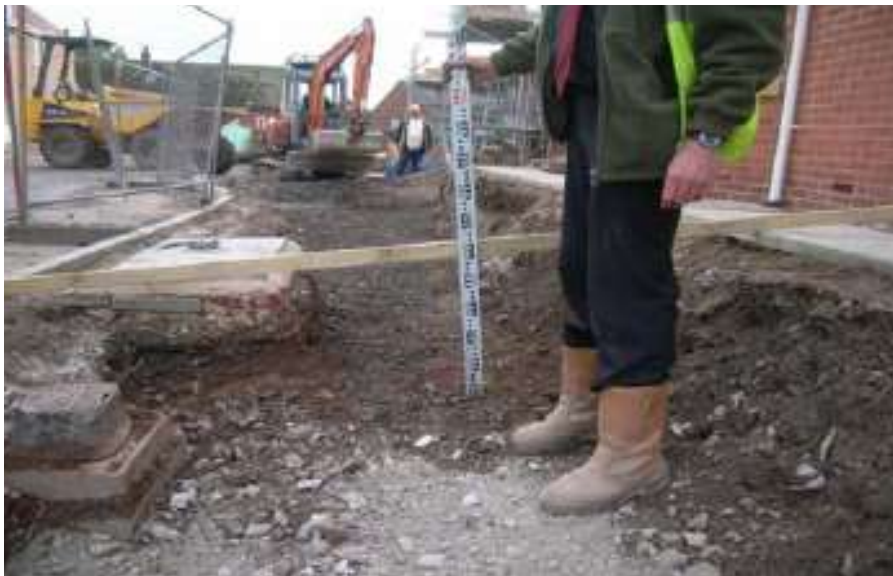
Photograph 3:  
Depth check of inert  
cover within areas of  
front gardens.

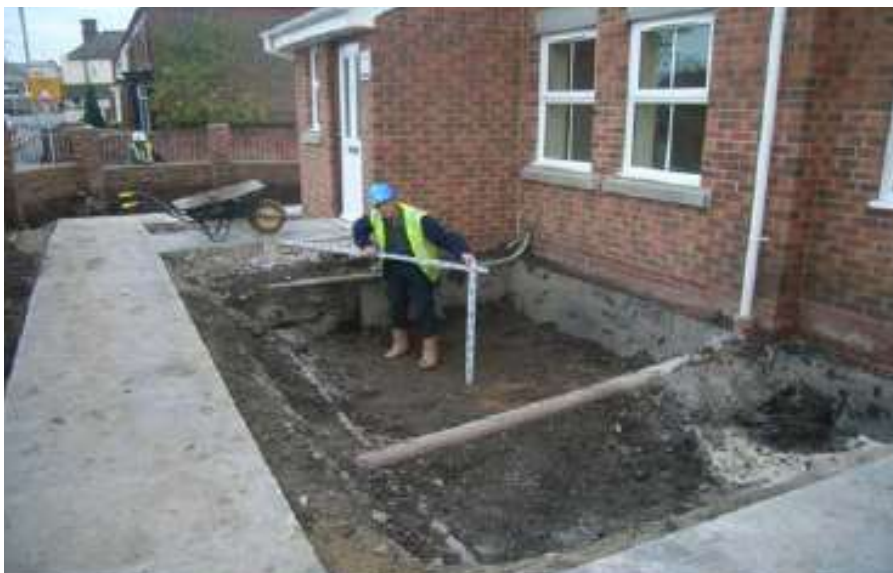
Photograph 4:  
Depth check of inert  
cover within areas of  
front gardens.

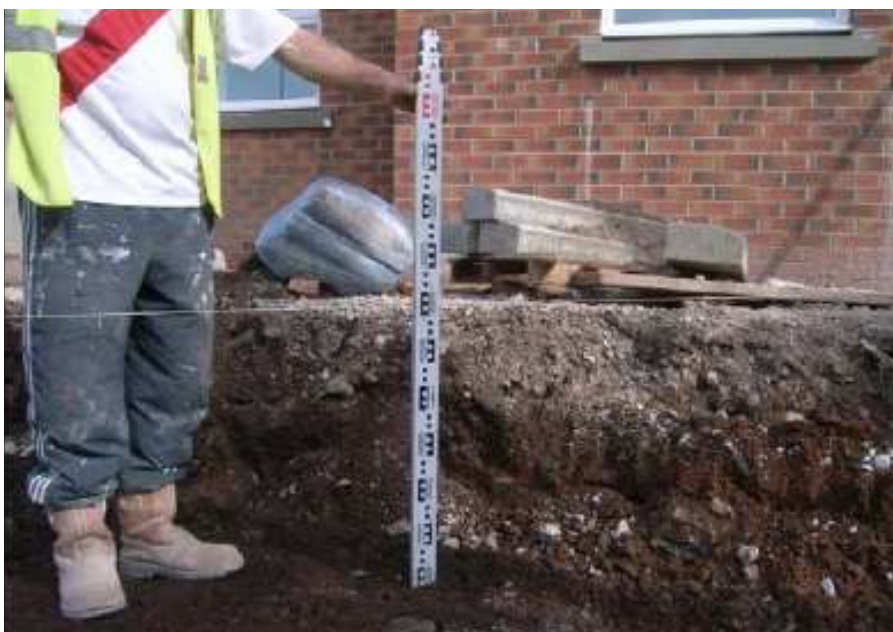
Photograph 5:  
Depth check of inert  
cover within rear  
gardens. Taut string  
line spans across  
excavation.

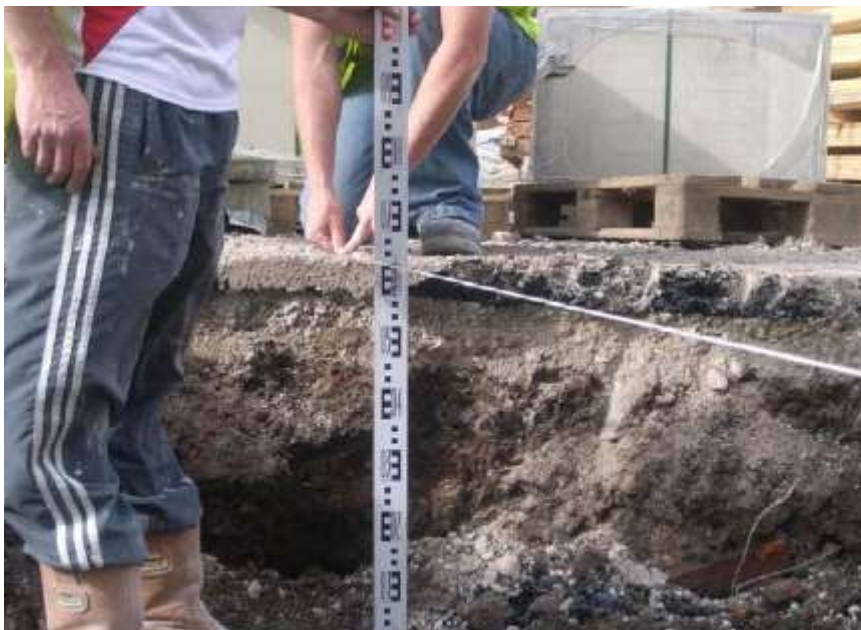
Photograph 6:  
Depth check of inert  
cover within rear  
gardens. Taut string  
line spans across  
excavation.

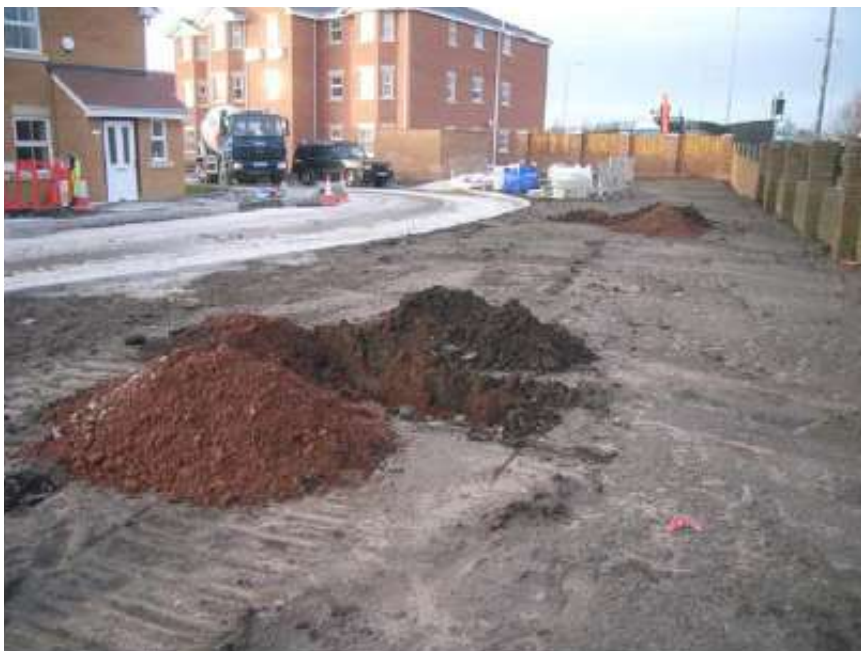
Photograph 7:  
Shows the spatial  
location of the  
verification pit.

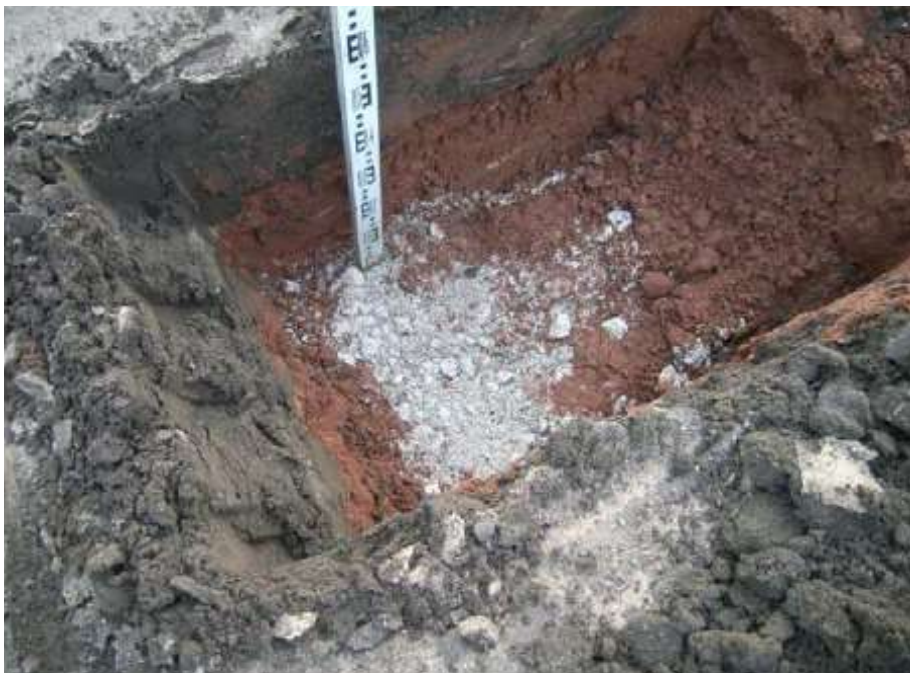
Photograph 8:  
Excavation within  
public open space  
and verification pit  
showing the presence  
of a remediation  
break layer at the  
base, a crushed  
sandstone inert fill  
overlain by topsoil.

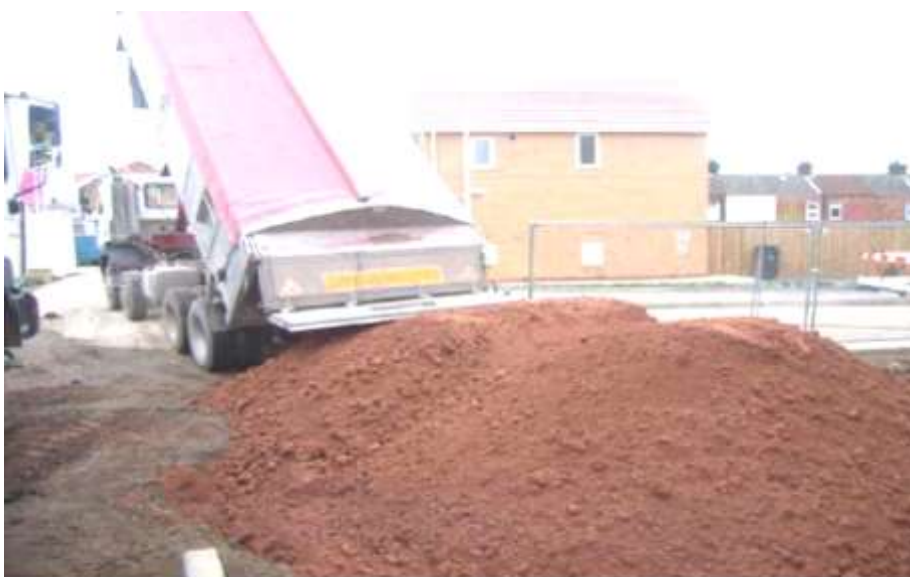
Photograph 9:  
Inert crushed  
sandstone being  
delivered. The spatial  
area of the  
remediation can be  
observed from these  
photographs (old  
terrace housing).

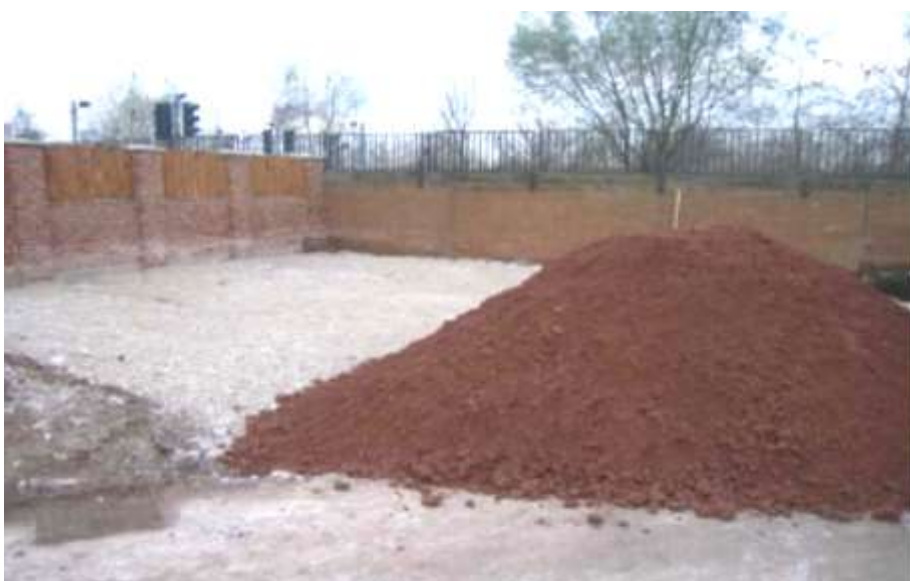
Photograph 10: Inert  
crushed sandstone  
being delivered with  
visible remediation  
break layer. The  
spatial area of the  
remediation can be  
observed from these  
photographs (traffic  
lights).

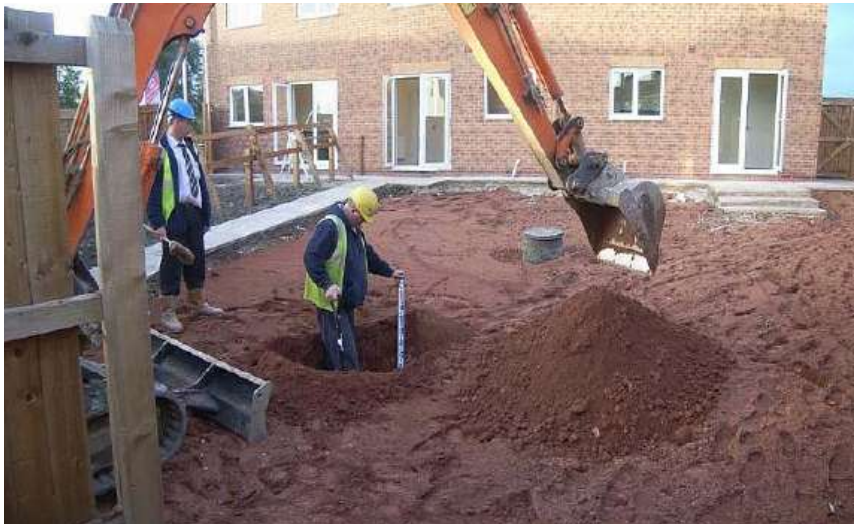
Photograph 11:  
Shows the  
remediation of the  
rear garden, with a  
significant depth  
(1.0m) of inert cover.  
This photograph has  
been stitched to form  
a panoramic  
photograph and  
hence there is slight  
distortion

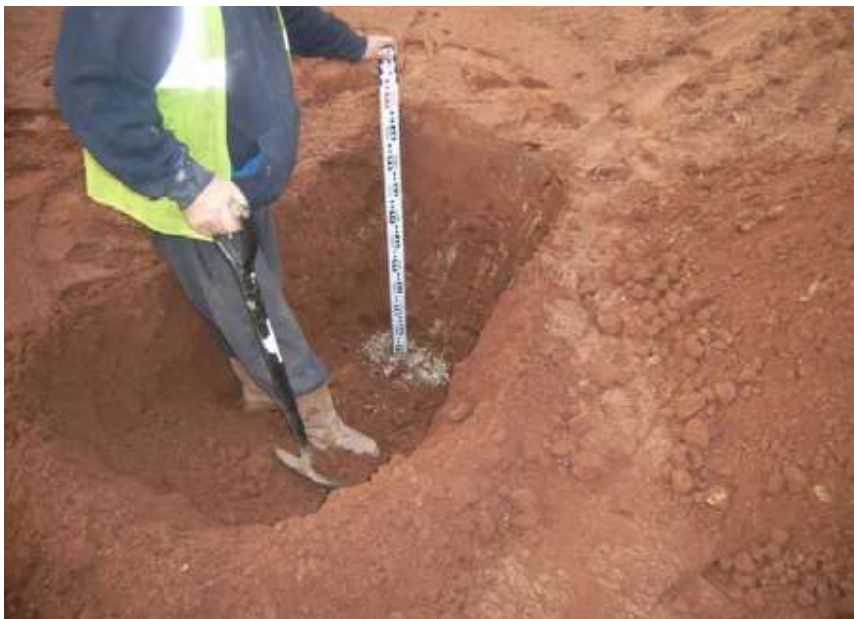
Photograph 12:  
Shows the  
remediation of the  
rear garden, with a  
significant depth  
(1.0m) of inert cover.  
Remediation break  
layer visible at the  
base of the  
excavation.
